ISSUE 57 Aug/Sep/Oct 2007

12-VALVE DOWEL PIN COMMON-SENSICAL SOLUTION (and 24-VALVE?)

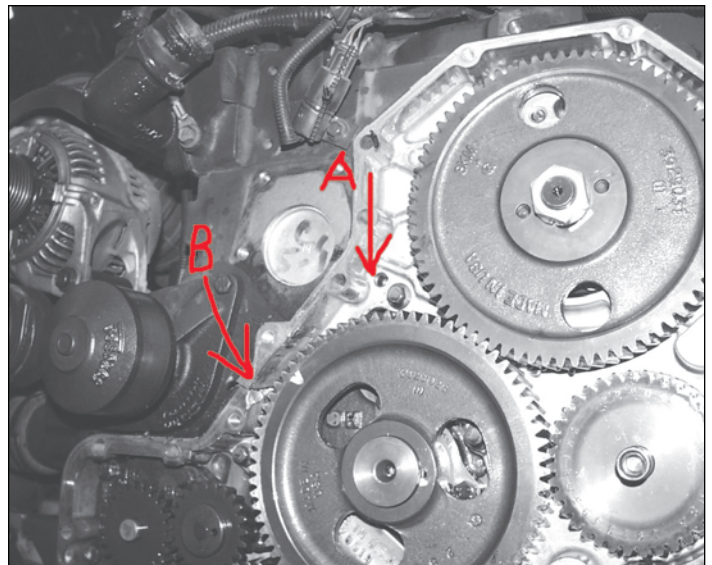
The belief is that the vibrations and weight of the P7100 fuel pump may cause the dowel pin to loosen in its bore and fall out. If the dowel pin does fall, it can be caught in the fuel pump gear causing a major problem (cracked cam nose): or it can fall between the cam gear and the front housing and, in its path to the bottom of the oil pan, crack the gear case housing. I've heard many a story of how the cracked housing has been fixed using J-B Weld epoxy. Alternately, the gear housing can be removed and replaced, but this is a big task, as the engine's camshaft has to be removed to remove/replace the housing. A final fall-out scenario, the pin falls to the bottom of the oil pan and resides in the bottom of the pan forever (or at least until the pan is removed). There is a screen on the oil pickup tube that prevents the pin from moving into anywhere other than the bottom of the oil pan.

For those not familiar with the dowel pin the arrow shows its location.

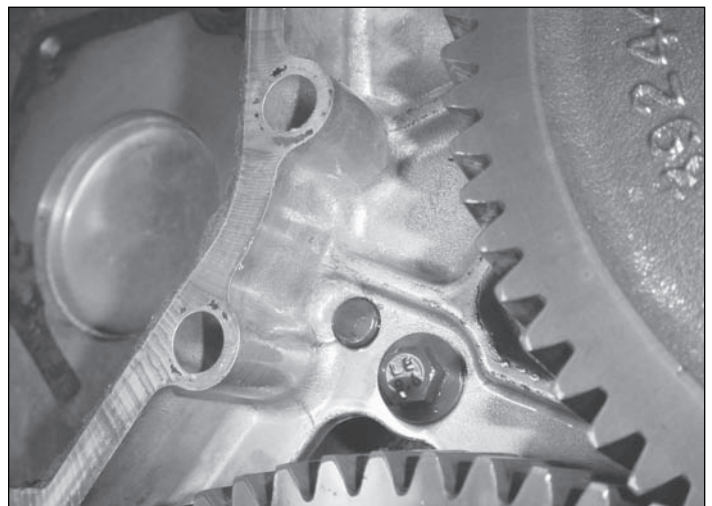
A close-up picture of the dowel pin.

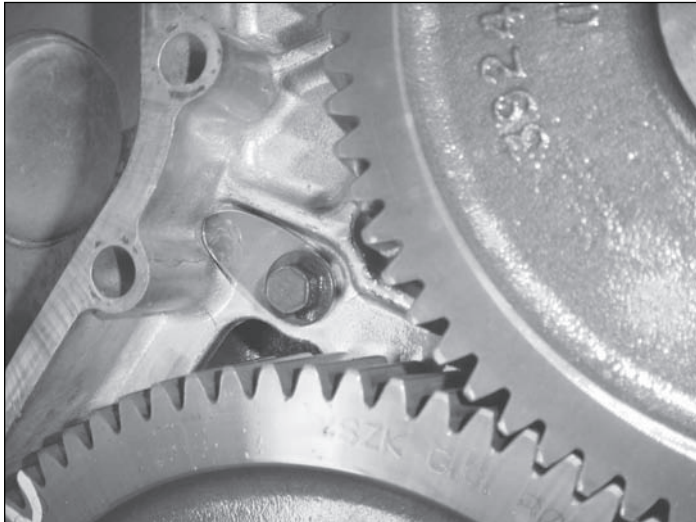
Above is a picture of an egg-shaped washer that is the TST solution to the problem.

- 13) Lucky step 13! Time to install the special egg-washer, preventive maintenance part. Locate the 10mm bolt next to the dowel pin and remove it, reinstall the longer bolt using the special washer supplied in the kit. This washer will prevent the dowel pin from backing out. Apply Loctite high strength (red) thread locker to the threads and torque the bolt to 18 ft-lbs.

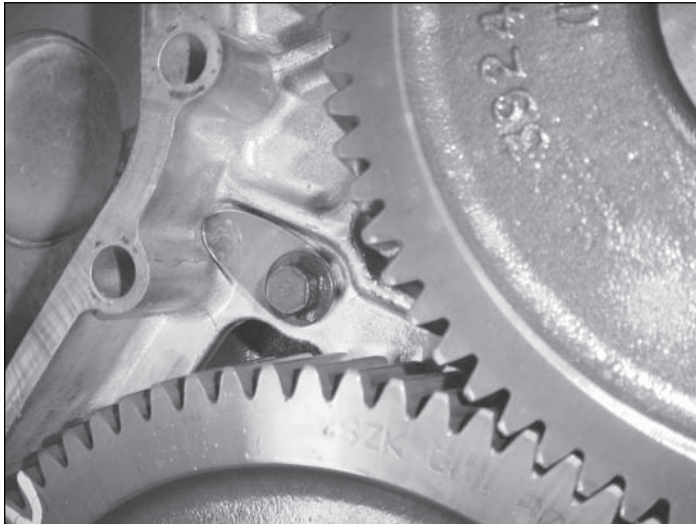
- 12) Locate the dowel pin and look to see if it is fully seated. Most of the pins will be flush with the gear housing or just below flush if they have not backed out. If the pin seems to be backed out find a small punch. With a hammer and punch tap on the head of the dowel pin and drive it into the block as far as possible.
