What's Wrong With My Truck?

GENO'S
GARAGE

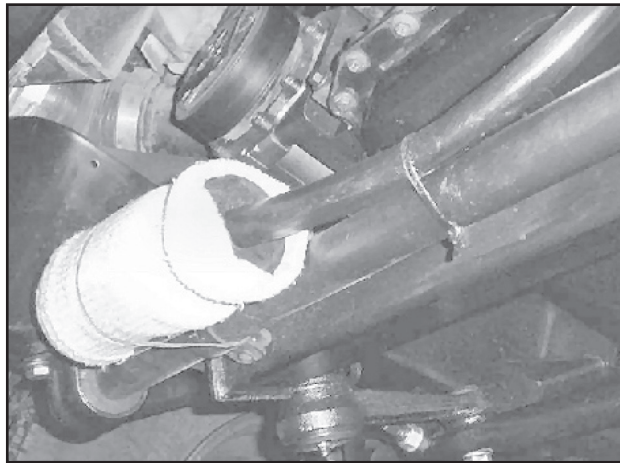
Flaw: My truck's dripping oil.

Fix: Until the introduction of the '07.5 truck and the new 6.7-liter engine, all Cummins 5.9-liter engines were positively vented to the atmosphere by a breather tube. The oil would drip out the bottom of the breather tube. When Second Generation trucks came out, this problem also resulted in a lot of erroneous front differential yoke seal replacements because the engine oil (not differential fluid) dripped down in the same area. Of course, if Dodge hadn't moved the differential to the left side, this problem wouldn't have existed. Most people simply put a small bottle with holes in the side on the bottom of the vent tube. It could still "breathe" but the oil was trapped in the bottle.

Effective with the '98.5 year model and the 24-valve engines, the breather moved to the front. And any truck on a steep descent could lose a lot of engine oil as crankcase pressure pushed it out the tube. Cummins offers a fix that moves the breather inlet back alongside the engine where it is less affected by crankcase oil level on steep grades—right where it was on 12-valve engines (Dodge TSB 09-002-02).

The old cotton sock idea is an easy fix with no drips or oily film on anything but the outer sock. Replace the sock while you are under the truck changing oil. Extend the tube and drip catch bottle down to the anti-sway bar and secured it with a couple of wire ties.

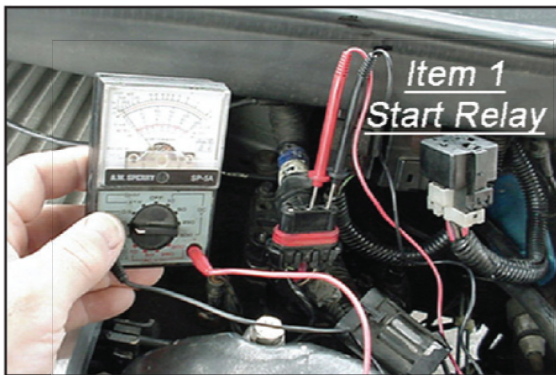
No voltage for "START" tells you to check the relay to the solenoid (Item 1).

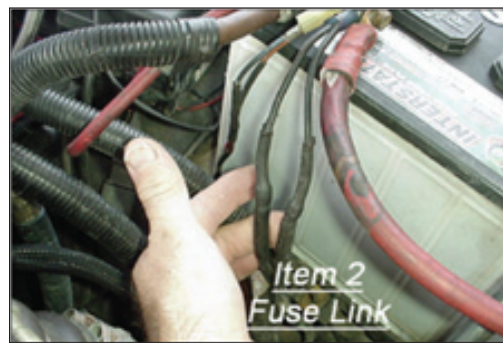
Also check the fuseable link that feeds the solenoid (Item 2) or fuse #9 in the fuse panel.

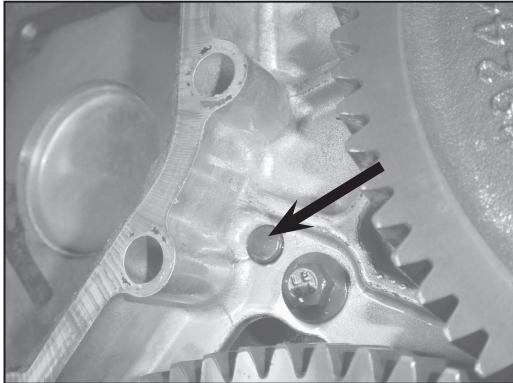
Fix: A potential problem for ‘94-‘98 12-valve trucks and some ‘99 trucks is the dowel pin used to locate the aluminum timing gear cover on the front of the engine. When this cheap part falls out, expensive things happen, and it’s shown some proclivity for falling out. There are a number of preventative measures, some of which can be done with hand tools. When replacing the dowel pin, replace the crankshaft oil seal and vice versa due to a seal leak. The fix involves staking the pin, covering the pin with a teardrop-shaped washer placed under a nearby bolt, or removing the pin altogether since it has already served its purpose in locating the housing during engine assembly.

A close-up view of the dowel pin.

Geno’s Garage offers a “Killer Dowel Pin” Repair Kit for ‘89-‘93, ‘94-‘98 and ‘98.5-‘02 Dodge Turbo Diesel trucks.

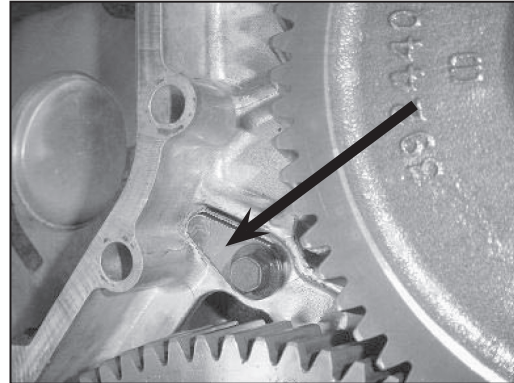
A picture showing an egg-shaped washer that covers the dowel pin.
