THIRD GENERATION SUSPENSION UPGRADES: PART THREE

by Doug Leno

BALL JOINT REPLACEMENT

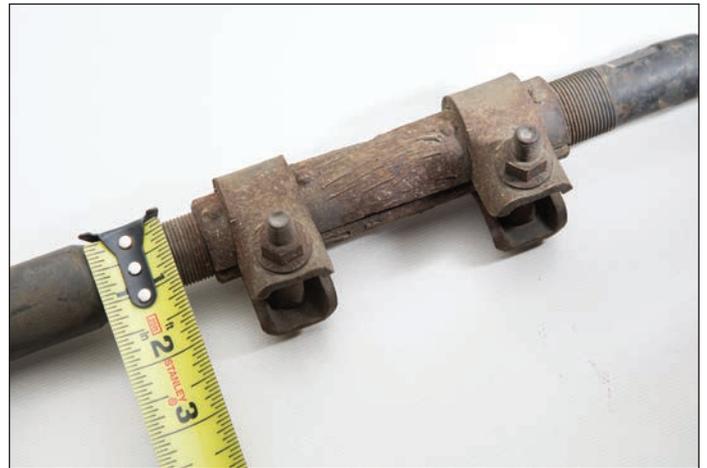
Beyond the geometry differences themselves, the new T-type steering system provides additional stiffness and stability via larger diameter tubes, 1.5" versus 1.25", compared to the older Y-type system (see figures 6 and 7). This made the decision to upgrade easy. Because the job would be a simple one, I decided to perform the upgrade myself.

Figure 6: My tape measure shows the 1.25" diameter steering linkage tubes used on the 2003-2008 "Y-type" steering system that I replaced. The newer "T-type" system uses larger 1.5" diameter tubes.

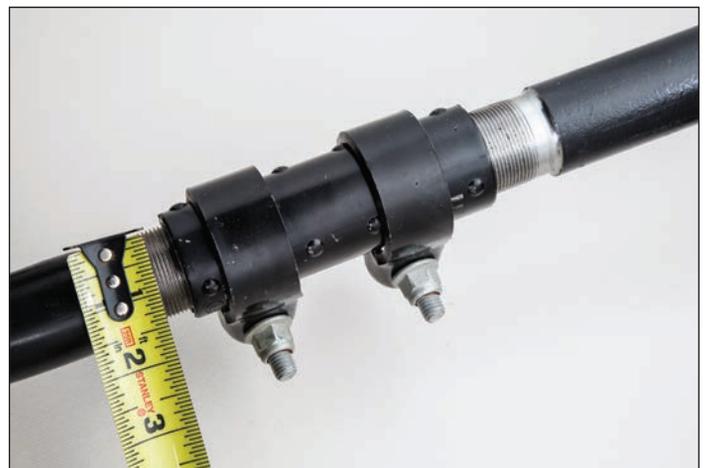
Figure 7: T-type steering system is made with 1.5" diameter tubing, and is considerably more robust than the older, Y-type steering system. The new system is over five pounds heavier.

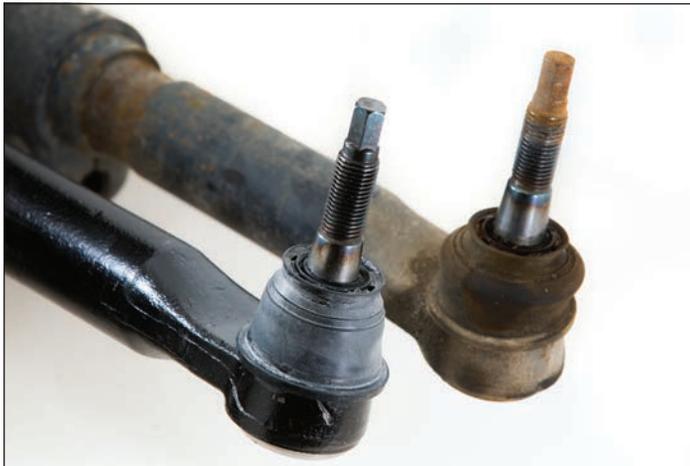
The left tie rod ball stud on about 264,000 of the above vehicles may fracture under certain driving conditions. This could cause loss of directional control and/or crash without warning.

Figure 10: I found no difference between "good" and "recalled" tie rod ball studs, the subject of N49. On the left is a verified "good" part which I installed on my truck. On the right is a recalled part from my dealer's boneyard.

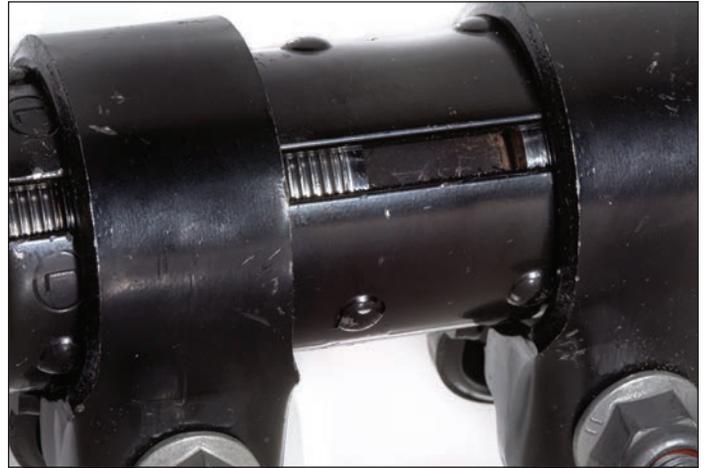
Figure 11: The adjustment collar on the newest T-style steering system. Note the inner mechanism in between the two threaded halves. This prevents the right hand tube from rotating along with the adjustment collar.

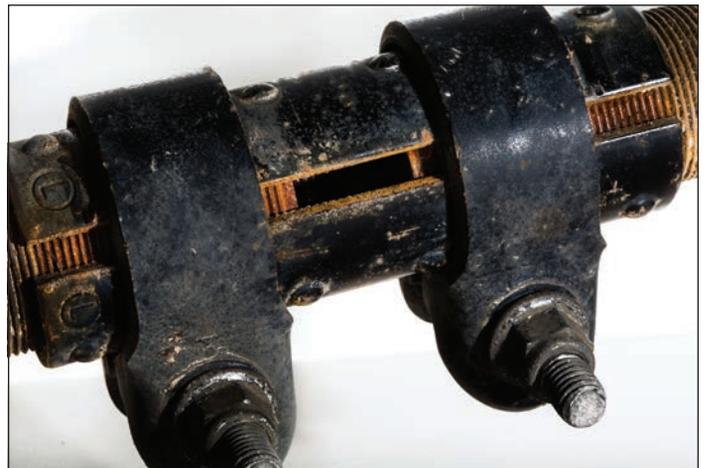
After further investigation I found what I believe to be the real reason for the recall: The recall does not appear to address the ball stud itself; it addresses the probability that a careless alignment technician might pre-stress the left-side ball stud during toe adjustment! If you carefully inspect figure 11, you will see the update: The newest tie rod has an internal mechanism to prevent the right-hand tube from rotating along with the toe adjustment collar. The older (recalled) tie rod has no such mechanism, as you can see in figure 12.

Figure 12: The older (recalled) system allowed the right hand tube to rotate along with the adjustment collar, allowing a careless technician to pre-stress the ball stud inside the steering knuckle.

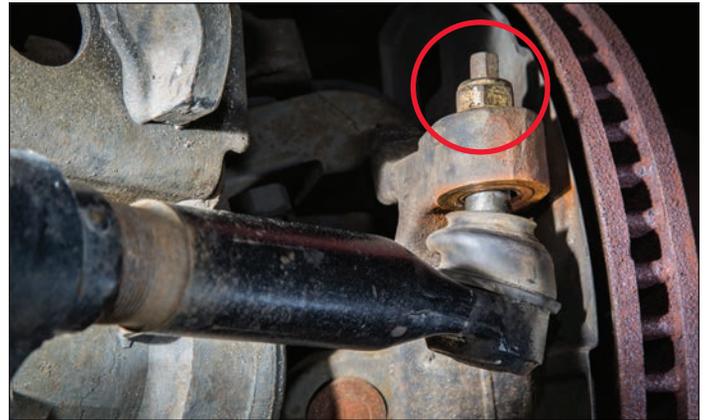
Figure 8: Dropping the old Y-type tie rod from the driver-side steering knuckle. The nut in this photograph (circled) is only partially removed.

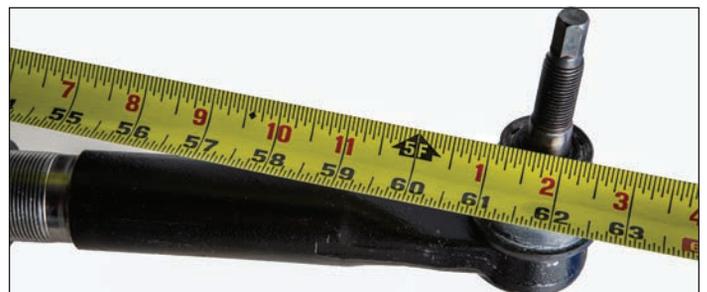
Figure 9: pre-adjusting the length of the new tie rod before installation.

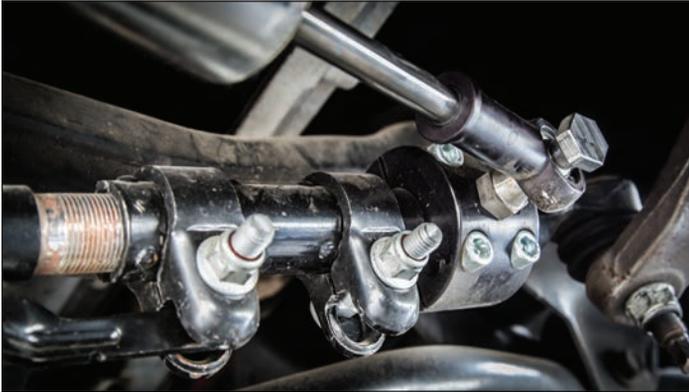
Figure 12: Installation of the Carli Suspension "High mount stabilizer" required a new clamp to accommodate the new tube diameter.

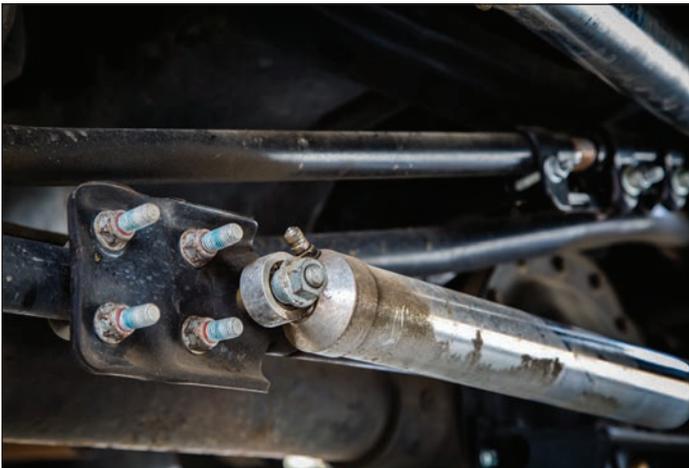
Figure 13: The Carli Suspension Low-mount stabilizer utilizes the factory supplied clamp, repositioned to the correct location per instructions from Carli Suspension.

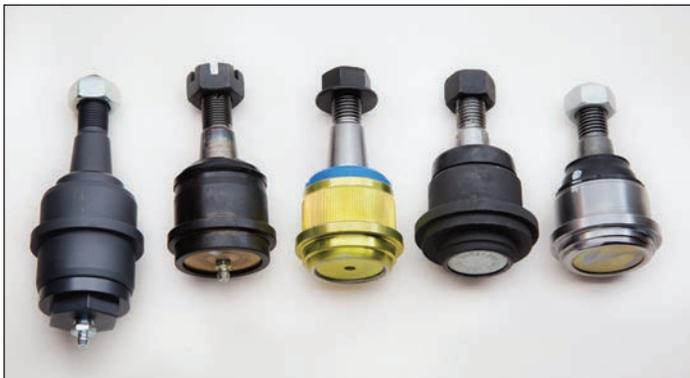
Figure 1: from left to right: Upper ball joints from Carli Suspension, Moog, Napa, Duralast, and Mopar. Some are smooth, some are knurled, some have a grease zerk, and some are sealed. The Zerk on the NAPA part in this photograph has not yet been installed.

Two characteristics were immediately apparent. First, note that the ball joints from Carli Suspension, Moog, and NAPA are outfitted with a grease zerk, while those from Duralast and Mopar are not. Secondly note that some parts are knurled, while others are smooth. In a surprising twist, I found that the two Moog parts supplied by my local O'Reilly Auto Parts store had different body textures: The upper ball joint (shown in figure 1) was smooth while the lower ball joint (see figure 2) was knurled. Both were supplied in identical boxes labeled "Moog Problem Solver."

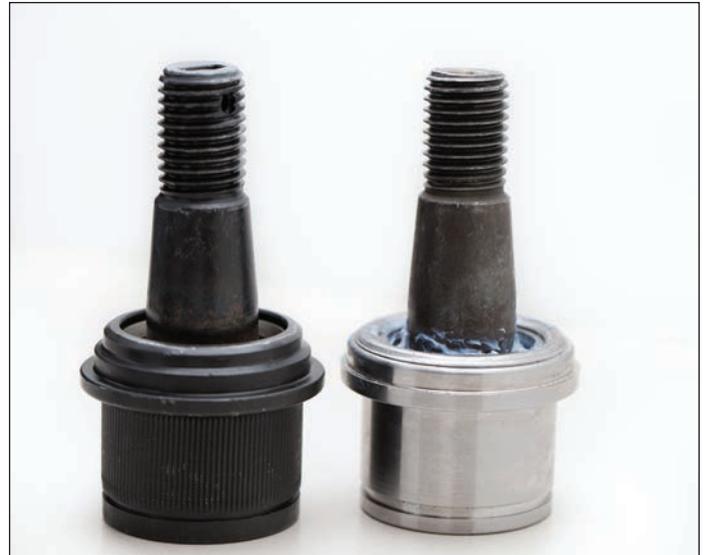
Figure 2: Lower ball joints from Moog (left) and Mopar (right). The Moog "problem solver" part supplied by my local O'Reilly Auto Parts store has a knurled body.

As you can see, the Carli Suspension ball joints were the only ones in my test group matching factory specifications, in both body size and surface type. The locally available parts from O'Reilly, Autozone, and NAPA all measured a few thousandths of an inch larger than the factory parts. The NAPA and Moog parts combine an oversize body with a knurled surface.

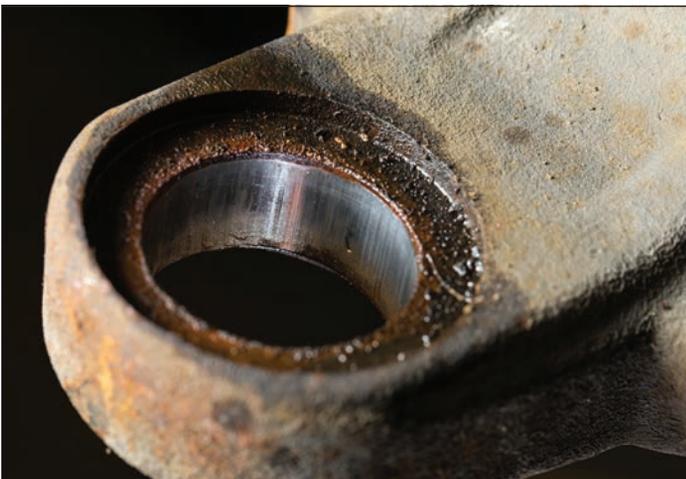
Figure 3: The smooth lower ball joint knuckle bore on my Turbo Diesel. I decided not to install a knurled or oversized part, in order to preserve the factory bore as long as possible.

- If the factory knuckle bore is not damaged it is best to choose replacement ball joints that match the factory supplied parts as closely as possible in surface finish (smooth) and in diameter (not oversized).

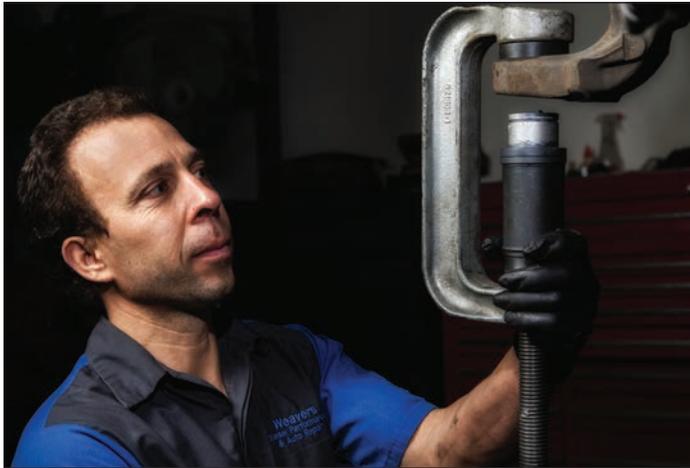
Figure 4: Raymond Driggs at Weaver's Diesel Performance, installing my lower left ball joint.

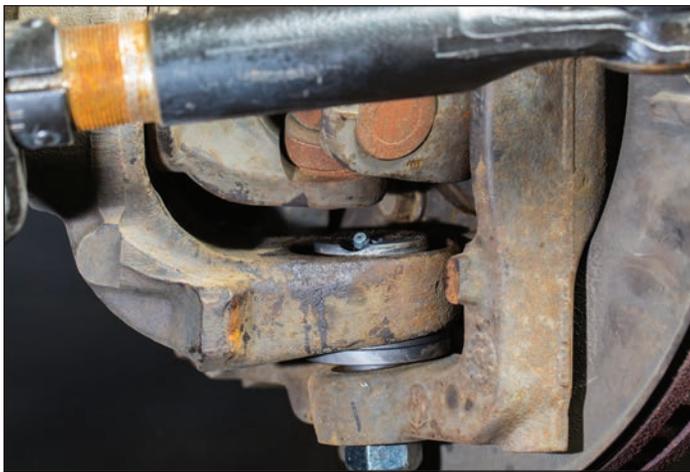
Figure 5: The Carli Suspension Lower Ball Joint, installed at exactly the right position so that the grease zerk is accessible.

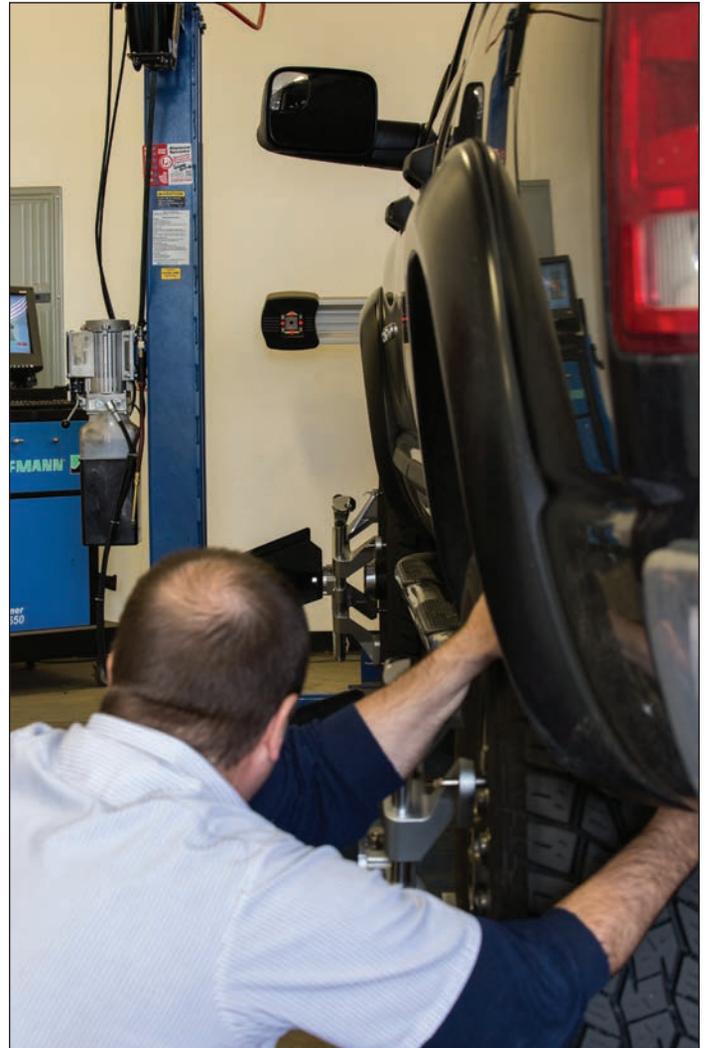
Figure 6: Four wheel alignment in progress at Auto Works automotive repair in Coeur d'Alene, ID. In this photograph, Troy Hocking is rolling my truck back and forth several inches at a time, to check wheel runout. All parameters including camber, caster and caster sweep, checked out.
