ISSUE 53

SECOND GENERATION HANDLING AND SUSPENSION PROBLEMS, OPTIMAL ALIGNMENT SPECIFICATIONS AND TECHNIQUES

By Andy Redmond

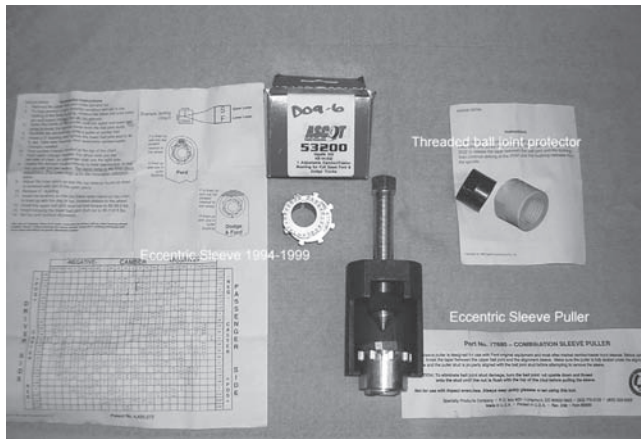
An assortment of front end parts.

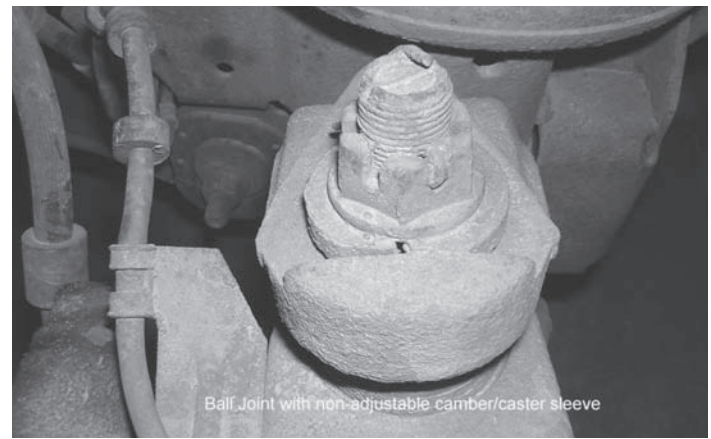
Ball joint with non-adjustable camber/caster sleeve.

Ingall's makes a slick product for the '94-'99 Turbo Diesel called an adjustable ball joint eccentric sleeve, part number 532 or 53200 (Ascot), suggested retail price of \$45. The eccentric sleeve allows for caster and camber adjustment, which the alignment tech can then set to the preferred settings. It fits in place of the fixed alignment sleeve that resides on the upper ball joint stud in the spindle, which is retained by the upper ball joint nut and cotter key.

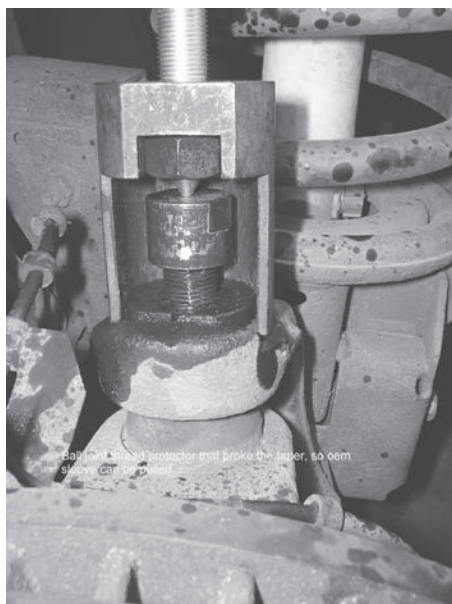
Ball joint thread protector that broke the taper, so OEM sleeve can be pulled.

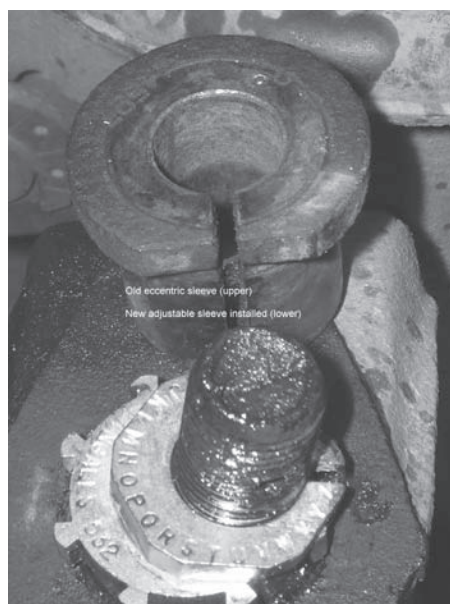
Old eccentric sleeve (upper).
New adjustable sleeve installed (lower).

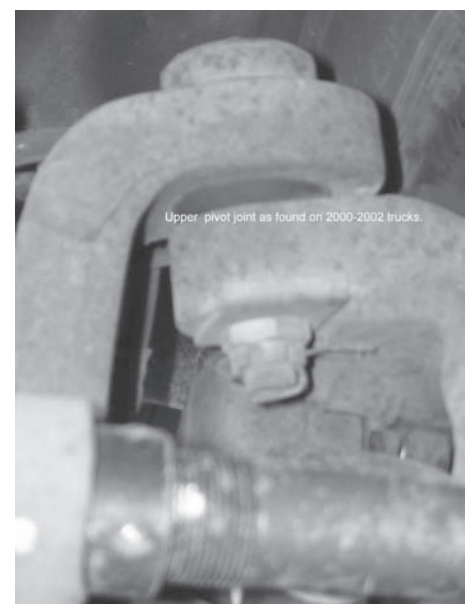
Upper pivot point as found on '00-'02 trucks.

Ingall's also makes a product for the '00-'02 four-wheel drive Turbo Diesel. The addition of the twin piston brake caliper caused many changes to the suspension components in these trucks versus the '94-'99 models. The upper ball joint on the later trucks is referred to as an adjustable joint or pivot. Ingall's makes such a replacement, which is swapped out for the original (non-adjustable) design. The part number is 61500 (Ingall's and Ascot). I have seen it retail for nearly \$150 dollars, per side.
