MEMBER 2 MEMBER

THIRD GENERATION SUSPENSION UPGRADES: PART THREE

by Doug Leno

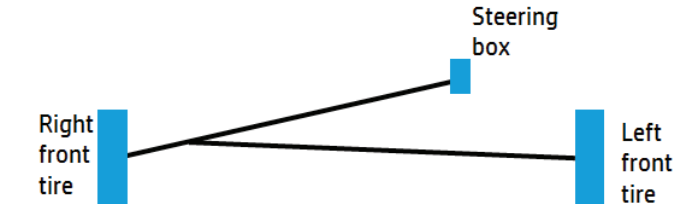
Turbo Diesels from 2003 through the mid-2008 model year were manufactured with what is known as a "Y-type" steering system, illustrated in figure 4. In the illustration, note that the tie rod from the left front tire connects to the steering drag link, forming a "Y" configuration. Why is this important? Imagine, for example, that the steering box in Figure 4 moved upward. This action would pull the left and right steering knuckles closer together, causing the tires to "toe in" (pigeon-toed). Conversely, moving the steering box downward would push the steering knuckles farther apart, causing the tires to "toe out." The main point of interest for this geometry is that *suspension toe changes dynamically during normal vehicle operation.*

Figure 4: "Y-type" steering system supplied on 2003-2008 model year trucks. In this configuration, suspension toe changes dynamically during normal vehicle operation.

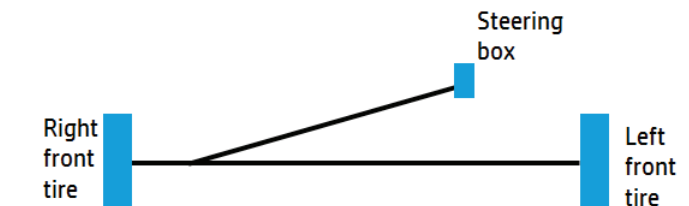
During the 2008 model year, Chrysler began to ship model 2500 and 3500 model Turbo Diesels with a different steering linkage geometry known as the "T-type", illustrated in figure 5. Note that for this geometry, the distance between the left and right steering knuckles is fixed, due to the rigid tie rod connecting the two together. *This means toe is not affected by suspension flex.*

Figure 5: During the 2008 model year, Chrysler introduced the "T-type" steering system, so named because the steering drag link "tees" into the steering tie rod. For this geometry, the distance between left and right steering knuckles remains fixed, keeping toe constant during suspension flex.

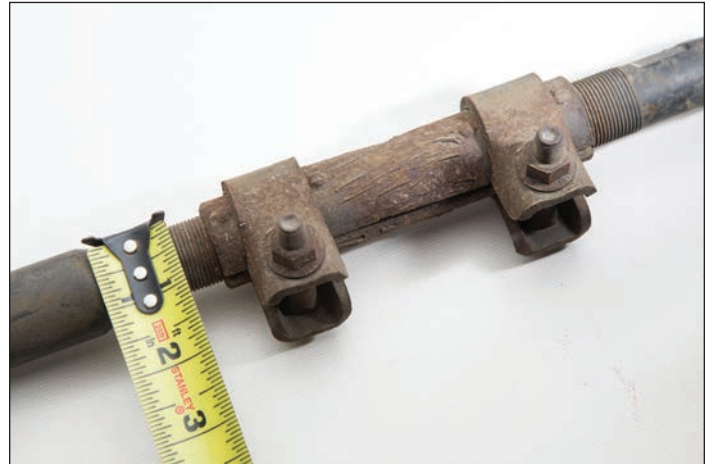
After 10 years and 150,000 miles, my factory steering system tie rod ends were showing the expected signs of deterioration and the wear produced some sloppy steering performance. To determine the repair, I first looked to see if there were any steering system recalls. I discovered "Safety Recall H46" which affected a small number of vehicles requiring a new drag link inner joint and/or pitman arm, but it turned out that this recall did not affect my vehicle. I was on my own for parts replacement.

Figure 6: My tape measure shows the 1.25" diameter steering linkage tubes used on the 2003-2008 "Y-type" steering system that I replaced. The newer "T-type" system uses larger 1.5" diameter tubes.

Beyond the geometry differences themselves, the new T-type steering system provides additional stiffness and stability via larger diameter tubes, 1.5" versus 1.25", compared to the older Y-type system (see figures 6 and 7). This made the decision to upgrade easy. Because the job would be a simple one, I decided to perform the upgrade myself.

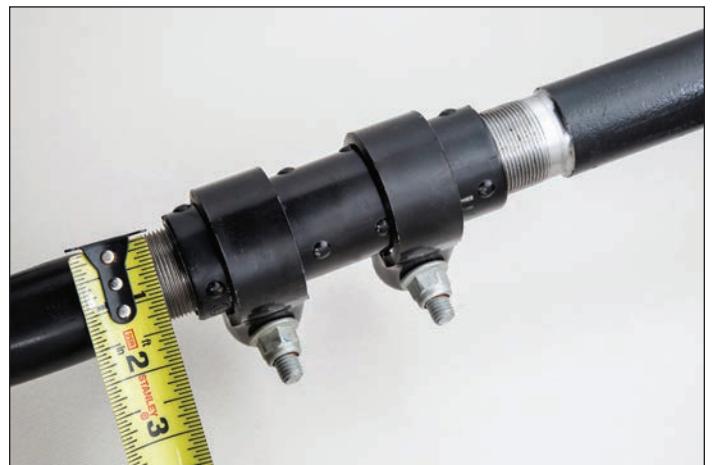
Figure 7: T-type steering system is made with 1.5" diameter tubing, and is considerably more robust than the older, Y-type steering system. The new system is over five pounds heavier.

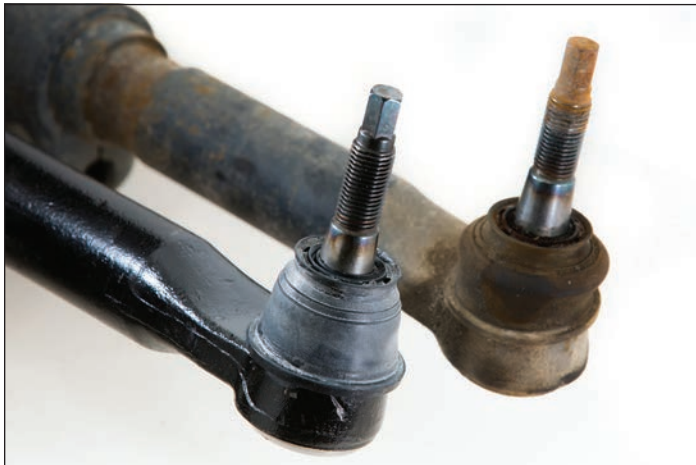
The left tie rod ball stud on about 264,000 of the above vehicles may fracture under certain driving conditions. This could cause loss of directional control and/or crash without warning.

Unsatisfied with this lack of detail, I requested permission to inspect a few steering linkages which my dealer had already replaced under the recall. I started by inspecting the left tie rod ball stud of both "new" and "recalled" systems, as shown in Figure 10. Do you see any difference? I didn't either!

Figure 10: I found no difference between "good" and "recalled" tie rod ball studs, the subject of N49. On the left is a verified "good" part which I installed on my truck. On the right is a recalled part from my dealer's boneyard.

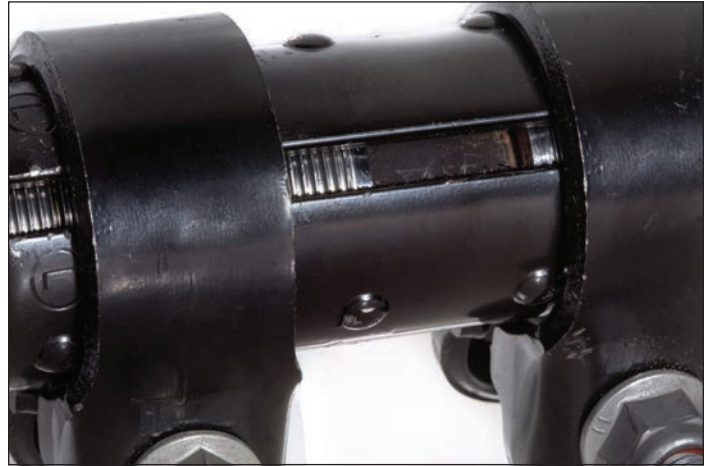
After further investigation I found what I believe to be the real reason for the recall: The recall does not appear to address the ball stud itself; it addresses the probability that a careless alignment technician might pre-stress the left-side ball stud during toe adjustment! If you carefully inspect figure 11, you will see the update: The newest tie rod has an internal mechanism to prevent the right-hand tube from rotating along with the toe adjustment collar. The older (recalled) tie rod has no such mechanism, as you can see in figure 12.

Figure 11: The adjustment collar on the newest T-style steering system. Note the inner mechanism in between the two threaded halves. This prevents the right hand tube from rotating along with the adjustment collar.

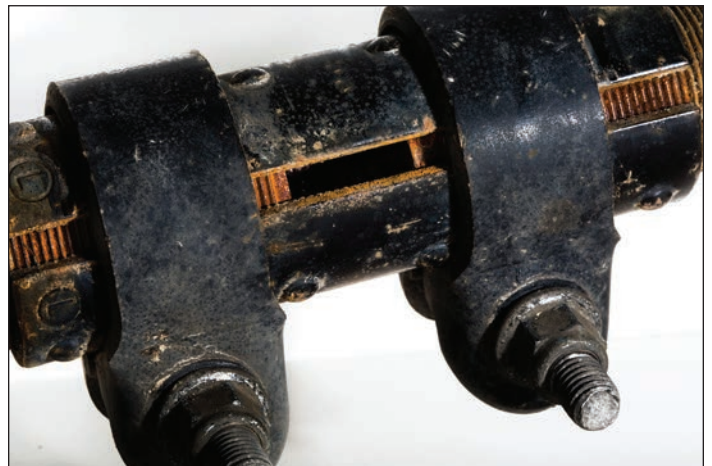
Figure 12: The older (recalled) system allowed the right hand tube to rotate along with the adjustment collar, allowing a careless technician to pre-stress the ball stud inside the steering knuckle.

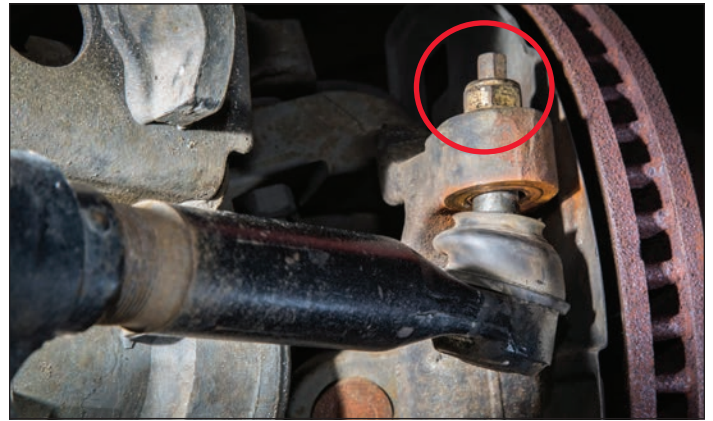
Figure 8: Dropping the old Y-type tie rod from the driver-side steering knuckle. The nut in this photograph (circled) is only partially removed.

After removing the Pitman arm from the steering box, the entire system can be removed by loosening the nuts on the left and right ball studs (see Figure 8).

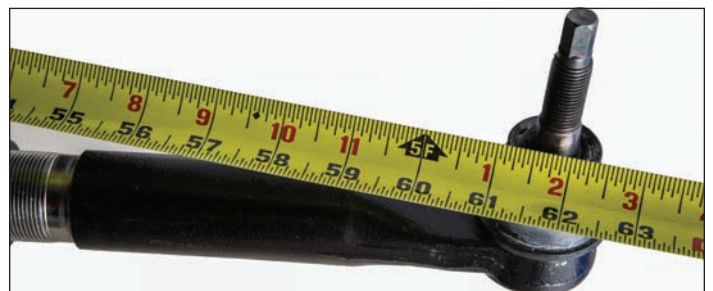
Figure 9: pre-adjusting the length of the new tie rod before installation.

Although most of us rely on alignment shops to check or perform the adjustment, our Turbo Diesels are easy to align, even in a home garage. "Total Toe" is the only adjustable alignment parameter, determined by the length of the tie rod set via the adjustment collar. This meant I had to set "Total Toe" myself, at least initially. Rather than measure the parameter directly on the vehicle, I decided to pre-adjust the length of the new tie rod to match the length of the old one (see figure 9), and then go to an alignment shop for final adjustment. It turned out my pre-adjustment was only 1/32" off!

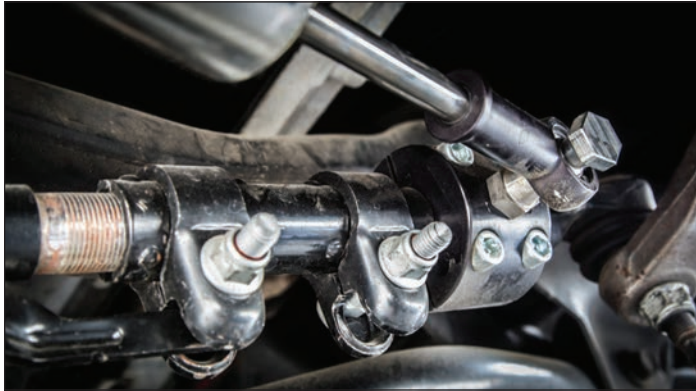
Figure 12: Installation of the Carli Suspension "High mount stabilizer" required a new clamp to accommodate the new tube diameter.

Carli Suspension's dual stabilizer system is compatible with either "Y-type" or "T-type" steering systems. As is the focus of this article, the newer steering system is manufactured with larger diameter tubes, which means that a different Carli suspension clamp is required for the upper stabilizer (see figure 12). Carli's low-mount stabilizer utilizes the factory supplied clamp, shown in figure 13. Note that for these photographs, I decided to break with tradition and show the installation after several hundred miles of road use. You won't see shiny new parts in these photos, but you will see how road grime accumulates, and how the axle tube itself protects the lower stabilizer (figure 13).

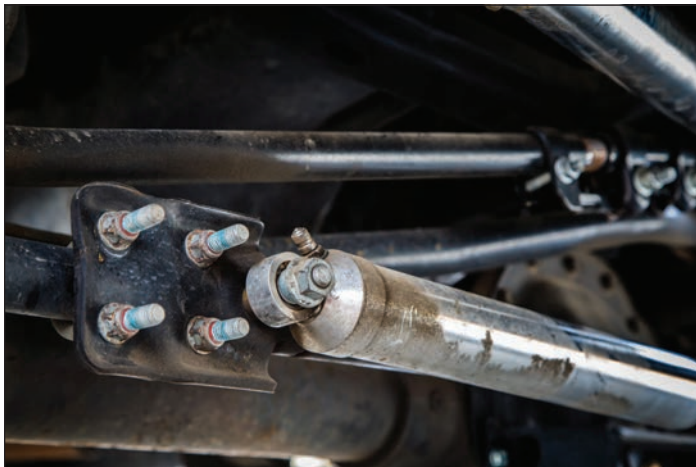
Figure 13: The Carli Suspension Low-mount stabilizer utilizes the factory supplied clamp, repositioned to the correct location per instructions from Carli Suspension.
