# TURBO DIESEL Buyer's Guide

# Vintage '94-'04 Transmission Lock/Unlock Problem

# TRANSMISSION NOISE PROBLEMS

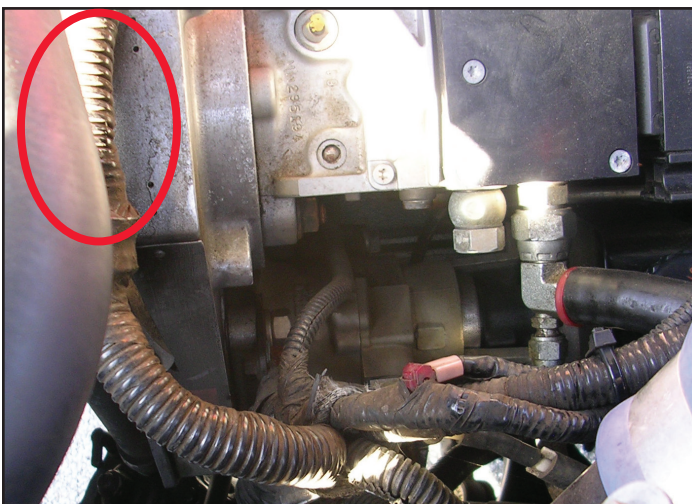
This has been one of the worst torque converter lock/unlock problems I've ever contended with. The clue in all of this came when I test drove the truck while using the scope screen on a Snap-On Solus and the voltage readings for every sensor on the engine and transmission were very erratic and what you could call "dirty". I wanted to update anyone interested and Dave (AKgriz) will probably post some photos later. We may even do a quick write-up as this is something you can bet should be looked at on other rigs with persistent lock/unlock gremlins.

The "Before" picture. The area Don described runs from the alternator across the top/front of the cylinder head (circled area).

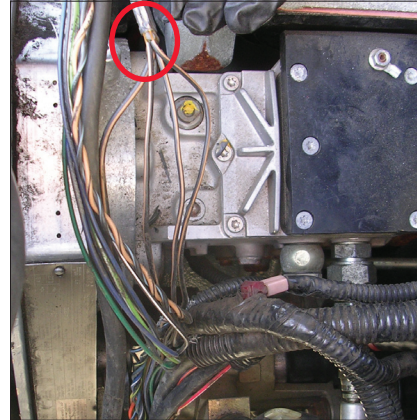
To test the "Final Answer" we cut into this '99 truck's wiring harness. The truck belongs to Geno's Garage employee Scott Sinkinson. We cut off a lot of wiring loom (down in the valley as well as across the front of the engine) to look for poor connections. The connection area is circled.

The above picture showed that we *really* cut into Scott's wiring loom. The actual "four sensor grounds laying on top of the large ground wire" is located just as Don described, forward of the injection pump area. It was easy to spot the wiring junction that Don described. It was not easy to access the wires. While I agree with Don, they are a bundle that is/was heat shrunk together, the bundle is well epoxied, the shrink is epoxied and the wires were air tight. I had to saw sideways through the heat shrink to get down to the wires. The shrink was not "sliceable."

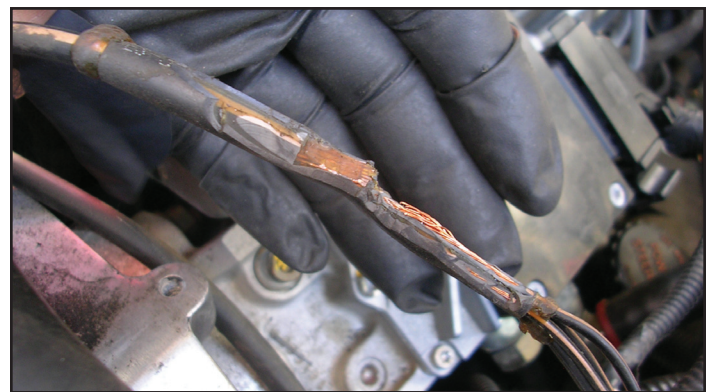
These wires are really secure.

Conclusion: I don't think we have the final answer. Scott and the Geno's staff agreed, his truck's wiring loom was tight and secure. Maybe, maybe if the wires were brittle and you happened to bend them at the junction? We covered the wires back up.

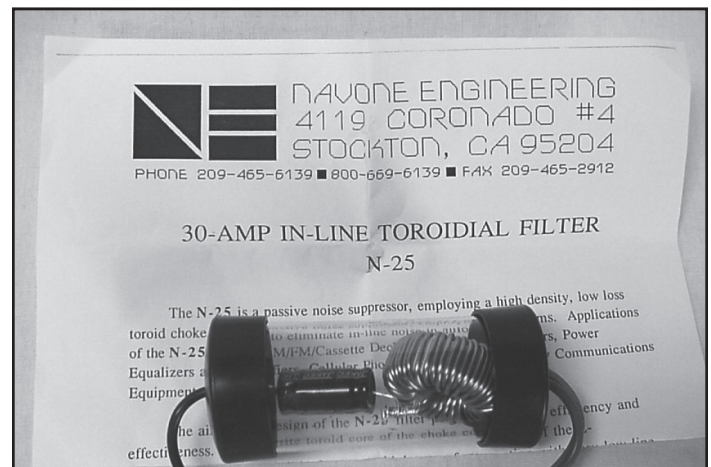
The Navone Engineering N-25 noise filter kit.

A final correction method was provided from a source on the TDR website. I have not tested this fix, but it looks promising. According to the description of the problem and its repair, the noise generated on the TPS signal wire is fed to the ECU, which sends it to the JTEC, which in turn controls torque converter lock/unlock. This fix consists of installing a filter at the JTEC connector C-1, pin 23, an orange/dark blue wire labeled TPS SENS IN. This wire is cut back from the connector, and the filter kit is soldered in place. The red filter wire is soldered to the cut wire on the connector side. The green filter wire is soldered to the cut wire on the harness side. The black filter wire is spliced and soldered to any one of three ground wires on C-1. All splices are secured by heat shrink and taped. It should be noted that the filter kit is not waterproof. The filter kit, with part number N-25, may be sourced through [Navone Engineering](#), telephone number (209) 465-6139.
