**Please read the instructions completely.
Improper installation can and will damage the turbocharger.**

**For a very helpful installation video, go to: https://www.genosgarage.com/install_instructions
INSTALLATION & TECH VIDEOS ► Electronic Turbo Actuator**

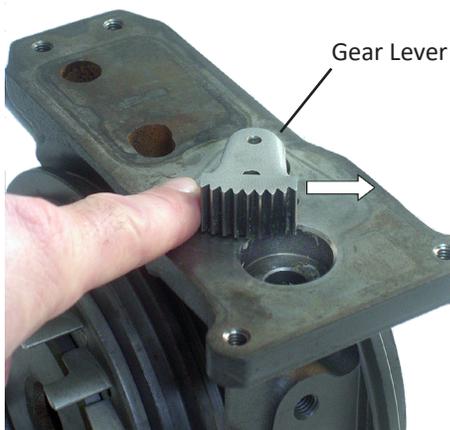
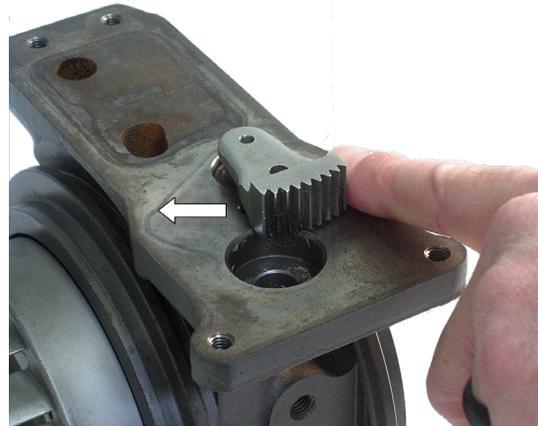
- 5** With the actuator removed check the gear lever for movement. It should easily be able to move full travel with one finger. You will want to use the side of the tip of your index finger, rather than the palm (front) of your index finger. We have found that the side of your index finger will have less available force to move the gear and falls more in line with diagnosing a turbo gear that requires too much force to be moved. (Full travel is approximately 1 inch).

Picture the turbo gear as a door. If a door is not opening or closing easily, you don't slam the door open and closed to find the restriction, you move it back and forth slowly feeling for any restriction. Any small amount of gear movement resistance at or near room temperature will be greatly amplified when the turbo is over 1000 degrees. Temperatures this high will cause all the moving parts and the turbo housing to thermally expand. You will also want to load the vane gear by pushing and pulling on it while moving it back and forth. The slightest amount of resistance at room temperature is enough to cause issues during operation.

We then suggest swiping the vane gear against each stop with moderate force. This is done to make sure that when the vanes are moved to the extreme ends of its travel, they do not stick. If the actuator lever cannot be moved easily from the full travel stop in either direction, or if any resistance is found when pushing away from either end of its fullest travel, the turbo must be replaced.
