HAVE RAM, WILL TRAVEL

INSTALLATION OF THE CITY DIESEL ELECTRONIC TURBOCHARGER ACTUATOR – PART TWO

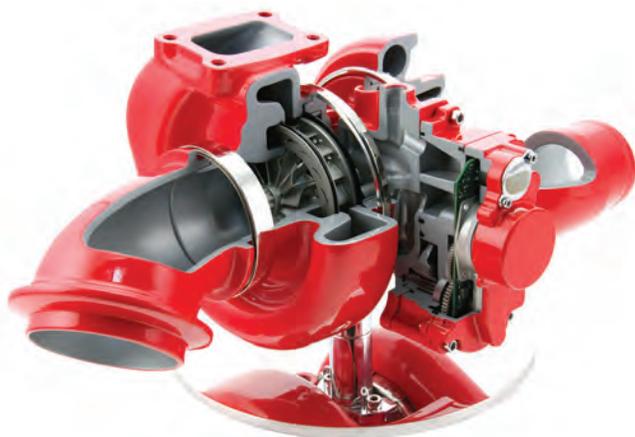
Up on a pedestal (and rightfully so), this Holset HE351 VGT is the key to managing intake air pressure for economy, power and emissions.

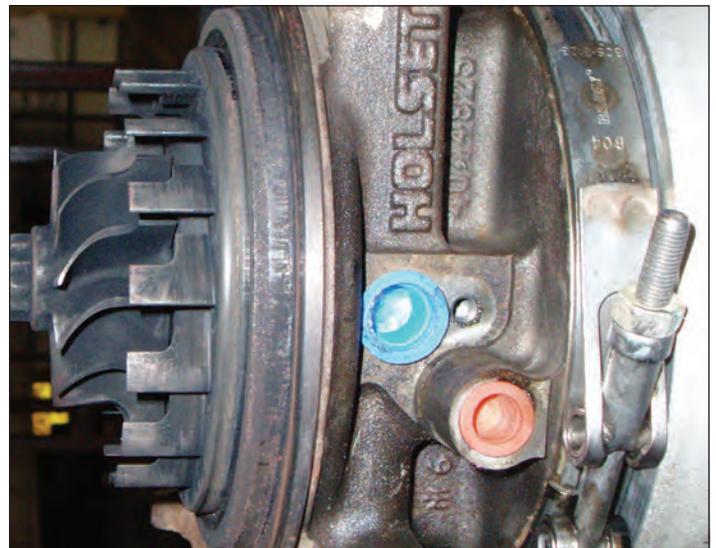
Open

With the sliding vane totally fully retracted, the turbo blades are open to exhaust flow. Exhaust flows freely and the pressure on the turbine blades builds intake air boost/pressure.

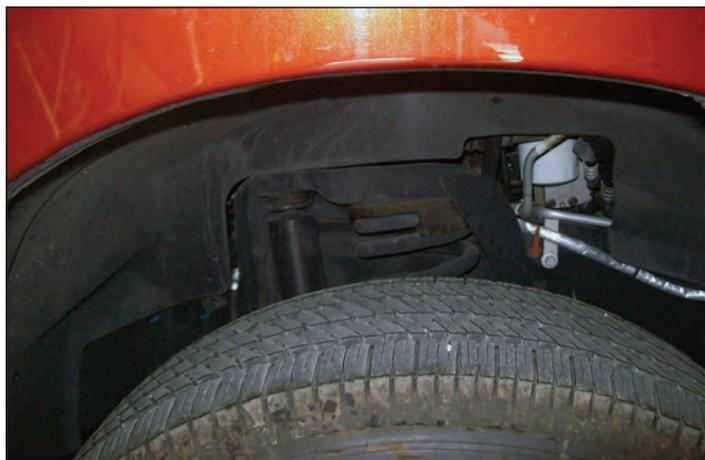
Initial view above right front tire with turbocharger covered by plastic inner fender. The shock absorber/coil spring tower can be seen, but not the turbocharger.

It is easier to remove the plastic inner fender after jacking up the corner under the suspension arm and putting jack stands under the arm and the frame behind it. Again, remove the tire for access.

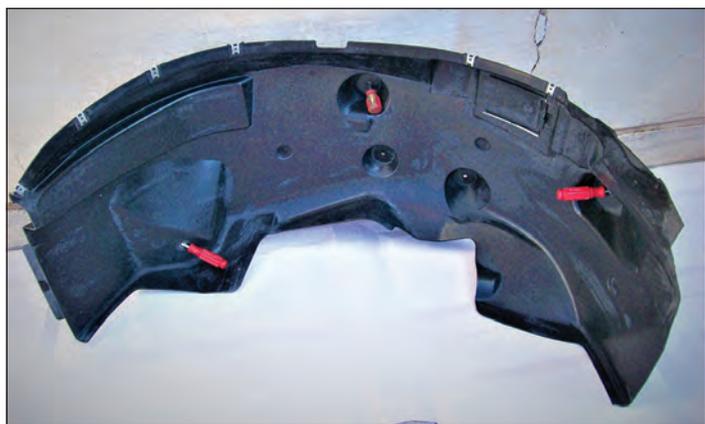
Now we are left with the real problem. Ram used three "Christmas tree" fasteners with 1" flat head tops that are in recessed pockets of the inner fender.

Tire side of inner fender with red-handled screwdrivers in the three "Christmas tree" positions.

It is very difficult to get under the fasteners with a sharp putty knife or a forked removal tool. The front two hold the inner fender tight enough that you can't get behind them with a long chisel, either. They make it very difficult to use the putty knife to pop the outer edge of the inner fender out of the outer fender lip. The fasteners are the non-reusable type, so I used my die grinder to cut through the center of the head so the head would pop off. After removing the inner fender, you can either push the rest of the stalk ("Christmas tree") through the 0.25" hole in the truck's sheet metal or pull it out with pliers.

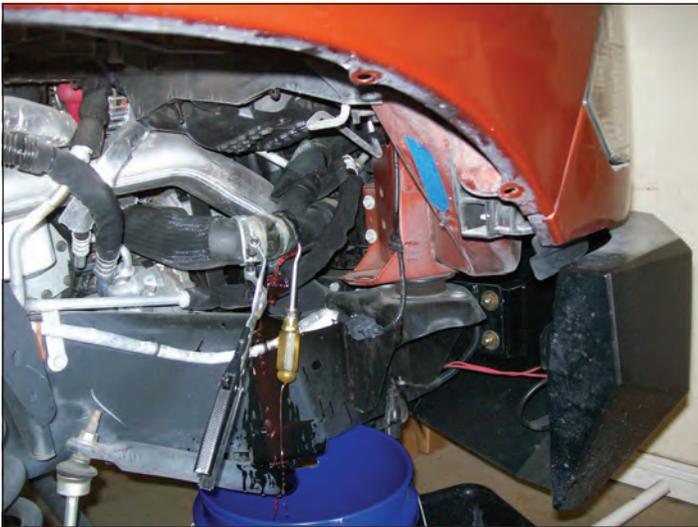
Coolant draining with ratcheting retainer clamp pliers and cotter pin removal tool between hose and plastic Y. Front Christmas tree retainer position is shown with blue arrow.

Once the plastic inner fender and tire are removed, you have direct access to the lower radiator hose at the plastic Y connection.

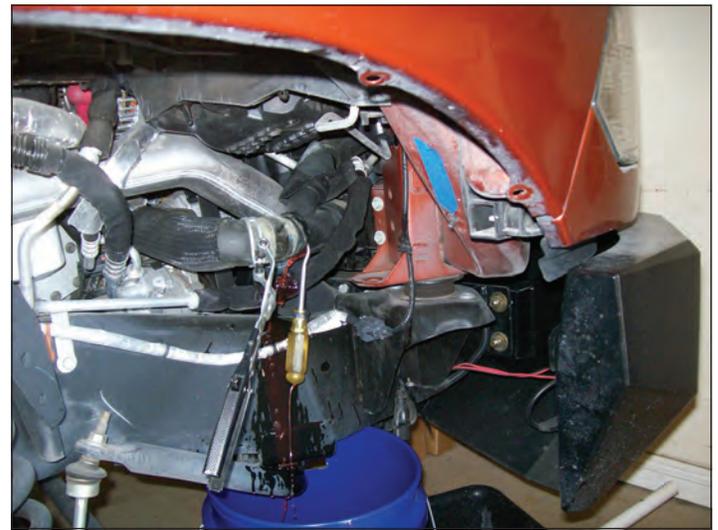
Coolant draining with ratcheting retainer clamp pliers and cotter pin removal tool between hose and plastic Y. Front Christmas tree retainer position is shown with blue arrow.

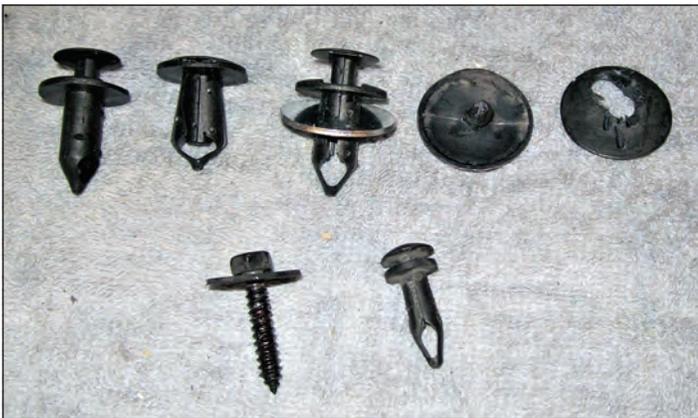
Jeep-style removable plastic fasteners open (head out), closed (head popped into base), and with 1" diameter washer. To the right are the inside of a Christmas tree fastener head and one that has been ground off with a die grinder. At the bottom are the sheet metal screw and the retainer for the bottom of the plastic trim at the rear of the wheel well.

Not wanting to use such fasteners again, I located three of my supply of re-usable plastic retainers (as used by Jeep for the grille) and drilled the sheet metal to 3/8" for them.

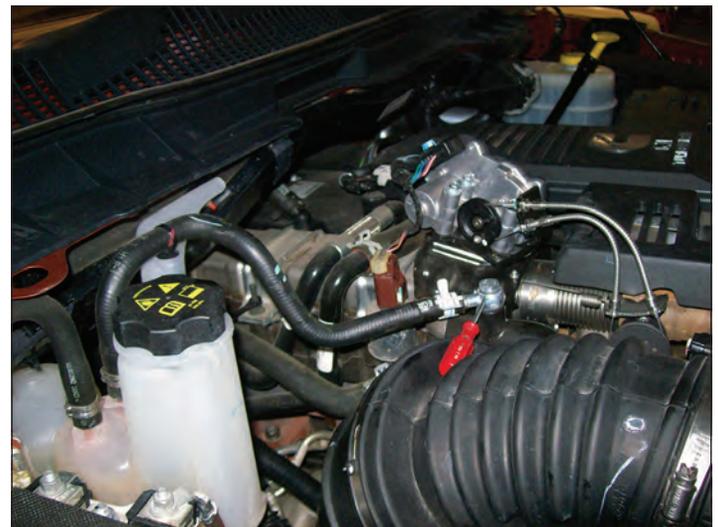
2013 coolant reservoir on left, red-handled screwdriver pointed to high-fill point banjo bolt.

I discussed this easy method of draining the coolant in Issue 100 (pages 100-101) when replacing the water pump. A five-gallon bucket will catch the coolant, and I put a larger pan under it to catch any errant coolant. The coolant tank and banjo bolt for the upper coolant level air bleed are shown.

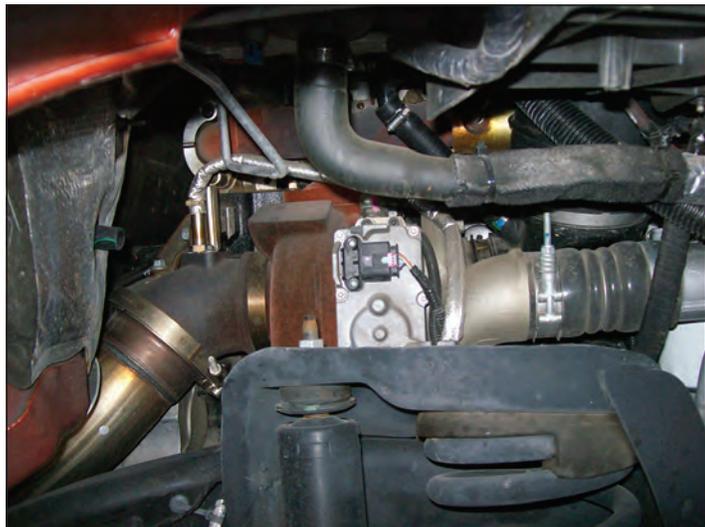
View of turbocharger and actuator with inner fender removed. Access to lower actuator mounting bolts is restricted by the shock absorber/coil spring tower.

The shock absorber/coil spring tower impedes access to the lower actuator bolts. For me, the next preparatory step was applying Mopar rust penetrant to the shoulders of the four actuator mounting bolts, and the exposed area of the bottom rear bolt. This bolt is the source of misery for a lot of people changing the actuator. By leaving the outer corner of the actuator open, water, salt, and dirt can enter and corrode the bolt to the actuator housing.

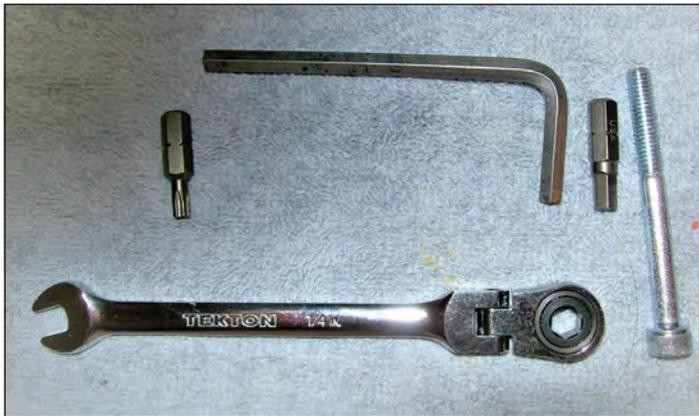
5 mm Allen wrench at top, 1/4" ratcheting box end wrench at bottom, City Diesel actuator bolt at right. Two short bits, tamper proof on left and 5 mm on right from Geno's.

I bought some 5 mm hex power bits with 0.25" hex heads, 6 inches long. From other projects, I had found that there was much less chance of stripping the hex if I used a proper bit, applied constant pressure in the direction of removal, and hit the end with a hammer to provide "shock" or "impact" to aid in removal. The same 0.25" ratcheting box end wrench that you got to use the hex bit that Geno's supplies with the actuator will work nicely with the power bit. You can actually use the power bit on the top two and, with the hole you drilled, the bottom left (rear) actuator mounting bolt. Geno's short hex bit with the ratchet works well on the lower right (front) bolt which has better access from the factory. You can also use a conventional allen key to break the bolt loose.

The factory four bolts holding the turbo actuator are grade 8.8, somewhat weaker than grade 5 in U.S. standard (110,000psi versus 120,000psi). City Diesel supplies plated grade 12.9 (170,000psi), which exceeds U. S. grade 8 (150,000psi). The factory bolts are sufficient for the torque specified, but marginal for removal after being in service for several years. They are also not plated, merely black oxide coated. Thus, we see good reasons why it is so easy to strip out the hex head of the left (rear) lower bolt, which is exposed to water, road salt, etc. Cummins created two unnecessary problems with low grade bolts, and an open channel in the actuator housing. Maybe they used the same engineer who gave our 12-valve engines the killer dowel pin.

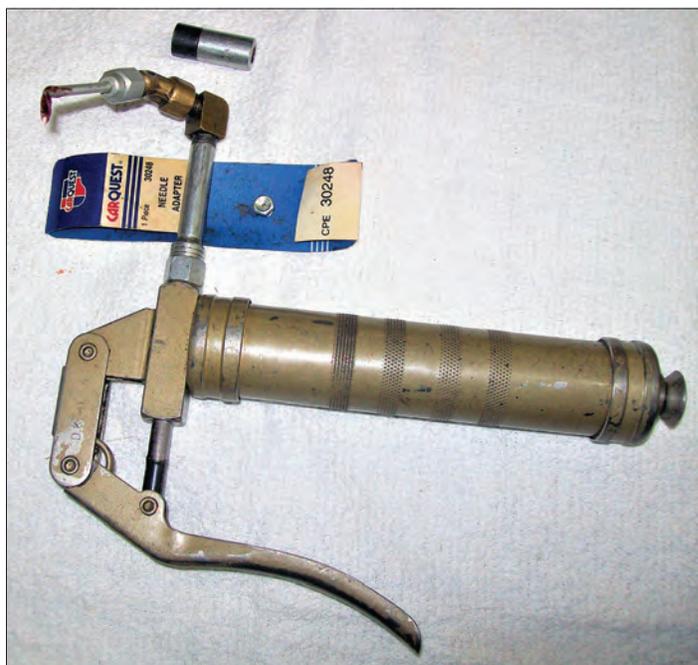
Needle type attachment on hand-held grease gun.
