# TURBO DIESEL

# TDR REVIEW

## THE HOLSET "VGT" REVISITED

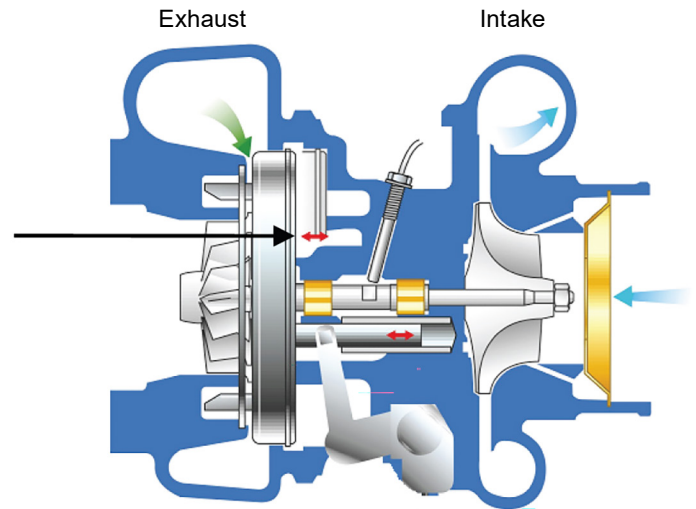
In this picture the high temperature, alloy sleeve is closed. Exhaust gas flow is restricted and, thus, the turbocharger is acting like an exhaust brake. Allow the sleeve to move to the right (see black arrow) and the exhaust gas flow is "full-on" allowing the turbine (exhaust) blades of the turbocharger to spin faster and create more boost

Precision is easier when the machine is simple: To that end the Holset VGT has only one moving part in the turbine's hot section. It is a high-temperature alloy sleeve with vanes at one end, and it moves axially, parallel to the turbine shaft. When the sleeve is fully retracted, exhaust gas flows freely from the exhaust collector through the turbine wheel. When fully extended, the sleeve and its vanes block off more than half the flow area between the collector and the turbine blades, increasing flow rate and directing it towards the turbine blades.

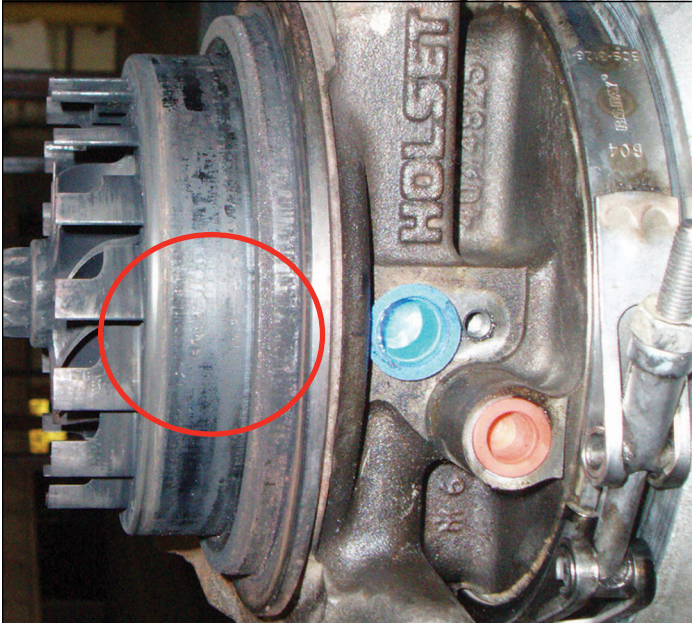
With the sleeve fully extended, the vanes are closed to exhaust flow. This creates exhaust gas back pressure (the exhaust cannot escape) and the turbo acts like an exhaust brake.

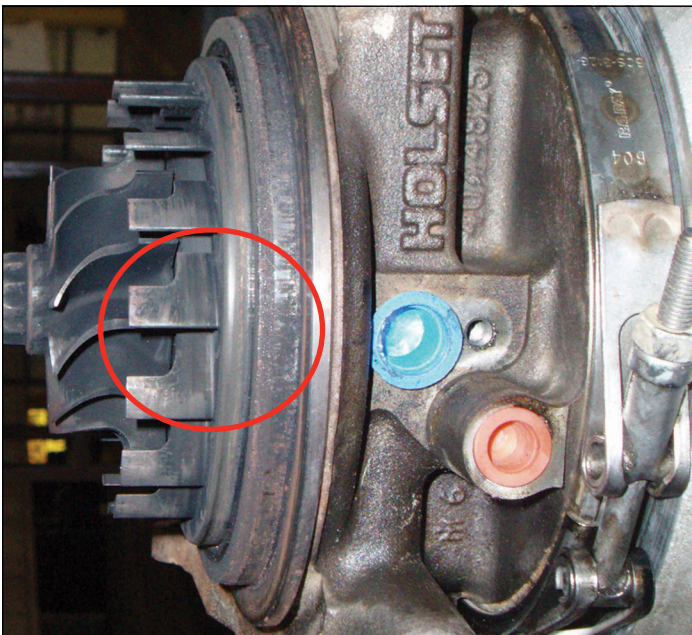
With the sleeve totally fully retracted, the vanes are open to exhaust flow. Exhaust flows freely and the pressure on the turbine blades builds intake air boost/pressure.

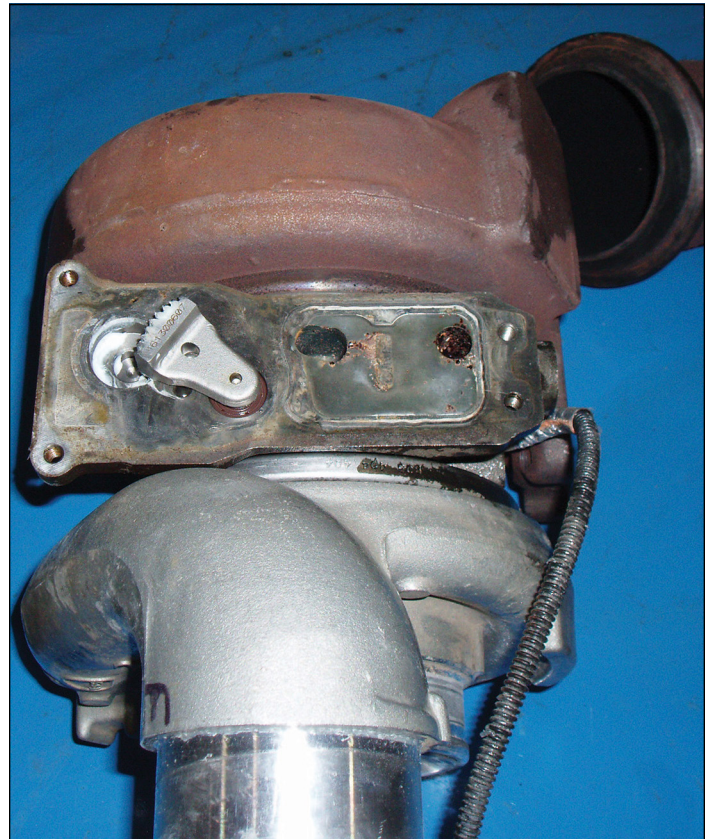
The gear rack on the left connects to the linkage that moves the vane sleeve. The two holes to the right of the gear are coolant passages.

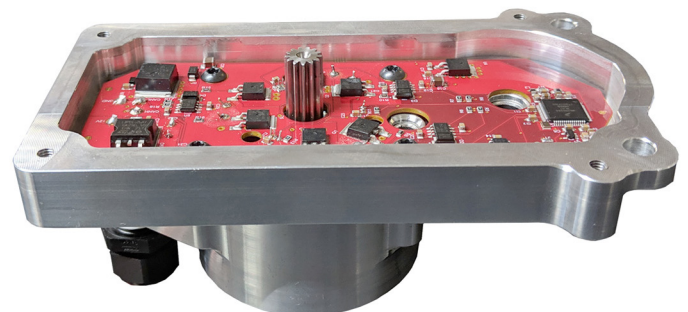
The City Diesel actuator for the '07.5-'12 6.7-liter turbochargers.
