# TURBO DIESEL

## EGR VALVE AND COOLER CLEANING

### What's Required When?

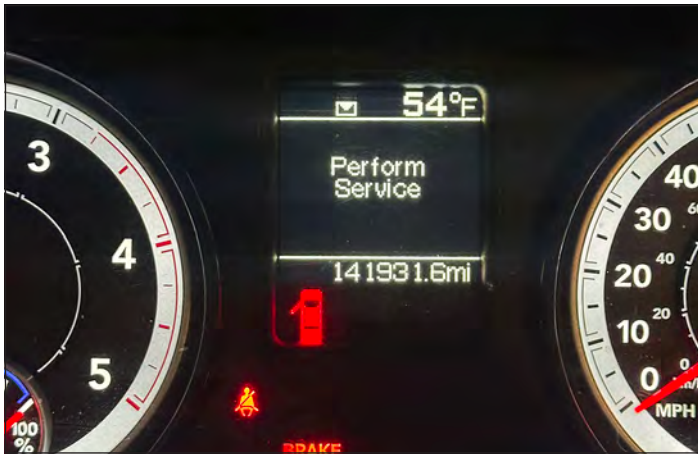
Perform Service at 135,000 miles meant I needed to change the CCV Filter and Clean the EGR Valve and cooler.

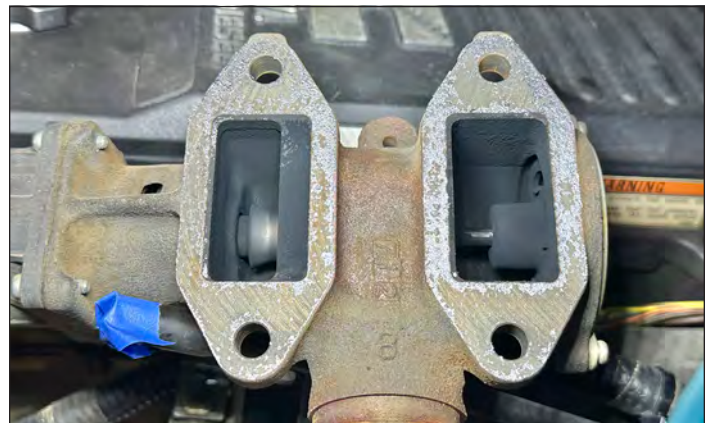
Seeing the inside of the EGR valve assembly was just as reassuring as looking into the EGR cooler. There was no grimy mess, just signs of normal exhaust gases.

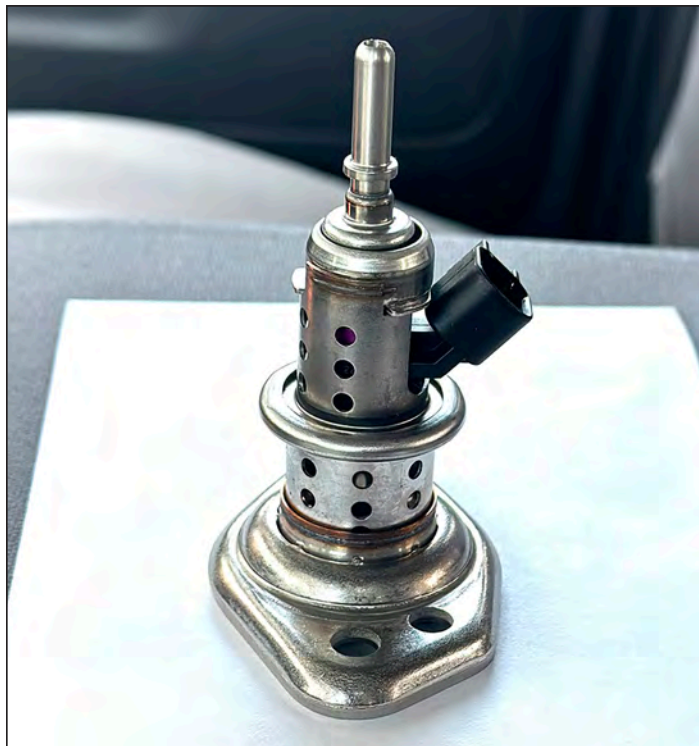
New DEF Injector from NAPA, \$200 after coupon, February 2024.

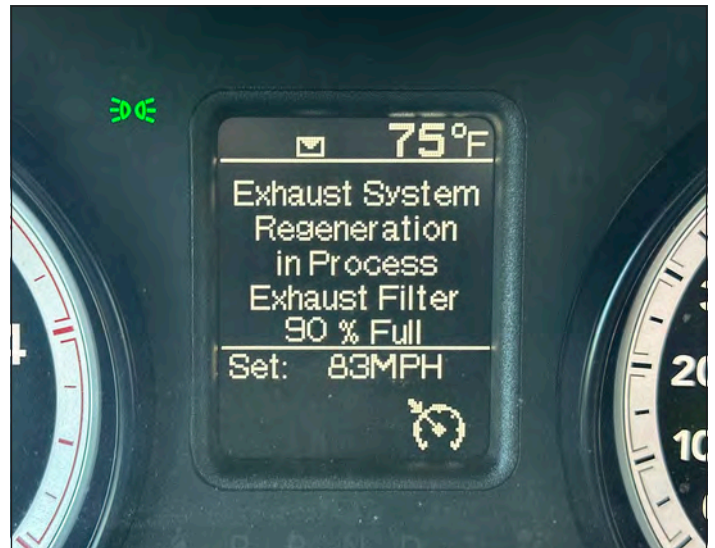
Exhaust filter was full, but after a bit of freeway driving: "Exhaust System Regeneration Completed" was my reward.

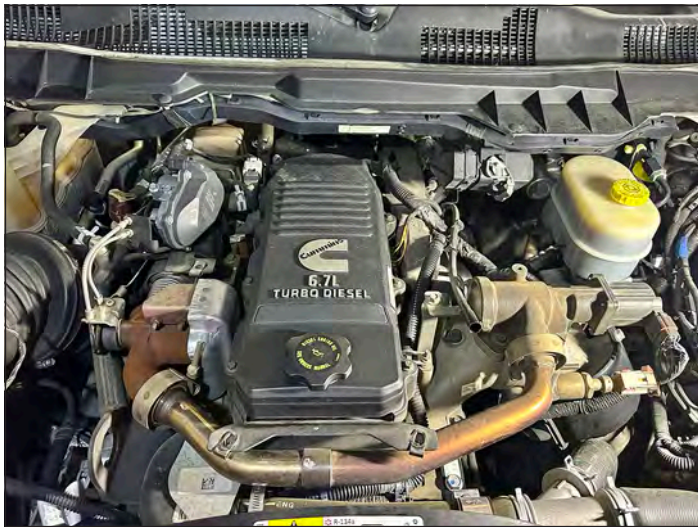
Remove dipstick and four 8 mm bolts securing the U-shaped cover at the front of the engine/valve cover. The EGR valve and electric controller is the T-shaped piece next to the oil dipstick and forward of the brake master cylinder. The EGR cooler is on the passenger side of the valve cover and mostly hidden by parts needing to be removed to access the cooler.

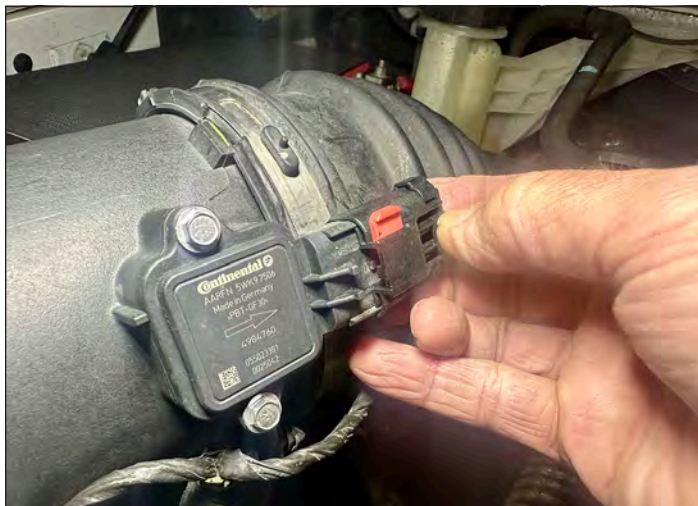
One of two wiring connections on the airbox lid, both should be disconnected before removal.

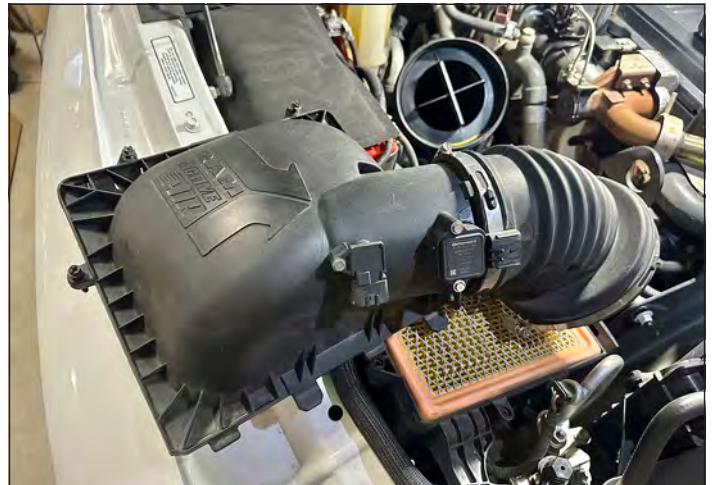
Loosen three screws and the clamp to lift the airbox lid and intake tubes that feed the turbocharger. I chose to separate the top section of tubing from the lower. It may be more efficient to keep everything connected, because joining the two sections of intake and securing the clamp during reassembly was "fiddly."

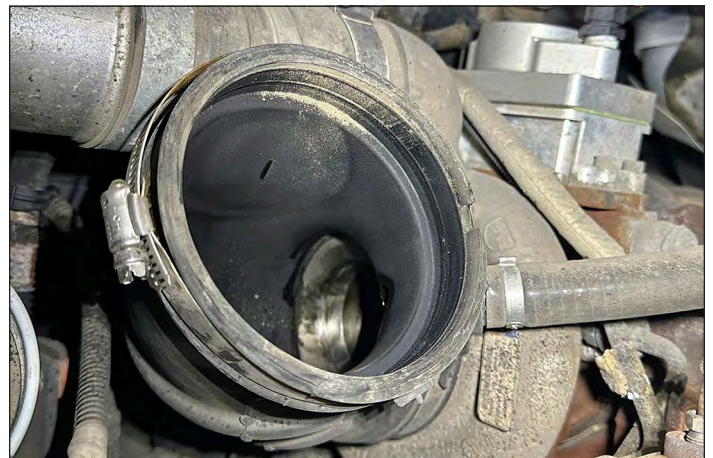
Even with a good garden hose rinse the day before, separating the two large rubber intake tubes to the turbocharger resulted in some grit falling into the top of the lower tube. It was easy to wipe clean.

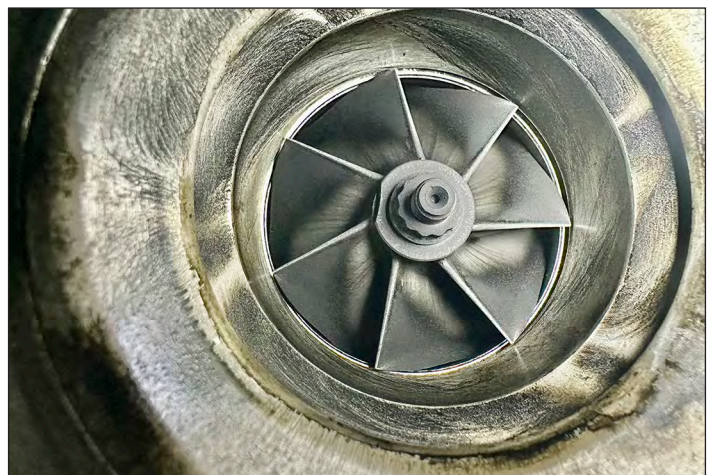
The turbocharger's cold side looked good to me.

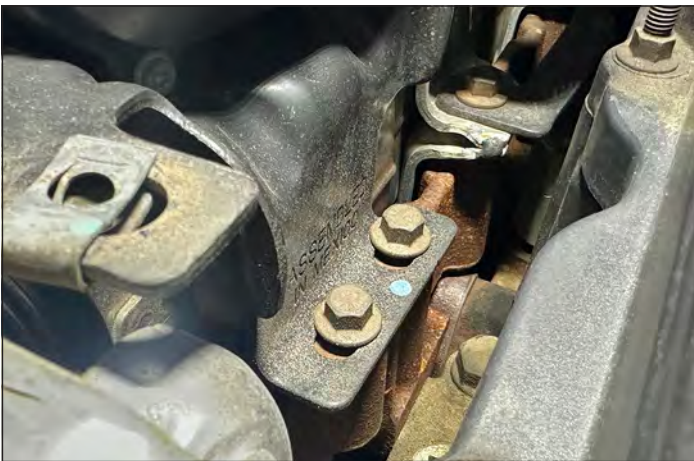
Four bolts secure the EGR control valve assembly bracket to the exhaust manifold. These two, vertical 10 mm bolts are next to the passenger side of the valve cover.

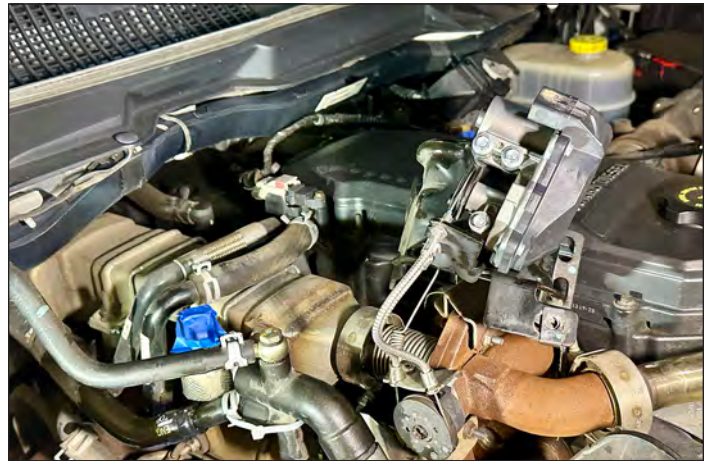
After all four bolts are out, rotate the control valve and bracket toward the valve cover. I held mine out of the way with a bungee cord. There is a spring that might fight you a little.

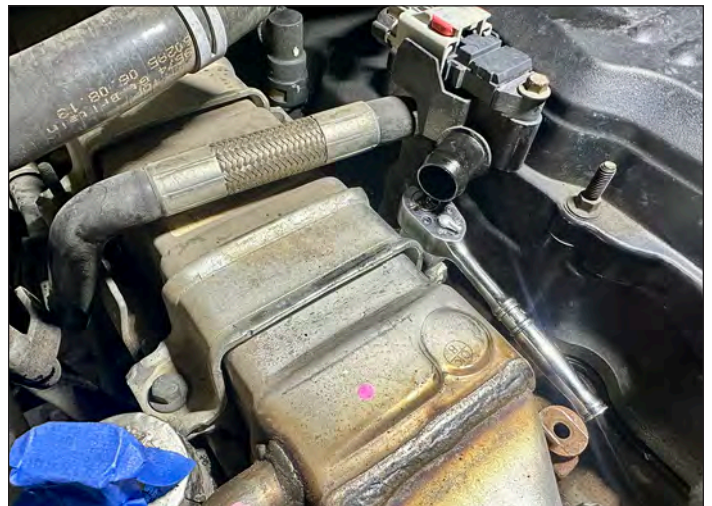
Showing the first of two hoses running over the top of the EGR cooler removed. To disconnect the slightly rearward and partially steel braided hose still attached here, the wiring harness connector and bracket attached the CCV filter/valve cover needed to be disconnected.

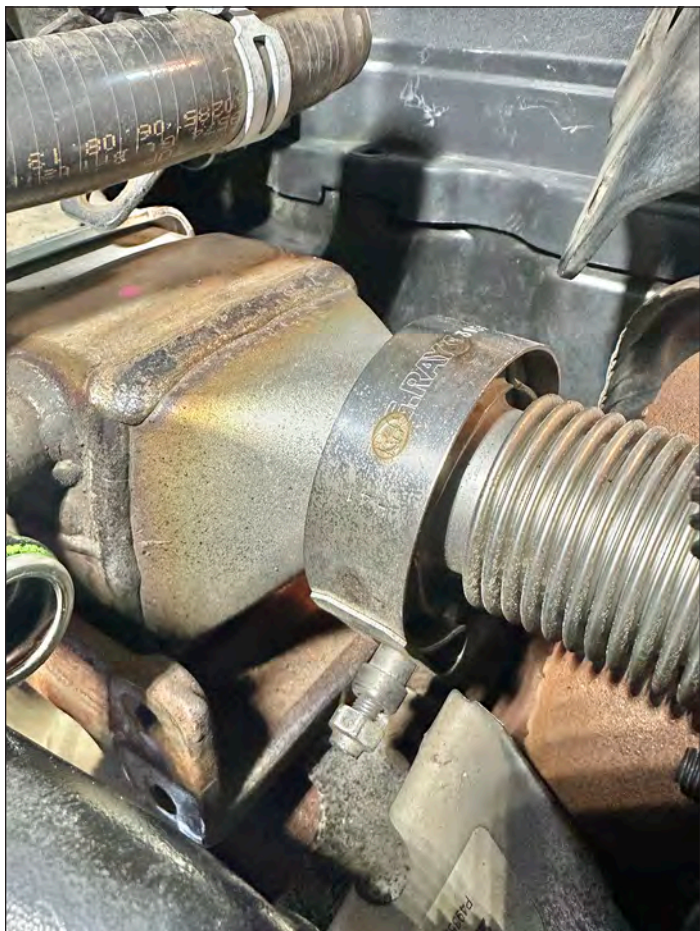
A 11 mm nut on this V-band clamp secures a crossover tube from the EGR valve on the driver side, to the front of the EGR cooler on the passenger side. Loosen the nut enough to disconnect the T-shaped end, then spread the clamp apart and remove the clamp.

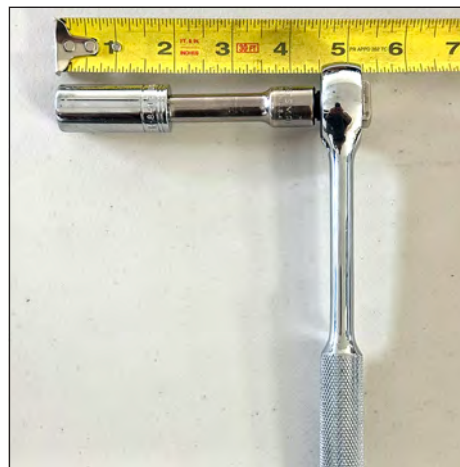
Long ratchet to the rescue.

The rear of the EGR cooler sits on two studs secured by 15 mm nuts, and this is the most knuckle busting part of the job. A long-handled ratchet would be helpful, but with my long arms I was able to use a regular ratchet to loosen the nuts, which were not very tight. The length of your deep socket, extension, and ratchet is important, and for me 5 3/8-inches overall worked well. This allowed dropping the socket onto the 15 mm nut, with the ratchet handle pivoting just above the top of the EGR cooler.

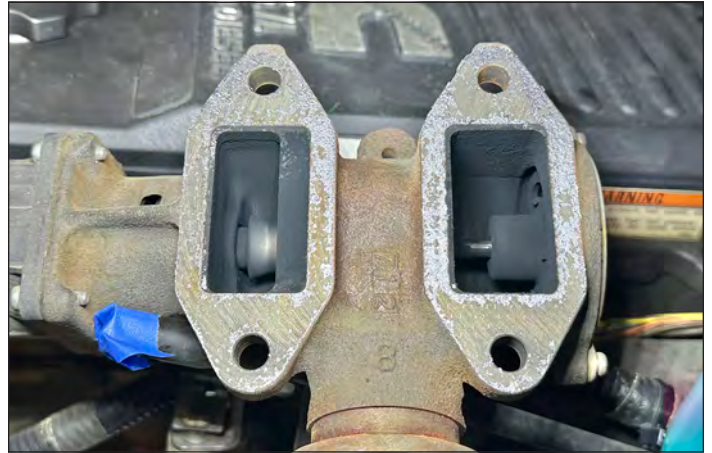
Seeing the inside of the EGR valve assembly was just as reassuring as looking into the EGR cooler. There was no grimy mess, just signs of normal exhaust gases.

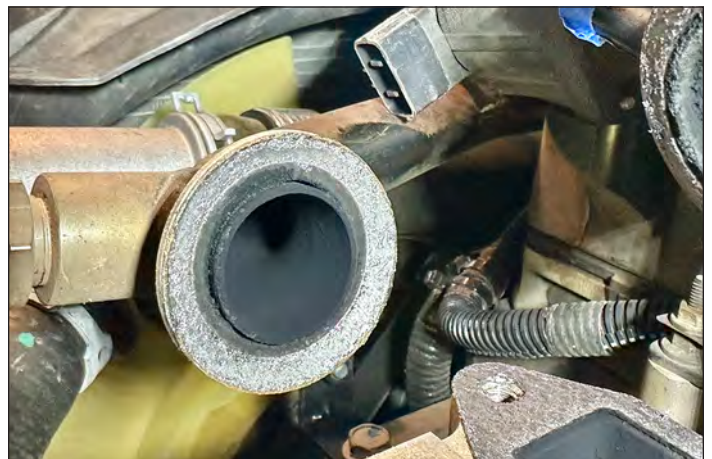
The crossover tube that routes EGR gases from the driver's side to the cooler on the passenger side also only had a thin layer of carbon inside. With no apparent slime or restriction, I decided against removing and cleaning this tube. Only the EGR cooler and EGR valve were cleaned.

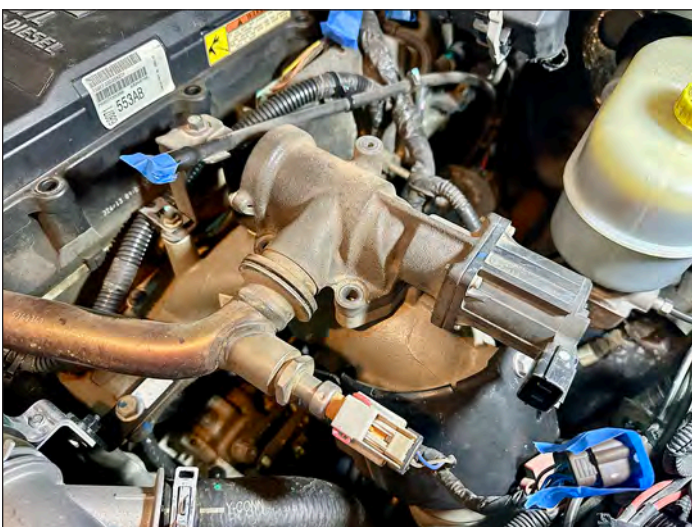
After removing the V-band clamp on the front, the EGR valve (already off in this photo), the four 10mm bolts securing the EGR to the manifold, and the wiring harness clip, the EGR valve can be lifted off the engine.

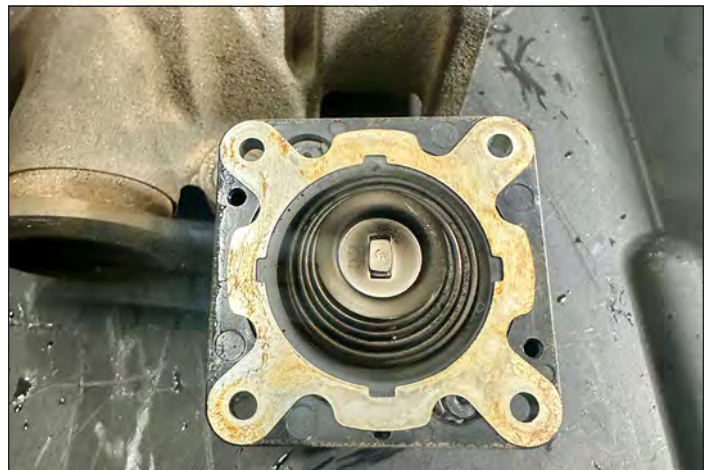
Four Phillips screws hold the EGR's electronic controller to the assembly. Remove before cleaning the EGR valve.

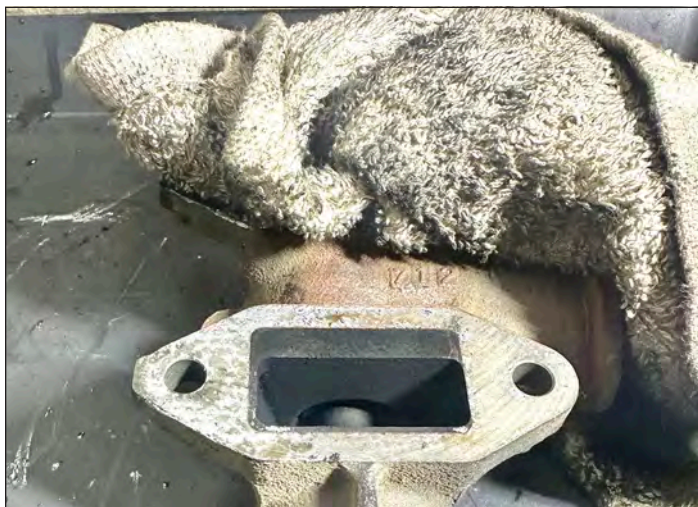
A spring-loaded part of the EGR valve sits behind the electronic controller. As recommended by Motor City Mechanic, stuffing a rag into one of the ports prevents the spring from compressing to facilitate disassembly.

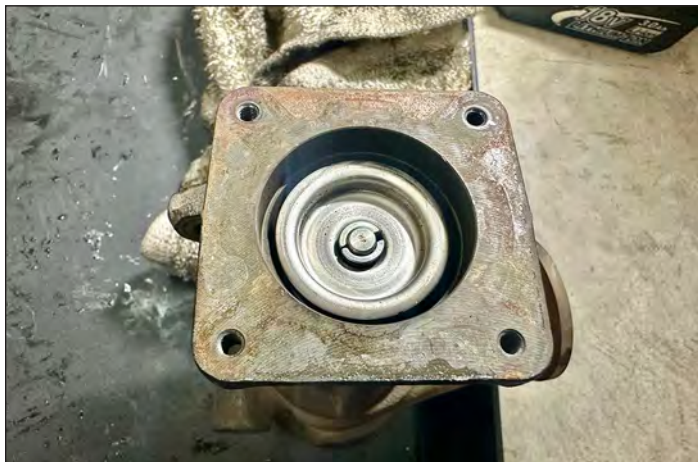
Two half-moon clips at the top of the shaft hold a spring under this cylindrical top piece. Push down on the cylindrical piece with your fingers and/or a screwdriver enough to release and then pop-out the clips to disassemble. Now the cleaning can begin.

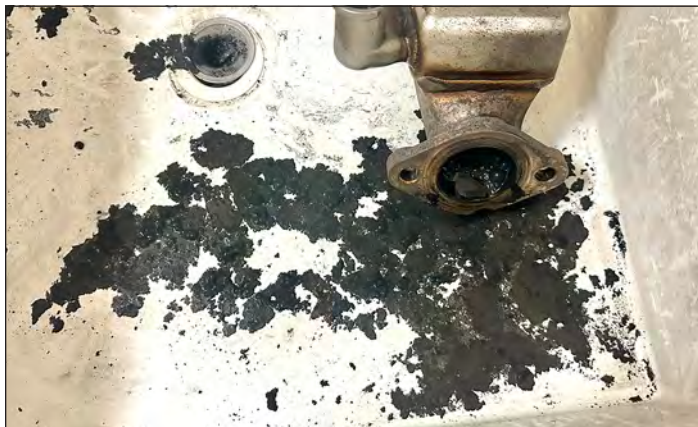
Before using any solvent, just running hot water through the EGR cooler released this nasty black crud. The inside of the cooler didn't look bad to the naked eye, but obviously there was junk inside.

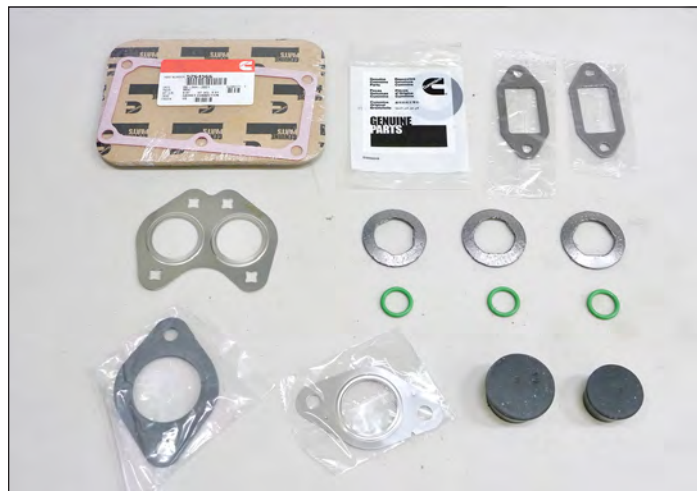
EGR Cleaning Kit

Contents of Geno's Garage EGR Cleaning Kit, without the crankcase vent filter, #EGRKIT-2, \$62. I actually purchased and used the kit with the crankcase filter, #EGRKIT-1, \$176. The first things used were the two rubber plugs (supplied by Geno's in the kit) at the bottom right of the photo, allowing for the cooler full of Purple Power to soak overnight.

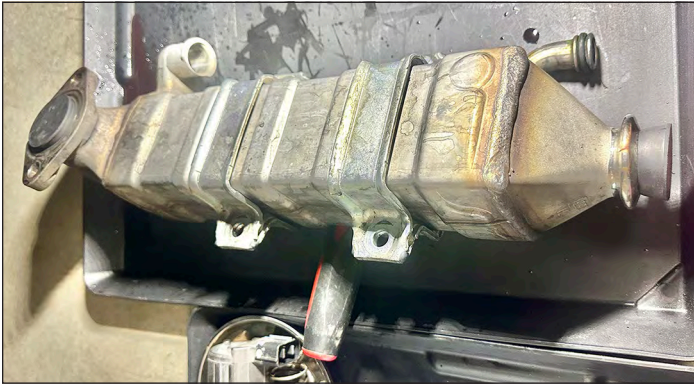
Time for internal cleaning. Note the cooler "plugs" from Geno's Garage.

With the larger plug wedged into the larger bottom hole of the cooler, it was filled with full-strength Purple Power. Purple Power is a little soapy/bubbly and foamed out of the smaller top hole when it was close to full. Stirring and breaking the bubbles with my finger allowed more to be added until the cooler was as full as possible. After fitting the smaller plug, the cooler soaked upside down overnight. In the morning, I propped it on its side with a screwdriver, and later upside down for a few hours before finally rinsing with water.

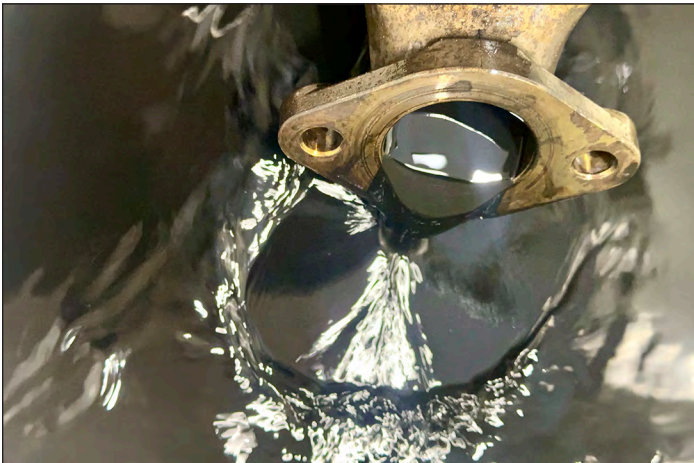
After 16 hours of soaking, this is what the Purple Power looked like coming out of the EGR cooler!

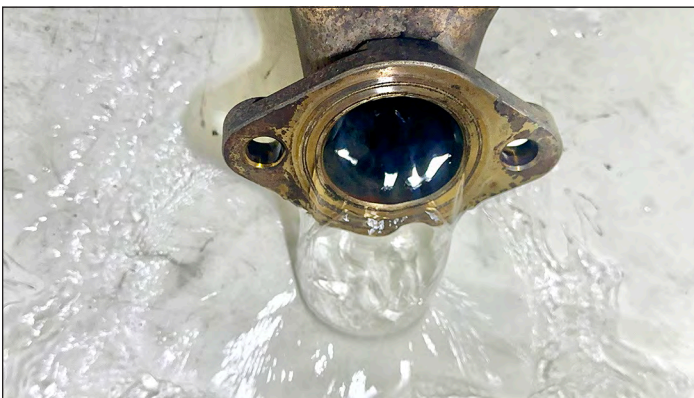
The cooler was rinsed with hot water numerous times, including shaking it with the plugs in-place, until the water came out looking as clean as it went in. Blow compressed air through the cooler to dry it out.

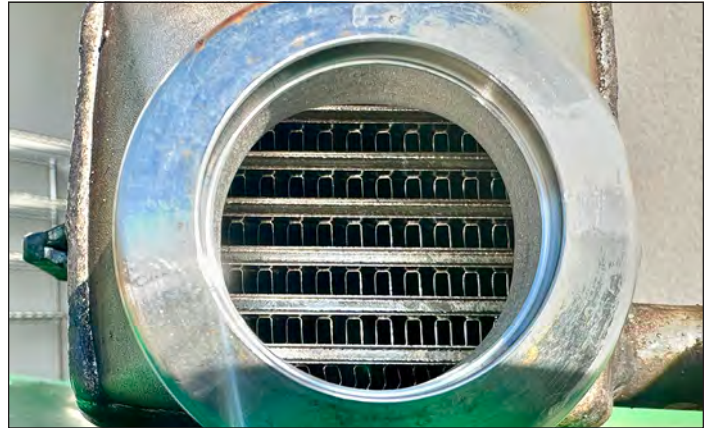
This is a 1,000-word photo regarding the effectiveness of Purple Power. Could the inside of the cooler look any better? Great

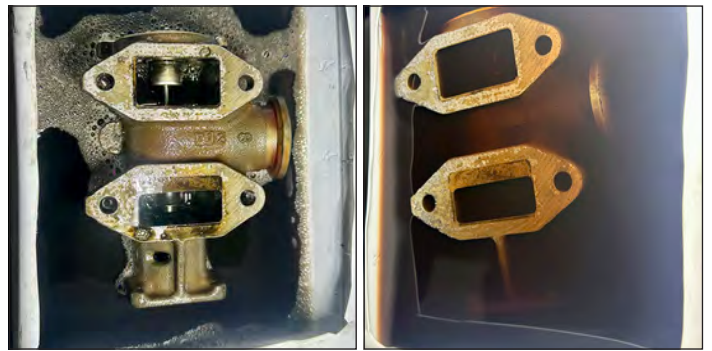
Gallon coolant bottle with one side cutout was used to soak the EGR valve overnight.

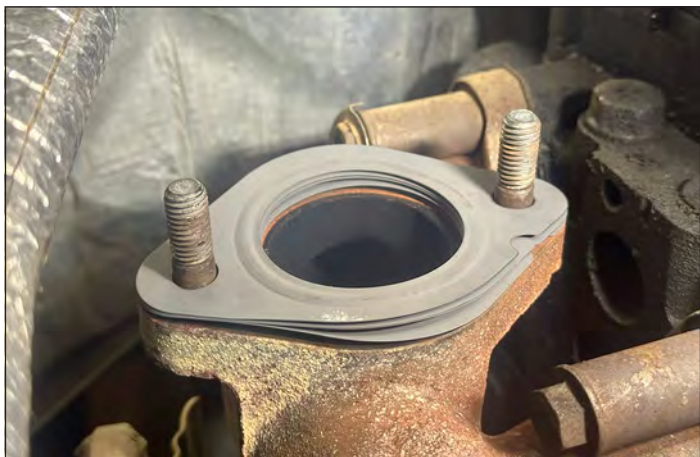
New metal gasket on the two studs for the rear of the EGR cooler before reassembly.

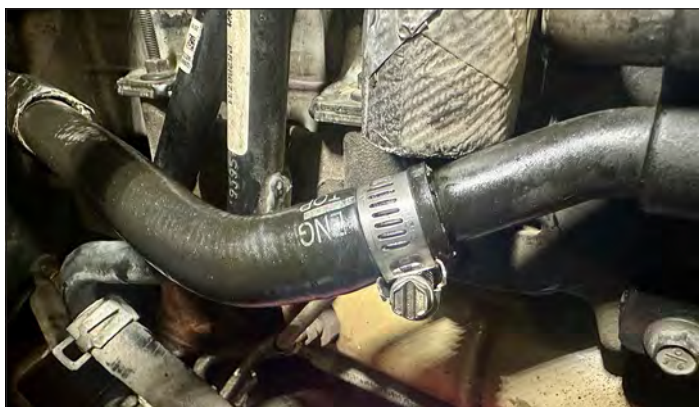
The OE spring-type hose clamp here gave me grief during reinstallation, so it was replaced with a common worm-gear clamp.

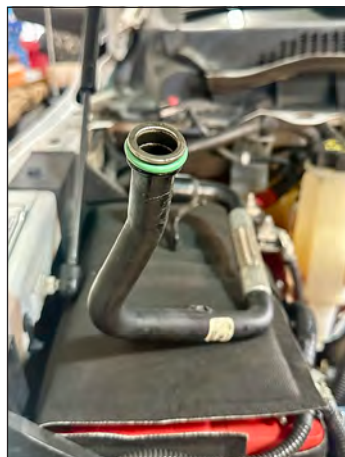
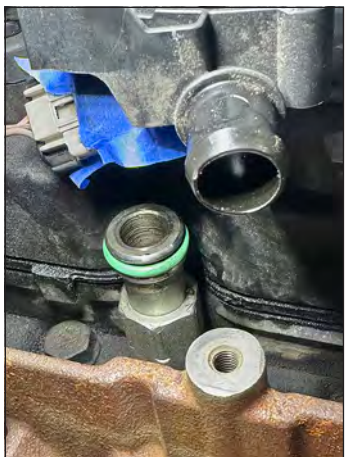
The Geno's Garage parts kit included three new green O-rings. One goes on the end of the elbow-shaped coolant port on the front of the EGR cooler, a second is for the hose with the steel-braided center that crosses over the cooler, and the third is for a hard fitting that sits between the cooler and the valve cover/CCV.

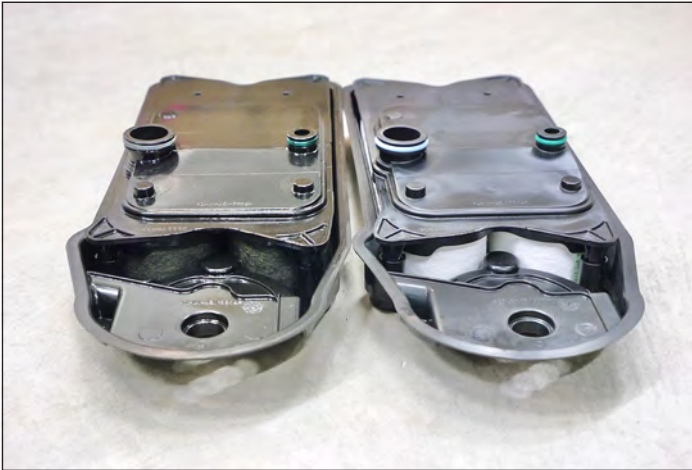
Old CCV filter on the left, new filter on the right.

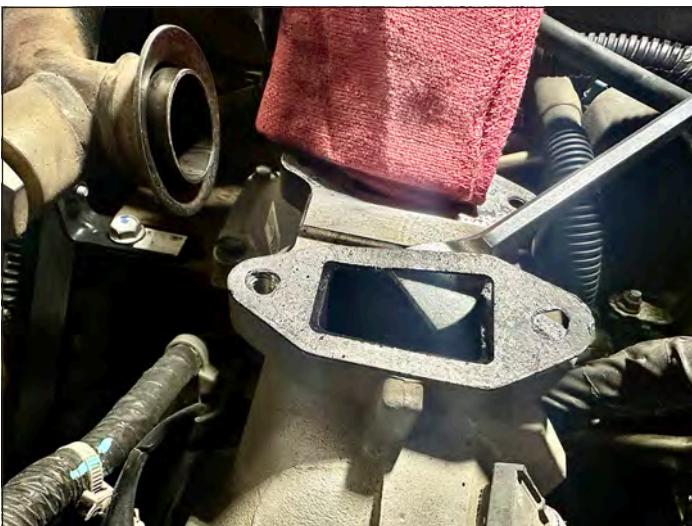
Gaskets below the EGR valve lifted easily, and only a little gentle scraping and chemical cleaning was needed before reassembly.

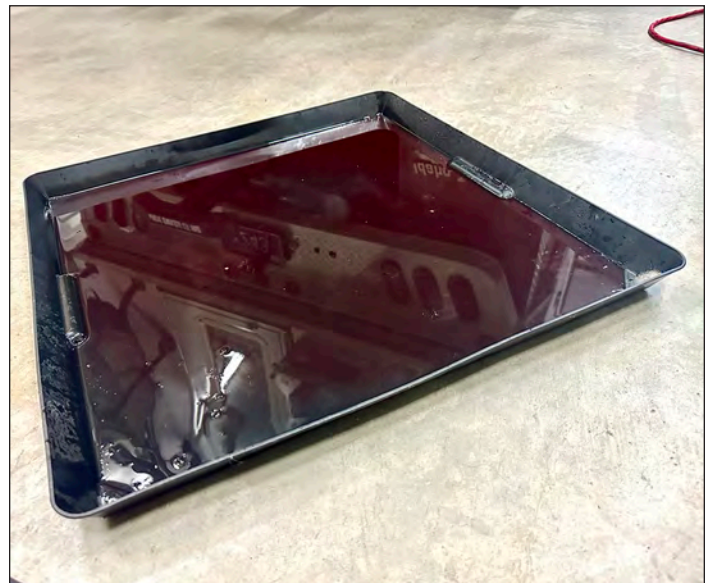
Just one-half quart (measured) of coolant was lost and caught by this pan.

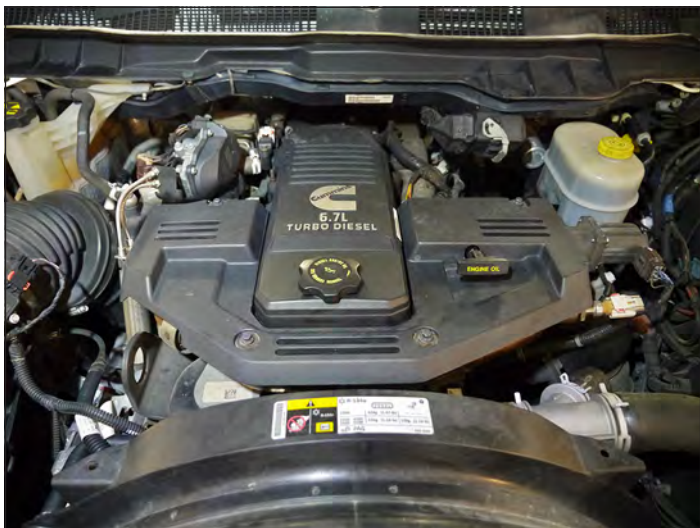
Back together and finished.

The truck started normally, there were no leaks, and a shakedown test drive was uneventful.
