MEMBER 2 MEMBER

THIRD GENERATION SUSPENSION UPGRADES: PART THREE

by Doug Leno

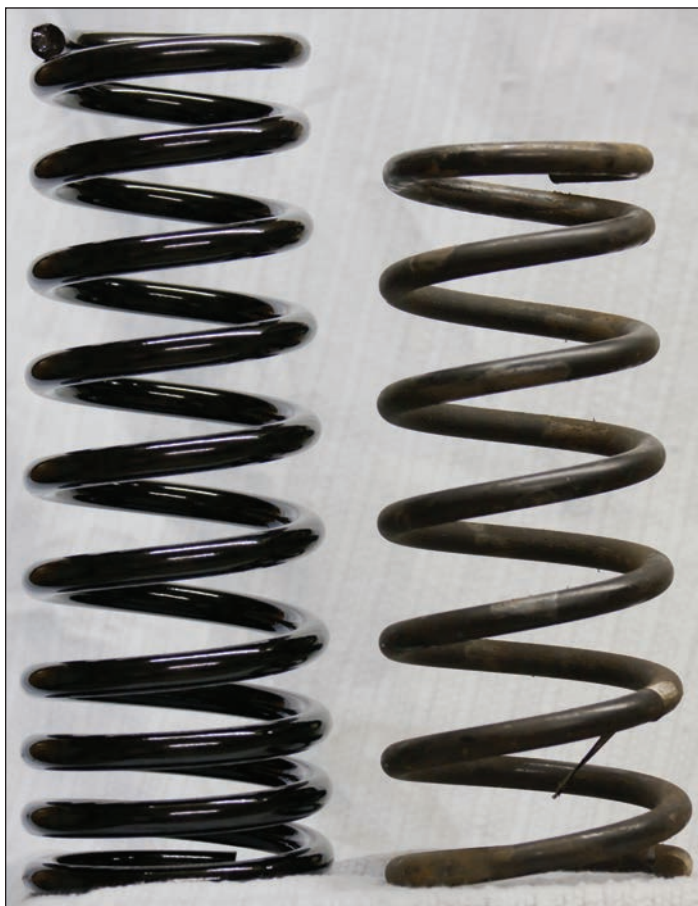
Figure 1: Carli Suspension multi-rate coil spring (left) installed in 2012, provided approximately three inches of lift compared to the factory spring (right)

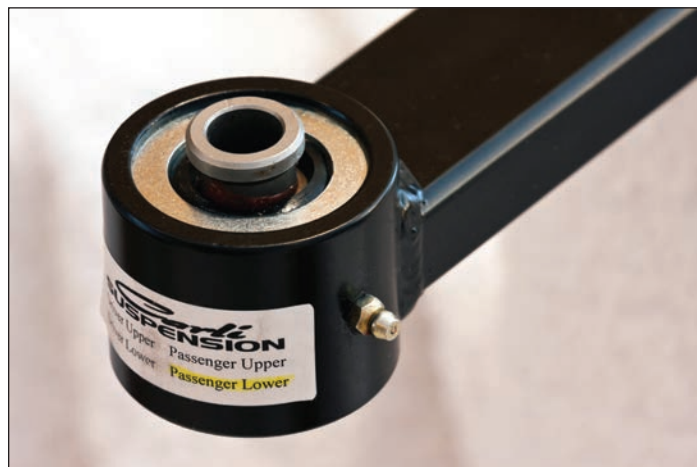
Figure 2: Carli suspension lower control arm, installed in 2012. The serviceable bearing eliminated the friction caused by the rubber bushings in the factory control arm.

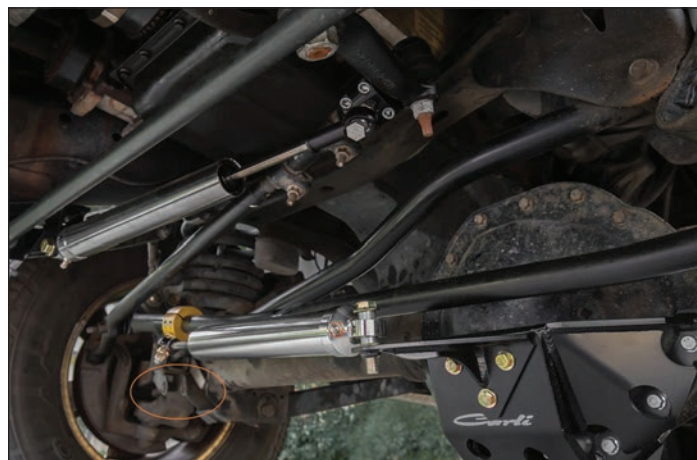
Part Two of the project was covered in February 2015, TDR Issue 87 (pages 13-17). In this article I described the Carli Suspension "dual-opposing steering stabilizer" solution. This upgrade greatly reduced the risk of stabilizer damage in off-road situations by locating both stabilizer bodies above the bottom of the axle tube (see figure 3).

Figure 3: My (Issue 87) Installation of the Carli Suspension "Dual opposing steering stabilizers." Without using the factory mount point, the lower stabilizer is located above the bottom of the axle tube, reducing the risk of damage in off-road situations.
