THIRD GENERATION SUSPENSION UPGRADES: PART THREE

by Doug Leno

BALL JOINT REPLACEMENT

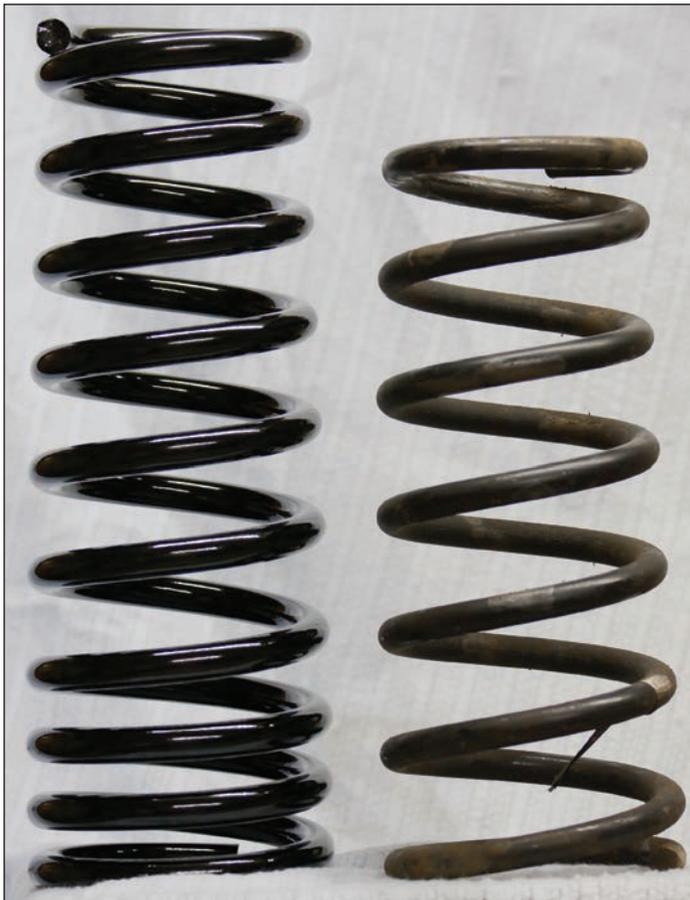
Figure 1: Carli Suspension multi-rate coil spring (left) installed in 2012, provided approximately three inches of lift compared to the factory spring (right)

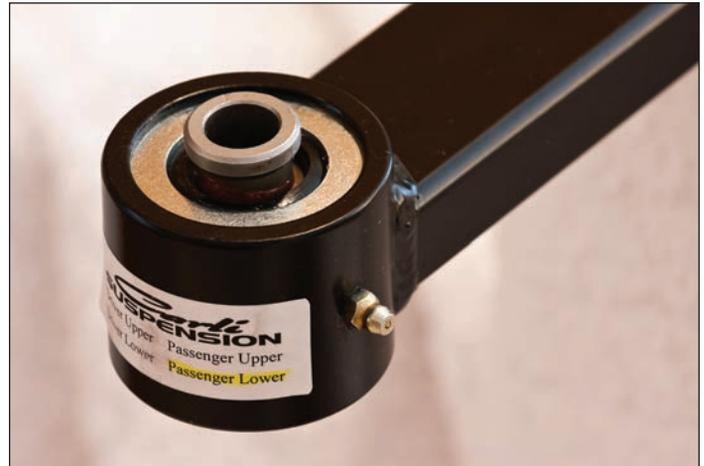
Figure 2: Carli suspension lower control arm, installed in 2012. The serviceable bearing eliminated the friction caused by the rubber bushings in the factory control arm.

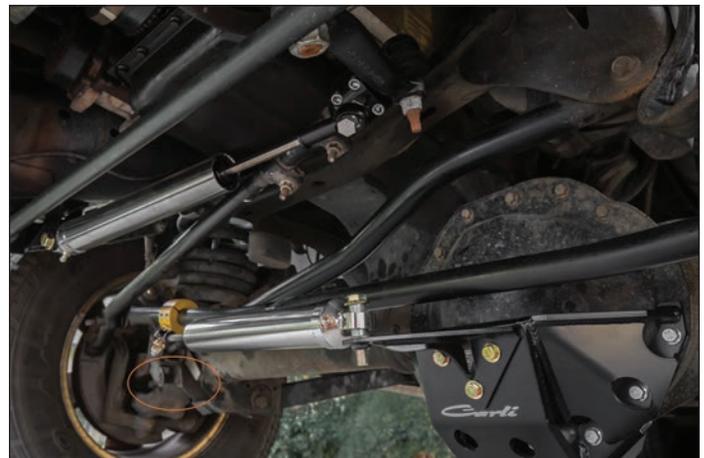
Part Two of the project was covered in February 2015, TDR Issue 87 (pages 13-17). In this article I described the Carli Suspension "dual-opposing steering stabilizer" solution. This upgrade greatly reduced the risk of stabilizer damage in off-road situations by locating both stabilizer bodies above the bottom of the axle tube (see figure 3).

Figure 3: My (Issue 87) Installation of the Carli Suspension "Dual opposing steering stabilizers." Without using the factory mount point, the lower stabilizer is located above the bottom of the axle tube, reducing the risk of damage in off-road situations.

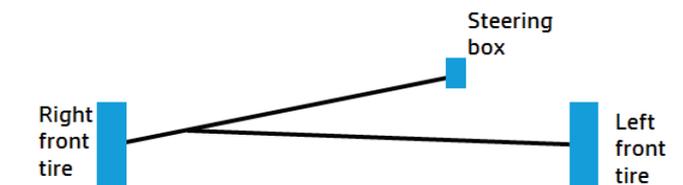
Turbo Diesels from 2003 through the mid-2008 model year were manufactured with what is known as a "Y-type" steering system, illustrated in figure 4. In the illustration, note that the tie rod from the left front tire connects to the steering drag link, forming a "Y" configuration. Why is this important? Imagine, for example, that the steering box in Figure 4 moved upward. This action would pull the left and right steering knuckles closer together, causing the tires to "toe in" (pigeon-toed). Conversely, moving the steering box downward would push the steering knuckles farther apart, causing the tires to "toe out." The main point of interest for this geometry is that *suspension toe changes dynamically during normal vehicle operation.*

Figure 4: "Y-type" steering system supplied on 2003-2008 model year trucks. In this configuration, suspension toe changes dynamically during normal vehicle operation.

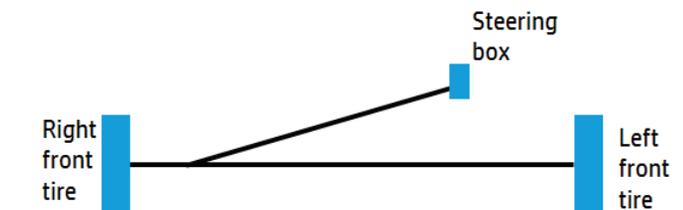
During the 2008 model year, Chrysler began to ship model 2500 and 3500 model Turbo Diesels with a different steering linkage geometry known as the "T-type", illustrated in figure 5. Note that for this geometry, the distance between the left and right steering knuckles is fixed, due to the rigid tie rod connecting the two together. *This means toe is not affected by suspension flex.*

Figure 5: During the 2008 model year, Chrysler introduced the "T-type" steering system, so named because the steering drag link "tees" into the steering tie rod. For this geometry, the distance between left and right steering knuckles remains fixed, keeping toe constant during suspension flex.
