TURBO DIESEL Buyer's Guide

A Publication of the *Turbo Diesel Register*

A WORD ABOUT THE TURBO DIESEL BUYER'S GUIDE

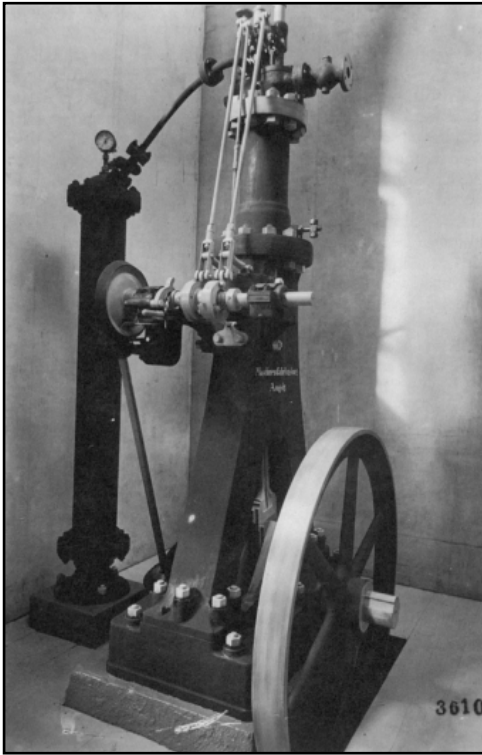
Diesel's first engine at the start of an 1893 test (photo courtesy of C. Lyle Cummins).

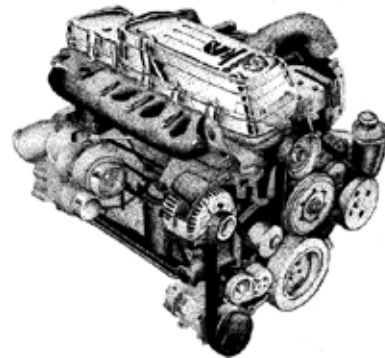
The Cummins engine used in today's Dodge pickup.

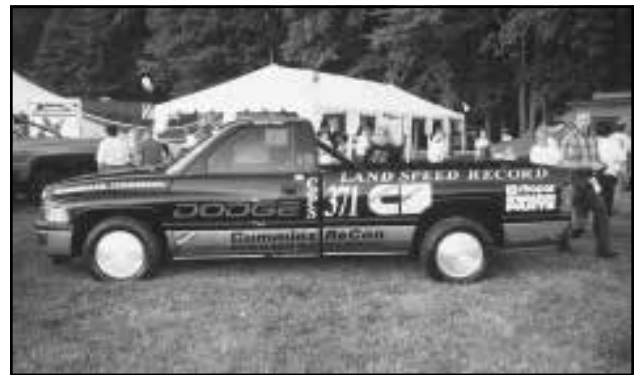
This interesting photo is an early '94 model truck that was modified to run at Bonneville. It successfully set a class record at the 1997 Bonneville Speed Weeks of 141.256 mph. (TDR Issue 15, page 44).

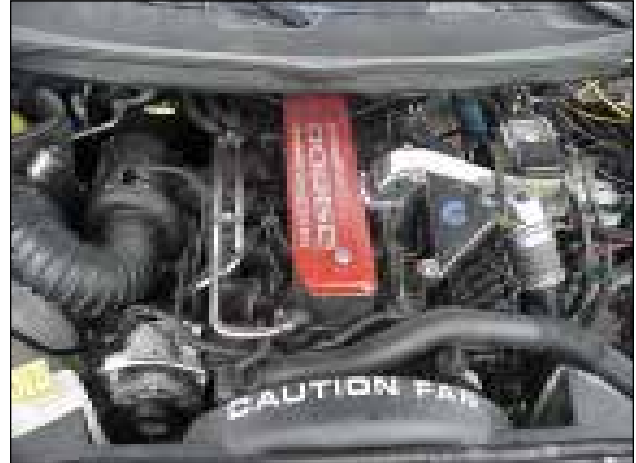
In the world of ever tightening exhaust emissions, long gone is this 12-valve engine with its mechanical P-7100 fuel pump.

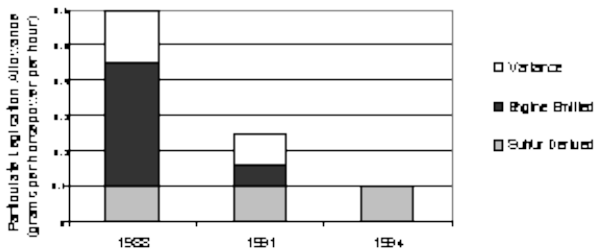
Diesel Particulate Emissions Makeup

As you can see from the graph, low sulfur fuel was a necessity for 1994. Without low sulfur fuel, the diesel particulate output of 0.1 gram/hp/hr would result from fuel sulfur alone, allowing for no design variance or engine-emitted particulates.

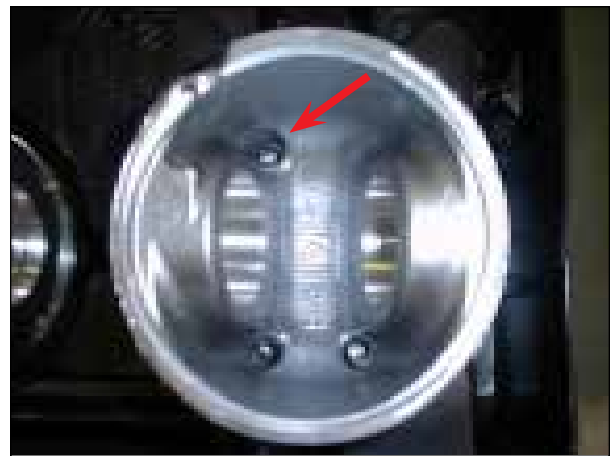
Underside of the HO piston. Note the passageway for oil to flow through the piston.

HO engines use a new system that includes a component called a "J-jet" for each piston. The J-jet nozzle is bolted to the block and directs a stream of oil to the underside of the piston. HO pistons have a passageway to direct the flow of oil through the piston head to cool it. HO engines also have an exhaust manifold that is capable of higher exhaust temperatures.

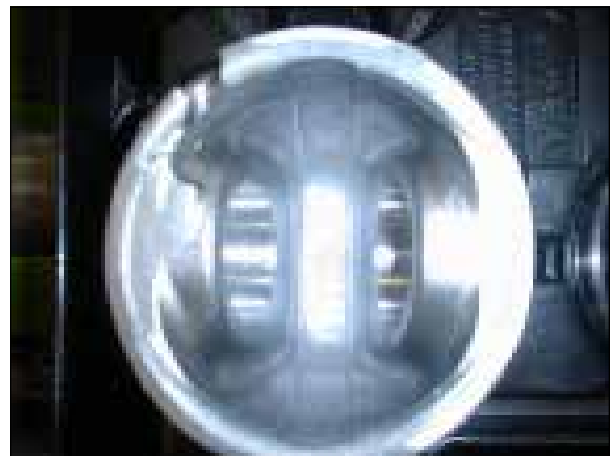
Underside of the standard piston.

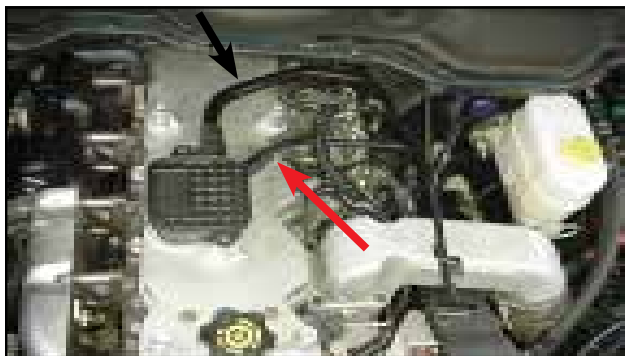
The 2003 crankcase vent system. The white arrow shows the inlet from the crankcase to the filter assembly. The red arrow points to the outlet hose that vents to atmosphere.

The crankcase vent system has been a point of contention for many Turbo Diesel owners. To virtually eliminate the driveway-drip problem Cummins and Fleetguard have redesigned the crankcase vent system. Thankfully the crankcase vent (read: low pressure vaporized oil) is *not* routed to the engine's air intake system [like the new 6.0 liter Power Stroke (Issue 39, page 96) or the Volkswagen automotive diesel (Issue 38, page 28)]. I can tell you from firsthand experience with crankcase vent oil and exhaust gas recirculation with a Volkswagen passenger car that it is messy. The vent on the Cummins engine goes from the engine to an oil separator box on top of the valve cover then is vented to atmosphere.

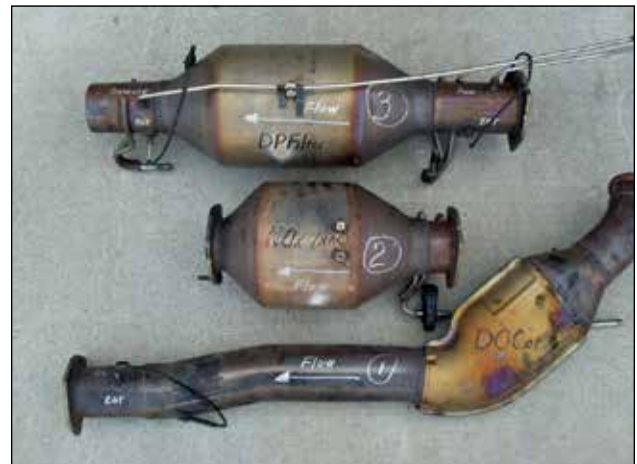
These components were taken from a Cummins test vehicle.

1. diesel oxidation catalyst (DOC)
2. NO_x adsorber catalyst (NAC)
3. diesel particulate filter (DPF)

"The system begins with a close-coupled catalyst—essentially a conventional diesel oxidation catalyst (DOC) incorporating a metallic substrate—mounted to a short downpipe just off the back of the turbocharger. A short distance behind and below the close-coupled catalyst is the NO_x adsorber unit, which is followed by a particulate filter. Both the NO_x adsorber and diesel particulate filter (DPF) use ceramic substrates.

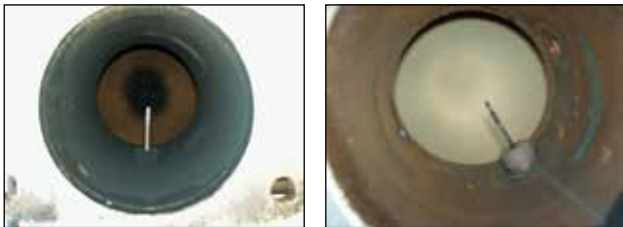
The "in" and "out" sides of the DPF.

"The third part of the aftertreatment is the diesel particulate filter (DPF). The DPF is regenerated when differential pressure sensors in the exhaust system detect a specified amount of loading on the substrate. Unlike the PM filter systems used on heavy-duty applications, there is no ash cleaning required, and the PM filter—like the NO_x adsorber and close-coupled catalyst—is rated for the life of the vehicle.

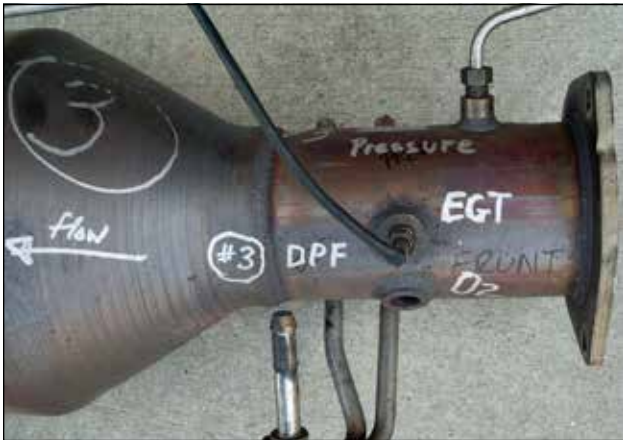
EGT, oxygen and pressure sensors monitor the need for regeneration of the NAC and DPF.

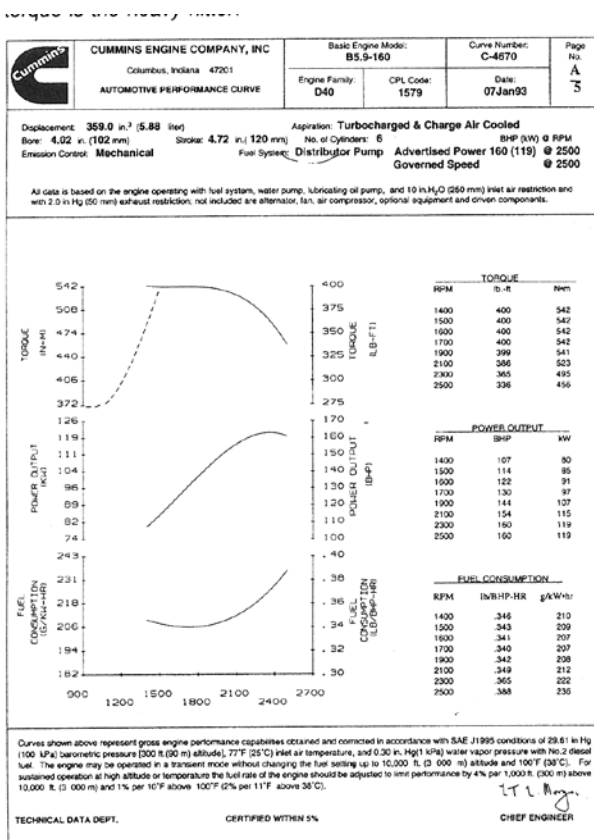
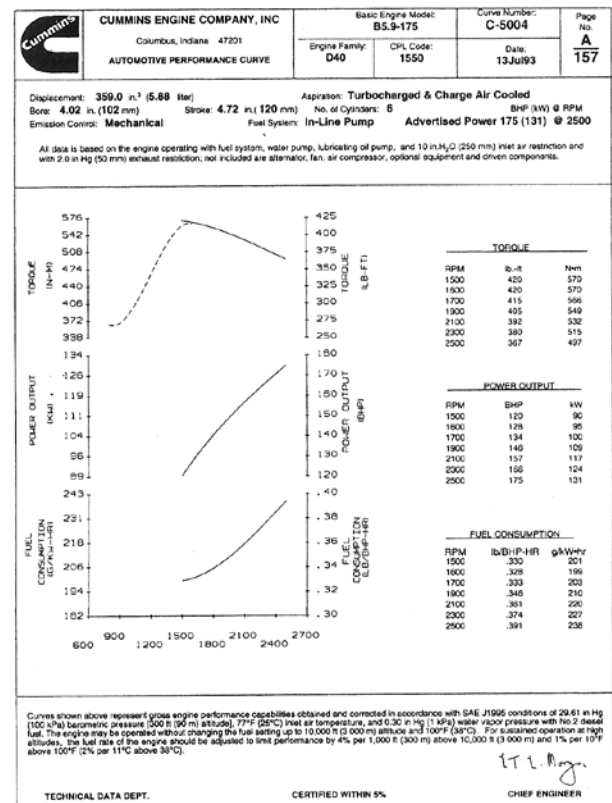
Interesting stuff? What does it mean to you? I hope you've learned from the efficiency relationships that it would be best to put your engine on cruise control at a speed corresponding to 1,600 rpm for the given 12-valve

performance curve. For 24-valve owners please see our discussion in the 24-valve topics on page 48. At 1,600 rpm you've got the torque peak of the engine available to keep your speed constant as you encounter a grade. If your speed drops below 1,600 rpm, you had better downshift because it's all "downhill" (back side of the torque curve) from there. You've obviously exceeded the maximum torque produced by the engine and multiplied by the gearbox/rear end ratio of the load you're trying to propel.

Final note, volumetric efficiency reaches its peak at the rpm at which the torque peak occurs. The physics to produce torque peak requires the greatest cylinder filling or volumetric efficiency.

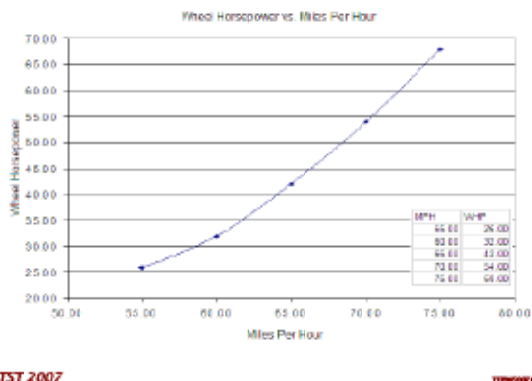
I felt finding a BSFC-like number for a Turbo Diesel would be a good way to check the relative fuel consumption. I knew our chassis dyno could be set to measure the horsepower at the wheels. But at what horsepower did we need to run the tests? The TST staff brainstormed the question and decided we needed to determine the actual horsepower it took to move a Turbo Diesel pickup at various road speeds. We took our '03 Dodge Ram out on the Interstate highway and ran it for several miles in both directions while recording instrument readings for air temperature, mph, gear selected, turbo boost, egt, rpm, and rail pressure. We gathered data for road speeds from 55 mph to 75 mph, in 5 mph increments. We then tied that truck to the chassis dynamometer and tried various loads until we could reproduce the instrument readings we took out on the Interstate. This gave us a horsepower value to use in our fuel economy tests for various road speeds. (See figure 1)

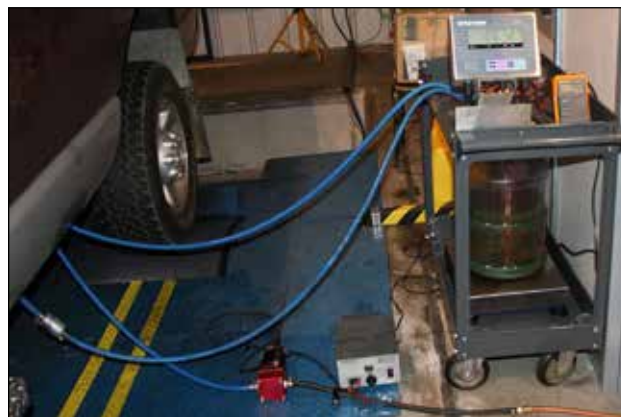
weigh the fuel as it is consumed. By carefully weighing a gallon of fuel, we could then determine the number of pounds per gallon. We could then use this pounds-per-gallon number to convert our pounds of fuel used back to gallons for the mpg calculation. This is the procedure that is used by Cummins in official ASE-type testing of big rigs at fleet accounts. We purchased an electronic scale with a digital readout that was guaranteed accurate to one hundredth of a pound and used a transparent five-gallon plastic jug as our fuel tank. We unhooked the quick connects from the truck tank and plumbed them such that the engine would draw and send its return fuel to the plastic jug (See picture below).

It took about four hours to add 50 feet of copper tubing to our return fuel line. We dropped that copper line into a large cooler and returned the fuel to the plastic jug. We then used a garden hose to run cold city water through the cooler to keep the returned fuel cool. By regulating the city water flow we could maintain the fuel temperature at a usable level.

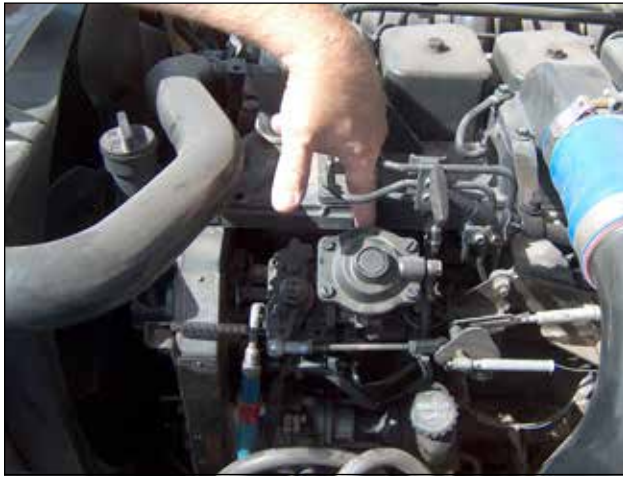
A Bosch VE pump on a Cummins B engine, with a finger showing the clearance between the AFC module and the cylinder head.

There are official tools and procedures for setting the timing of the VE pump. Many years of working with these pumps on Dodge applications have resulted in some "quick and dirty" procedures that you can use on a try-and-fit basis. You can try small incremental positioning (turning) of the pump to see what effective timing works best for your truck. If you want to take the pump timing about as far advanced as you would want, for good performance and economy, the result will be around 5/8" to 3/4" clearance between the air-fuel control module (afc) and the cylinder head, about a finger-width. Advancing the pump too much (moving the top toward the

head) gives white smoke, but not the amount of engine fuel knocking or rattling that you would get from advanced timing with an in-line P7100 pump. Better mpg may occur with advancing the VE pump timing slightly from stock. Retarding the pump timing will generally result in lower engine power.

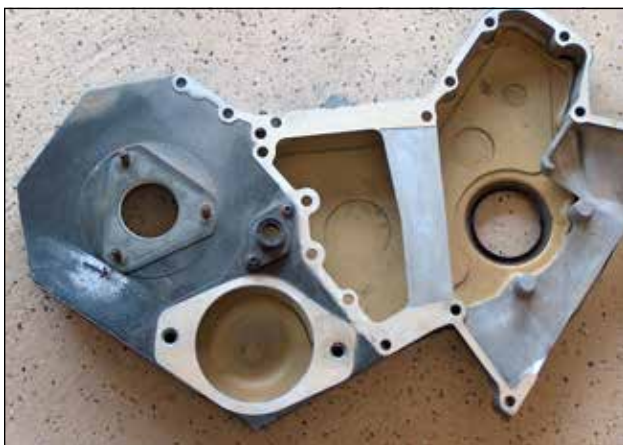
Engine side of a VE-pump style Cummins gear housing.

If you decide to use the “finger clearance” method, first look closely at the pump flange to the outside of the outermost mounting stud and nut. You should find a chisel notch on it, and a corresponding notch in the gear housing. These marks serve to indicate the “factory” timing setting. To rotate the pump and advance the injection timing, you need to loosen the three 13 mm headed nuts and the injector line nuts at the back of the pump (so you won’t twist the lines and strain them). The pump will resist turning until the nuts are loose enough, because of the fiber mounting and sealing gasket that can be seen in the photos. The Snap-on Blue Point SP144 wrench helps greatly in removing the two hard-to-access pump mounting nuts. The Snap-on flare nut crow’s-foot helps to loosen the injector line nuts. It should be 16 mm (5/8”, part number FRH200S) or 17 mm (part number FRHM17).

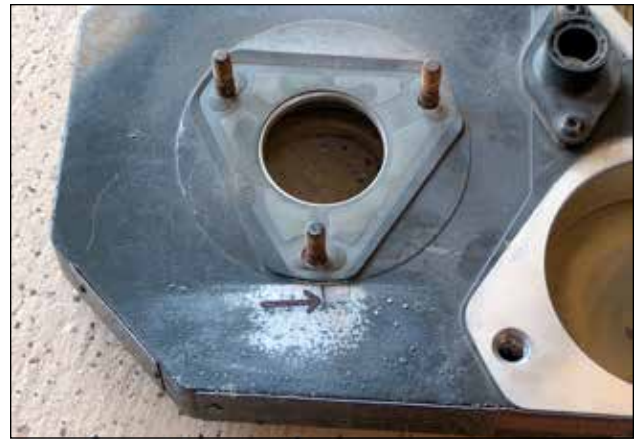
Close up view of the VE pump mounting area of the gear housing with the housing timing mark and the pump-to-housing gasket.

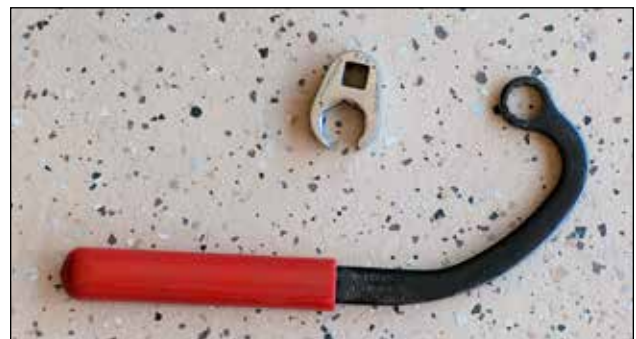
Snap-on flare nut crow’s-foot and pump mounting nut wrench.

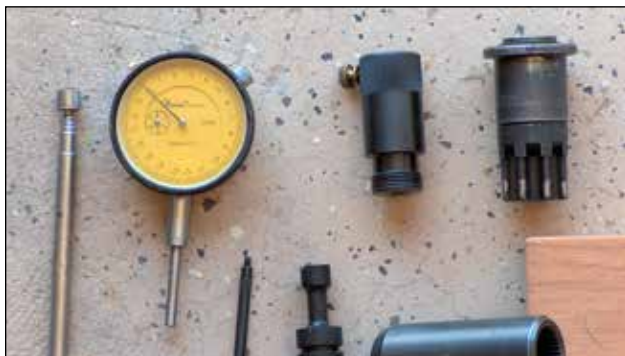
T5. Miller MLR-6860 P7100 pump timing tool kit. At the left is a magnet on a telescoping “stick.” To its right is the dial indicator with the stem extension below and to its right. To the right of that is a timing pin with a steel tip epoxy glued onto it. The special splined socket is at bottom right, with the splined end resting on a block of wood. At top center is the adapter that holds the dial indicator and screws into the top of the pump barrel. At top right is an engine barring tool that plugs into the aluminum block adapter plate and meshes with the flywheel teeth.

To set the timing of the P7100 pump, you need precision tools and all fuel system internal parts must be kept scrupulously clean. You need Miller MLR 6860 pump timing tool kit and a Snap-on Blue Point SP504 plate style gear puller (or equivalent). When you remove the #1 delivery valve, do not touch it dry with bare fingers. Use a clean telescoping stalk/magnet and keep it covered with clean diesel fuel.

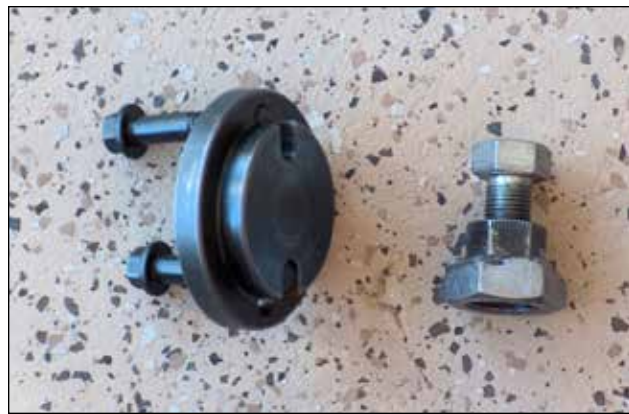
T6. The Snap-on SP504 gear puller with M8x1.25x40 bolts and the home-made pump shaft turning tool at right.

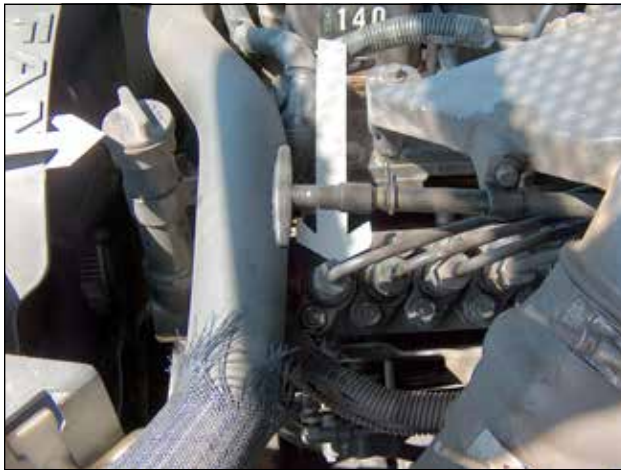
T7. A Bosch P7100 pump on a Cummins B engine, with arrows pointing to the oil filler tube/cap, and to #1 injection line and pump barrel.

1. Install a dial indicator so you can track the fuel injection event within the pump. Install the engine barring tool in the flywheel and rotate the engine crankshaft until the needle indicates the lowest point of the pump plunger. To get to the plunger, you have to remove #1 injection line, [right hand arrow in photo T7] use a special splined socket to remove the "tower" on the #1 pump barrel, and then use a magnet-on-a-telescoping-stick to pull the delivery valve and its steel casing (about 5/8" diameter) out of the pump barrel. [see photo T8] Then you thread on a special holder for the dial indicator, and install the indicator so the measuring stem is on top of the plunger. [see photo T9]

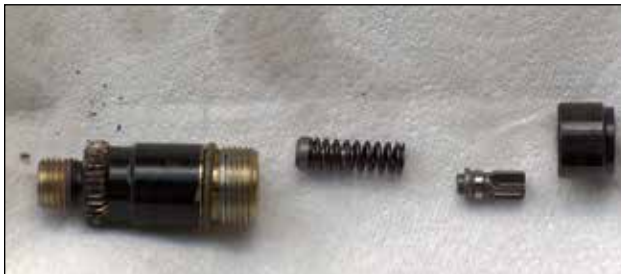
T8. Delivery valve parts removed from #1 injection pump barrel assembly in order to set timing.

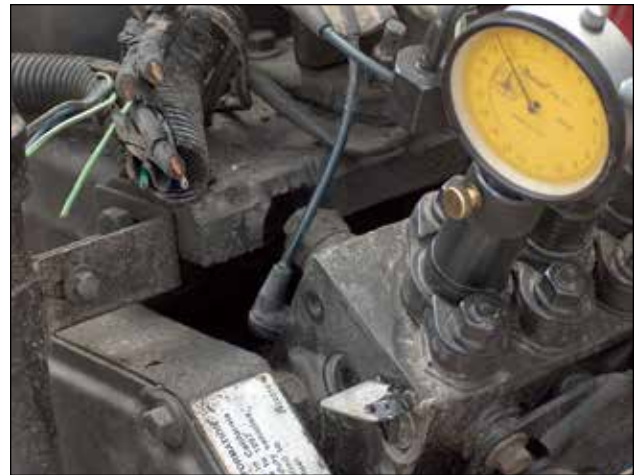
T9. Dial indicator installed in #1 barrel of a P7100 injection pump.

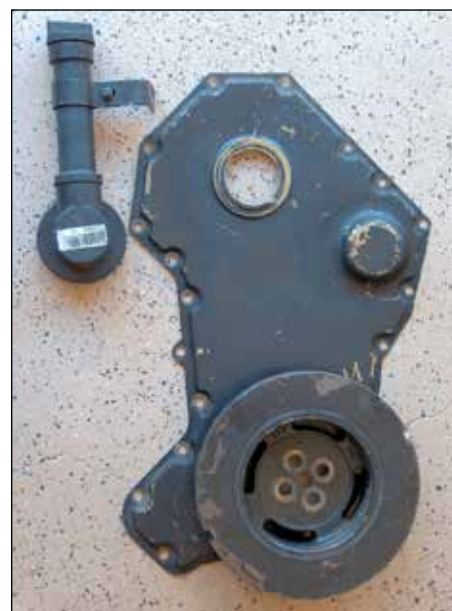
T10. A Cummins gear housing, front side, with the oil filler tube at yop left.

2. Rotate the engine crankshaft to TDC for #1 cylinder and make sure it is the TDC of injection (with a four cycle engine, one is injection/firing TDC and the other TDC is "overlap" of the exhaust and air intake events). The correct TDC will have #1 valves closed and both valves for #6 cylinder will be slightly open.
3. Compare the amount of plunger lift at TDC to timing in degrees using the table on page 105 for the specific version of your P7100 pump. Now you know what the timing is before you reset it.
4. While the barring tool prevents the engine from turning, remove the 30-mm hex nut and washer from the pump shaft. The nut is behind the oil filler tube (left hand arrow in photo T7, and bottom left in photo T10), and to access it you have to unthread the oil fill pipe from the base, and unthread and remove the base from the engine gear housing cover (T10).

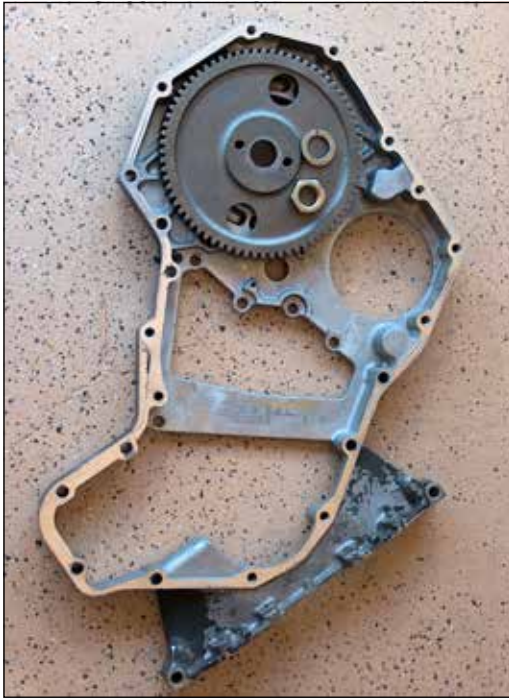
T11. A Cummins B gear housing with a P-pump drive gear, washer, and nut.

- Use a puller (Snap-on SP504 or similar) to “pop” the gear (photo T11) loose from the tapered pump shaft. If you watch the big and little dials of the indicator, you will see how much the pump timing retarded on this occasion. Use of the puller is illustrated on a CP3 pump and gear in Photo T12. (Notice that the CP3 uses a small 36 tooth gear and thus spins at crankshaft speed, not camshaft speed!)

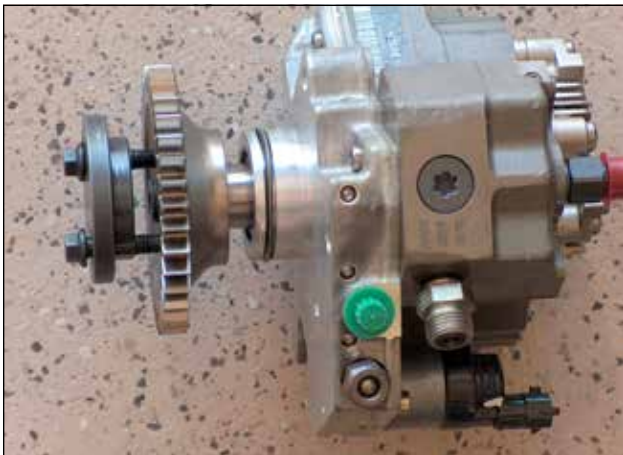
T12. Use of the SP504 gear puller is illustrated here with a Bosch CP3 pump.

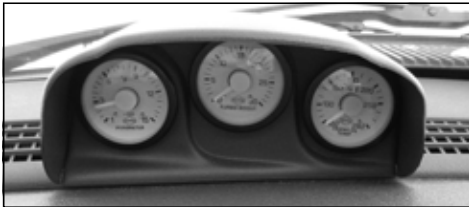
Now that you have the specifications in hand—wait a minute, you don't have a boost gauge? This instrument is easy to source, relatively cheap (\$40-\$60) and easy to install. The majority of gauges on the market are mechanical devices that do not require electricity to operate. To put a gauge in, one can use a "boost bolt" to access the pressurized intake air.

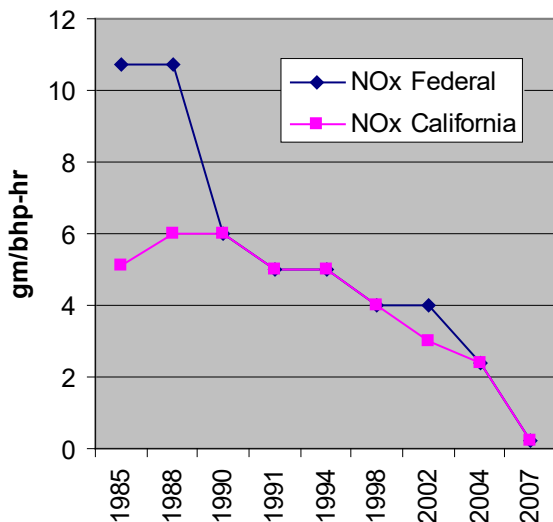
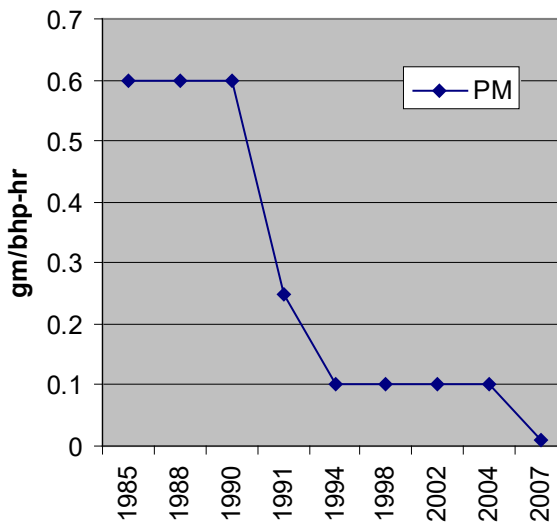
Note the sharp, ten-fold drop in emissions from year 2004 to 2007. I recall that one of the first TDR magazines stated that emissions were the driving force behind changes to the diesel engine. The 2007 emissions targets nail home that statement. Certainly ultra-low sulfur fuel will help, but the engineering it will take to meet the targets is difficult to imagine.

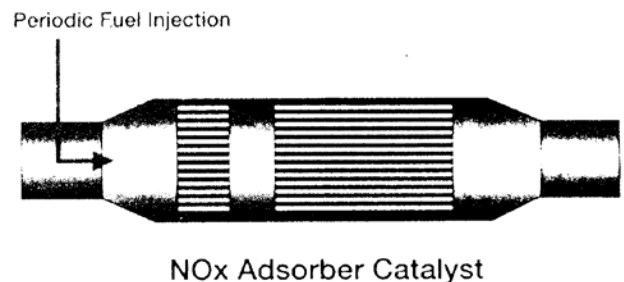
The elimination of all excess oxygen in the exhaust gas for a short period of time can be accomplished by operating the engine in a rich mode. This is done by injecting fuel directly into the exhaust stream ahead of the adsorber to consume the remaining oxygen in the exhaust. Either way, the engine and catalyst must be controlled as a system to determine exactly when regeneration is needed, and to control the exhaust parameters during regeneration itself.

NO_x adsorbers are expected to appear first in light-duty applications.

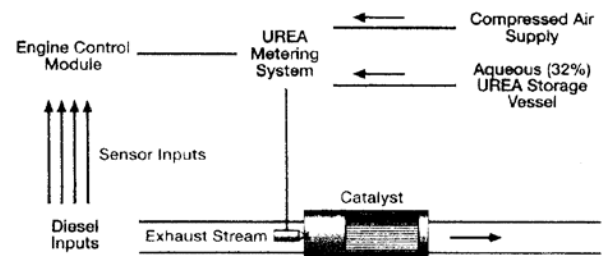
Selective Catalytic Reduction - SCR

Basic Principal - Spraying UREA into the exhaust stream to promote NO_x reducing catalyst activity.

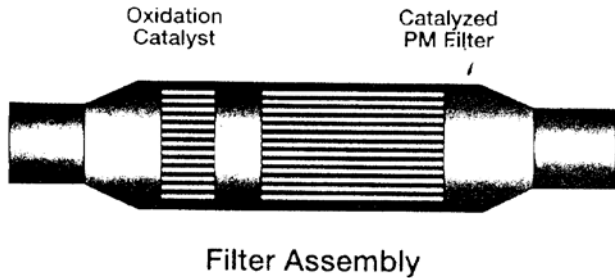
There are several methods to control or raise the exhaust temperature to manage the regeneration event in the DPF. The most promising methods for an active integrated system for 2007 are management of the engine combustion process in combination with an additional oxidation catalyst. This will allow regeneration to take place under low-ambient/low-load conditions when exhaust temperatures are low, as well as during normal operation.

As oil is consumed and particulate matter is burned off through regeneration they become ash and collect in the filter. The ash must be cleaned from the filter or plugging will occur. Maintenance may be required on diesel particulate filters.

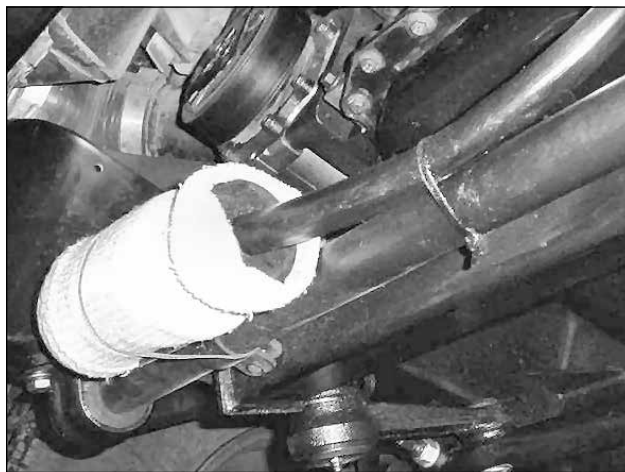
The old cotton sock idea is an easy fix with no drips or oily film on anything but the outer sock. I replace the sock while I am under the truck changing oil. I extended the tube and drip catch bottle down to the anti-sway bar and secured it with a couple of wire ties.
Gary-K7GLD, Canyon City, OR

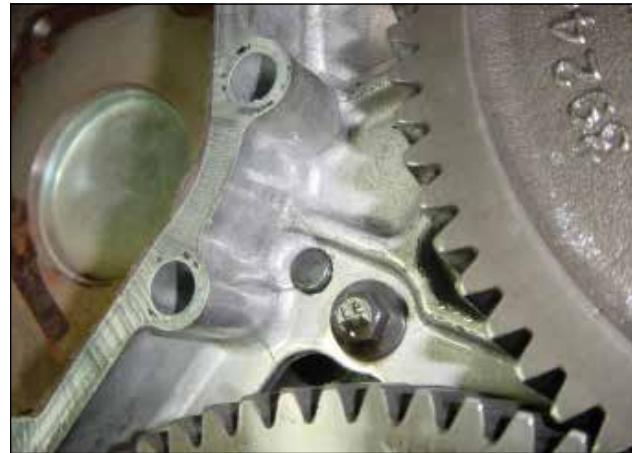
A close-up picture of the dowel pin.

leak. The fix involves staking the pin, covering the pin with a teardrop-shaped washer placed under a nearby bolt, or removing the pin altogether since it has already served its purpose in locating the housing during engine assembly.

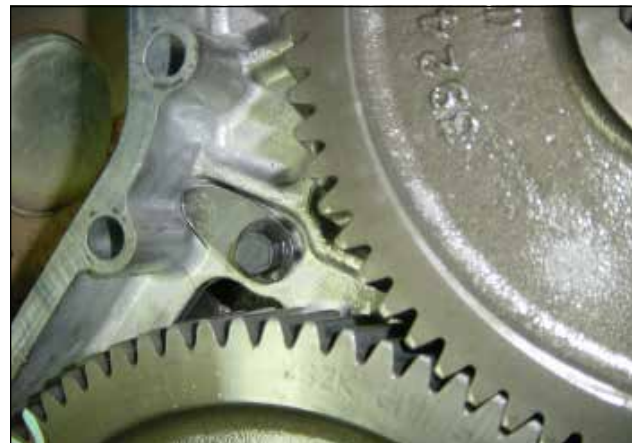
A picture showing an egg-shaped washer that covers the dowel pin.

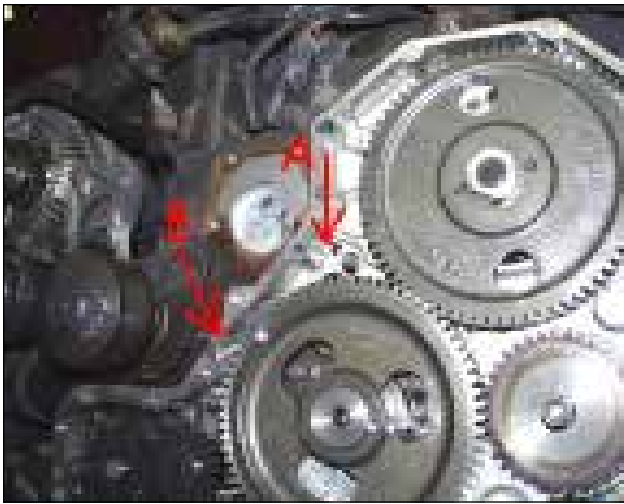
For those not familiar with the dowel pin the arrow shows its location.

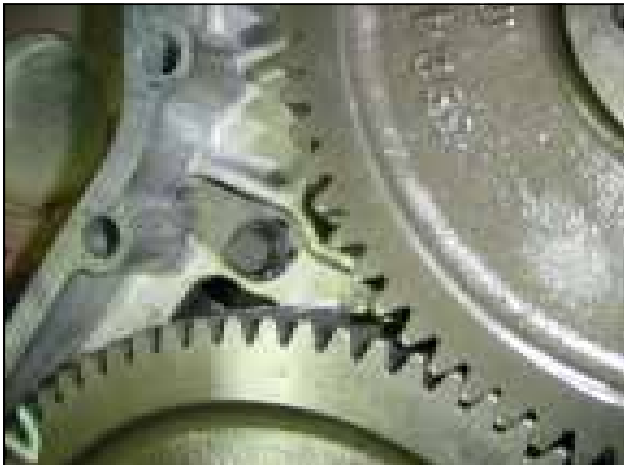
A close-up picture of the dowel pin.

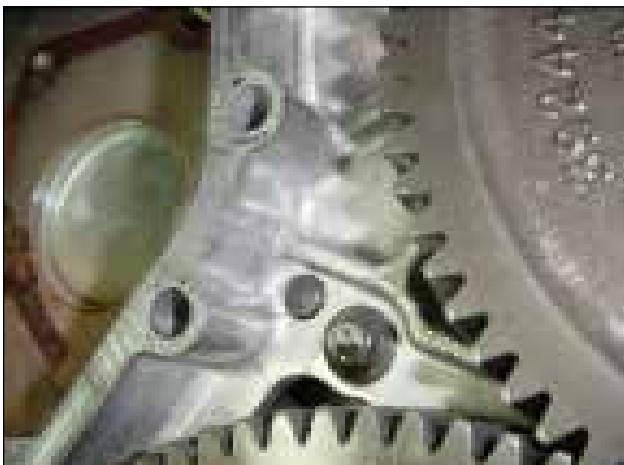
Above is a picture of an egg-shaped washer that is their solution to the problem.

- 13) Lucky step 13! Time to install the special egg-washer, preventive maintenance part. Locate the 10mm bolt next to the dowel pin and remove it, reinstall the longer bolt using the special washer supplied in the kit. This washer will prevent the dowel pin from backing out. Apply loctite high strength (red) thread locker to the threads and torque the bolt to 18 ft. lbs. torque.
- 14) Using a gasket scraper, clean the gear housing gasket surface and the gear housing cover.

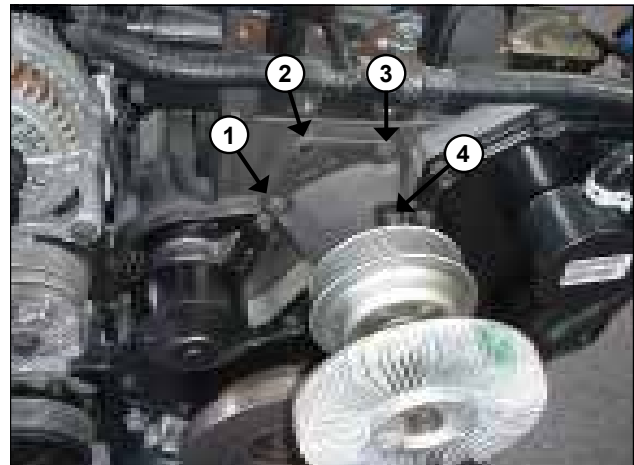
- 7) CAREFULLY work the fan and the fan shroud out together. This takes time, so go slow. Working with a friend helps. Make sure not to DAMAGE the radiator cooling fins or any hoses that may be in the way.

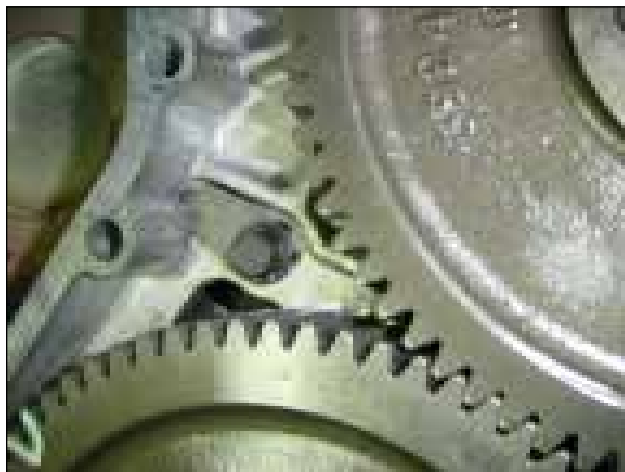
- 12) Locate the dowel pin and look to see if it is fully seated. Most of the pins will be flush with the gear housing or just below flush if they have not backed out. If the pin seems to be backed out find a small punch. With a hammer and punch tap on the head of the dowel pin and drive it into the block as far as possible.

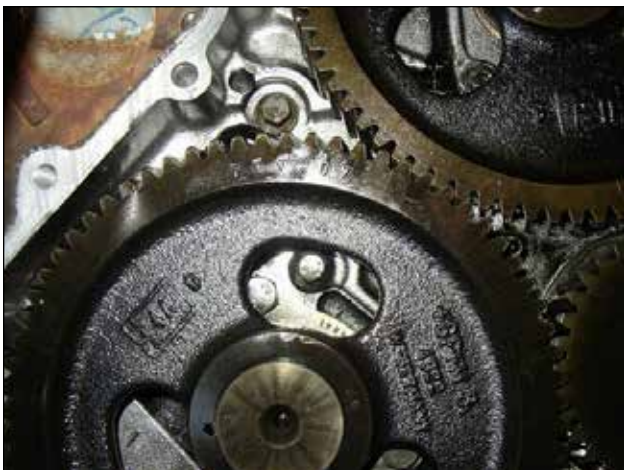
When I checked the dowel pin, commonly known among members as the Killer Dowel Pin (KDP) in my '89 Turbo Diesel D250 with 182,000 miles, it had not moved. I drove the dowel pin back about 0.020-inch and peened the bore. For members who want to tighten the 10-mm gear case bolts, I have included photos of the three gear case bolts behind the cam gear that should be tightened also. The top bolt is located at about 12:30 o'clock.

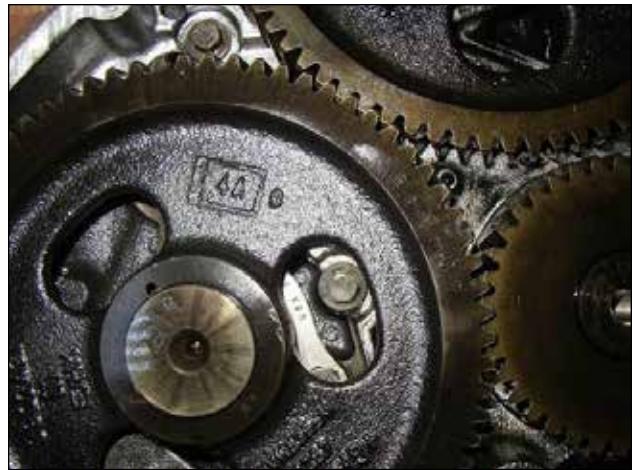
The second bolt is at 2:00 o'clock. Both of these bolts are easily accessed through a hole in the camshaft gear when the crankshaft is rotated.

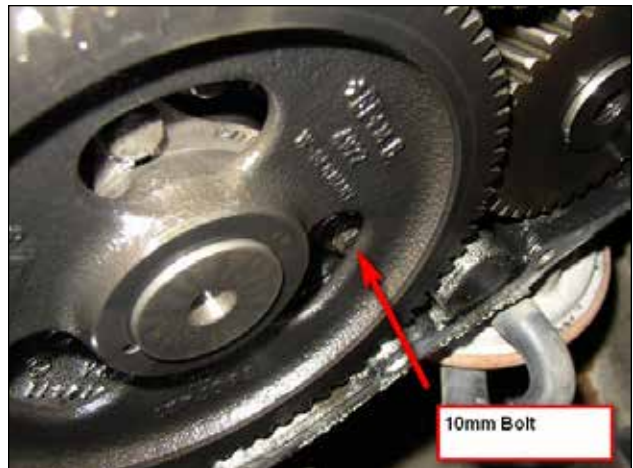
The third one is difficult to access and is at about 4:30 o'clock. I cut the head off a 10-mm wrench and welded it to a screwdriver to make a crow's foot type wrench to get to it. It is good to have a cheap 10-mm wrench or two to sacrifice for this project.

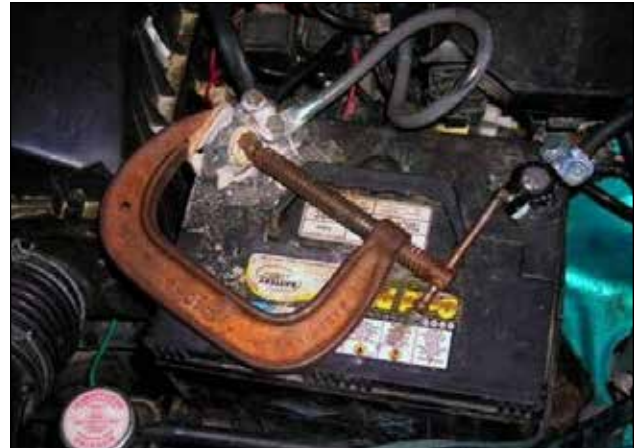
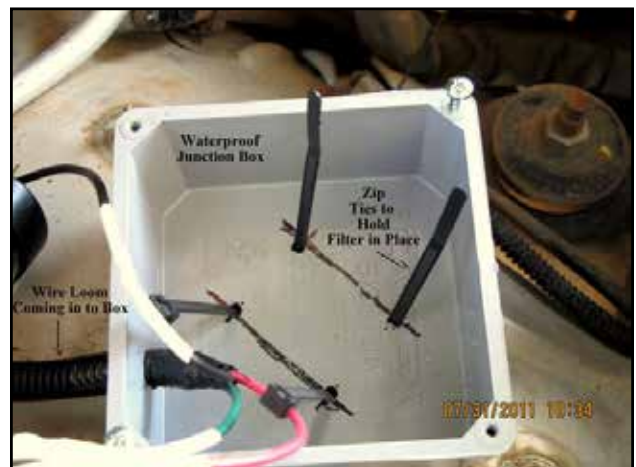
I followed the advice of TDR member "cerberusiam" and separated the alternator ground and charge wires from the rest of the wire harness. I re-routed the two wires and cleaned all the ground connections.

I also installed a Navrone noise suppression filter Model N-25 by Navone Engineering at (<http://www.davidnavone.com/cart.asp?24&cat=2> or 800-669-6139) as seen in the photos which may be helpful to other members who might want to use this electrical noise filter. I rerouted the alternator charge line and ground at the same time. After completion of the project, I have driven the truck on the highway and could not reproduce the torque converter unlock/lock issue.

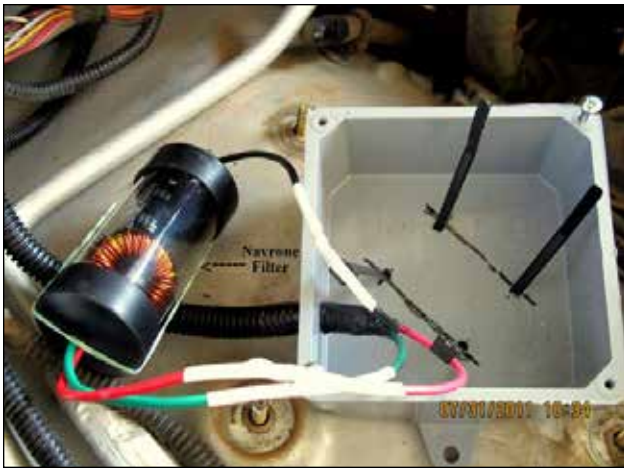
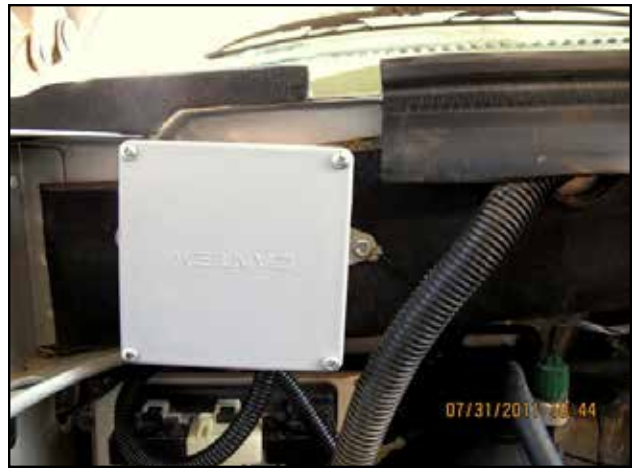
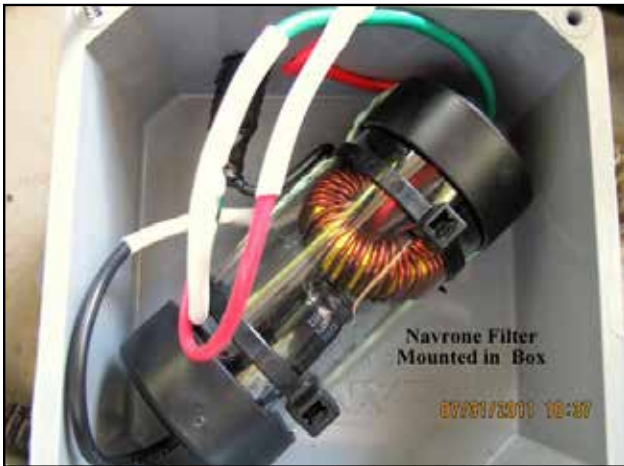
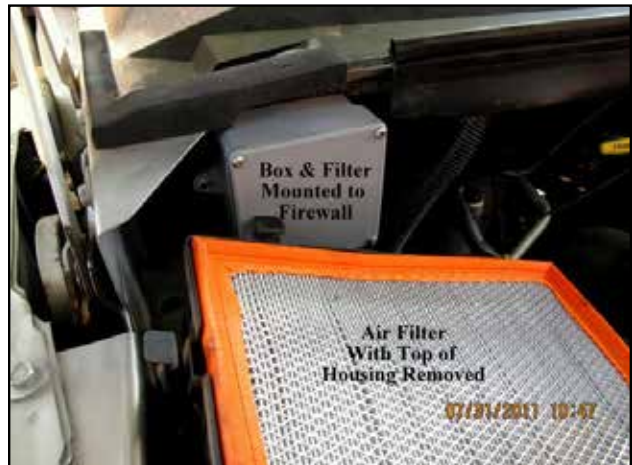
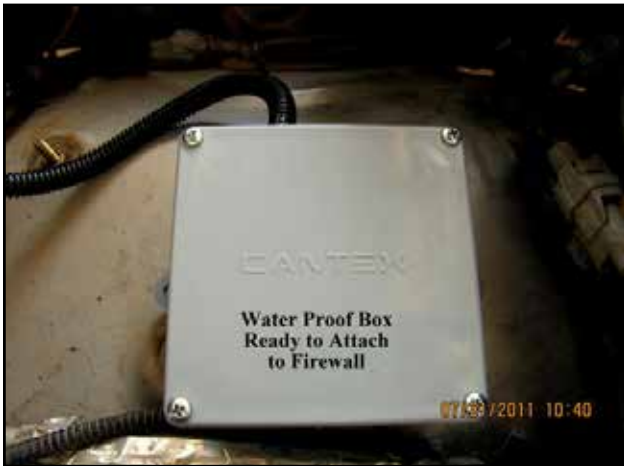
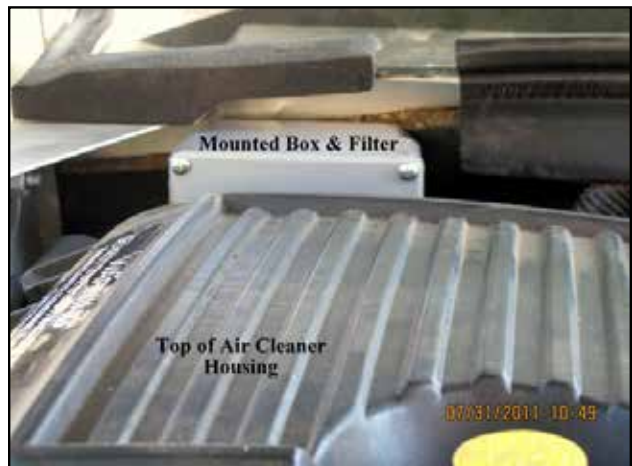
Photos of final installation with air cleaner housing re-installed.

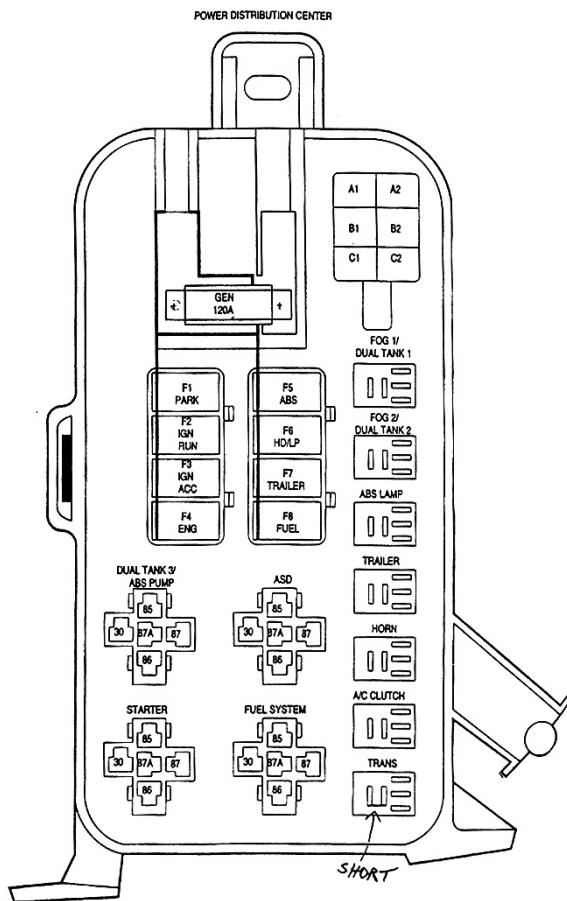
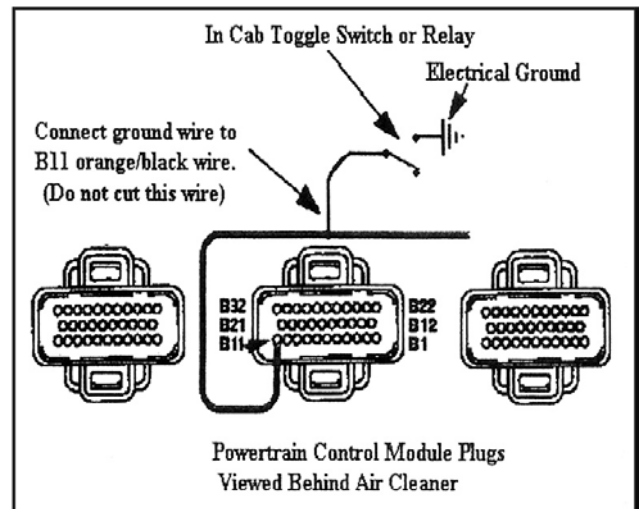
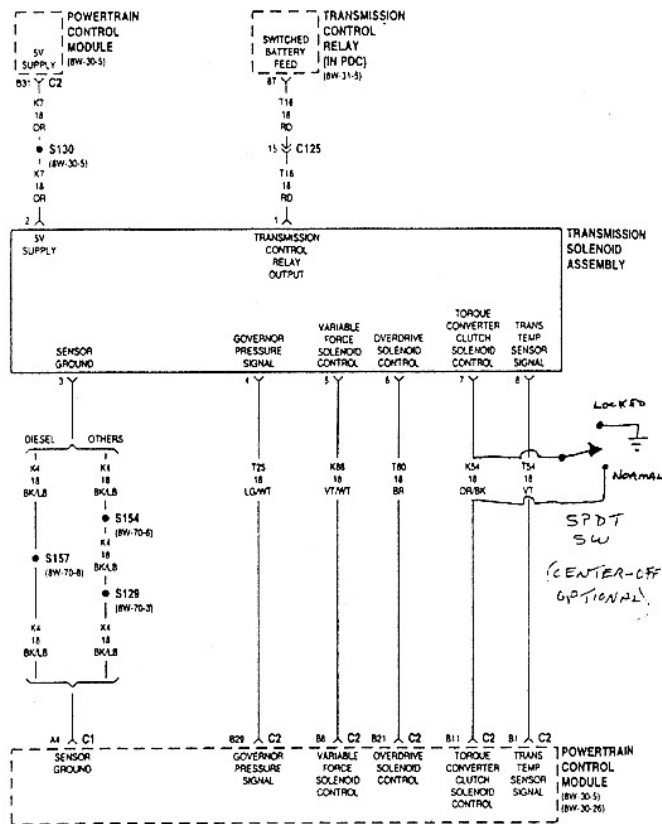
Add Jumper Wire
Do NOT Reinstall Relay
Power Distribution Center
Next to Driver Side Battery

1. Install jumper wire in place of the trans relay in the Power Distribution Center (black box behind driver side battery) as shown in diagram below. This jumper wire will supply 12-volt positive to the transmission torque converter clutch solenoid. This jumper will be electrically hot thus it should be installed so as not to short against ground.
2. Install ground wire from the B11 orange wire with black stripe to a switch or relay such that the ground source can be turned on and off. The B11 wire is located in the middle computer connector located on the firewall behind the air cleaner.

Driver must ground the B11 wire, have gear selector in Drive, and be moving fast enough to be in 2nd gear before the torque converter clutch will engage. Transmission will shift from 2nd to 3rd, and 3rd to 4th (unless Overdrive is off) with the torque converter clutch locked. Once in 4th, the transmission will not downshift unless the ground source is interrupted, i.e. the switch is turned off.

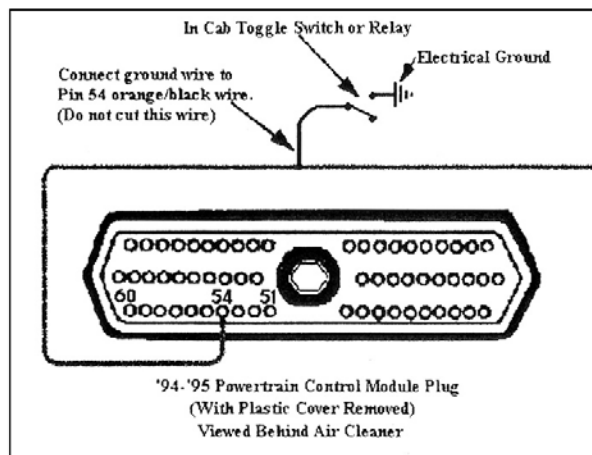
TORQUE CONVERTER LOCKUP SWITCH FOR '94-'95 RAM

The following diagram is supplied at no cost or obligation by TST Products. Note that use of this method of lockup may be hard on vehicle drivetrain and may void vehicle drivetrain warranty. Use makes vehicle drive like a manual transmission in 4th gear such that vehicle may/will stall at low speeds/stops if lockup is not disconnected.

Install ground wire from the pin 54 orange wire with black stripe to a switch or relay such that the ground source can be turned on and off. The pin 54 orange wire with black stripe is located in computer connector located on the firewall behind the air cleaner.

Driver must ground the pin 54 wire, have gear selector in Drive, and be moving fast enough to be in 2nd gear before the torque converter clutch will engage. Transmission will shift from 2nd to 3rd, and 3rd to 4th (unless Overdrive is off) with the torque converter clutch locked. Once in 4th, the transmission will not downshift unless the ground source is interrupted, i.e. the switch is turned off.

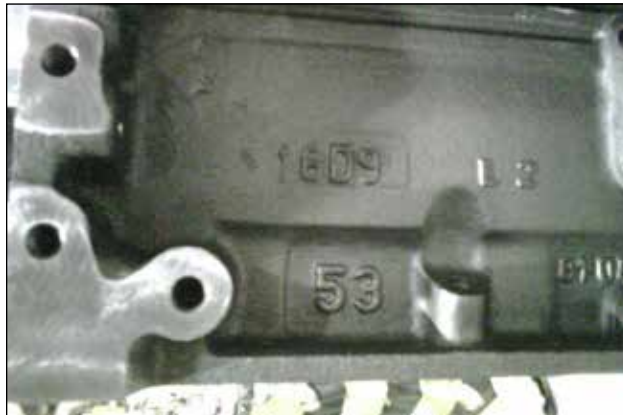
You can't miss it, "block 53," on the driver's side of the engine, toward the front gear case, behind the vacuum pump.

Disquieting reports concern members who have a truck with a 53 block casting number. Although this is not the first time this problem has been addressed (see Issue 48, page 30, Block Identification and Block Replacement), I've seen little documentation as to its cause, repair procedures, or longevity of any repairs. This infamous casting number has some history (albeit limited) of the cast iron block cracking below and behind the center expansion or freeze-plug (passenger side of engine). Model years affected are late '98.5 production 24-valve engines up to 2001. Okay, now that affected model year owners have flashlight in hand and are searching for the block number, its location is found on the lower left front corner (driver's side) of the engine block behind the vacuum pump/power steering pump assembly.

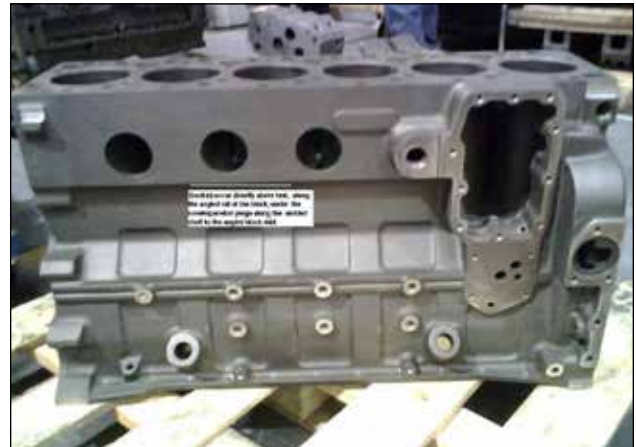
Crack(s) occur directly above text, along the angled rail of the block, under the core/expansion plugs along the molded shelf to the angled block skirt.

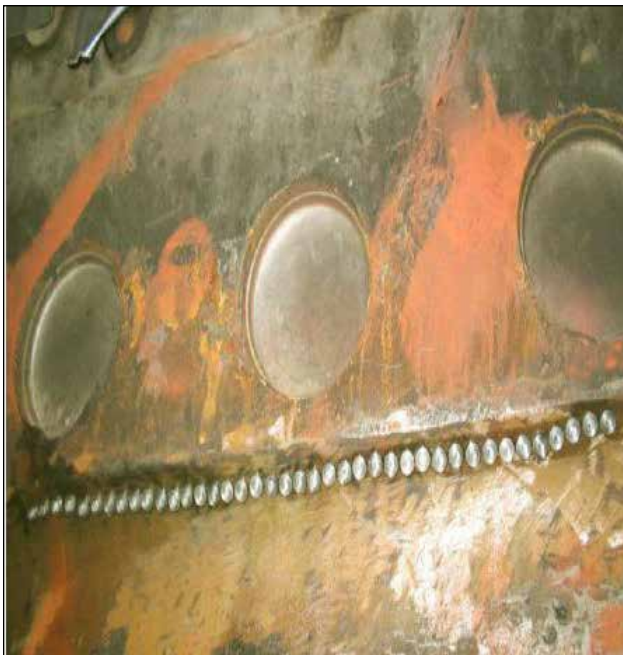
The crack is then drilled with many precise holes. A fixture that is provided with the kit controls the depth of the holes and their spacing along the crack. Pins are then inserted into the holes. Manufactured by Lock-N-Stitch, the pins have a special break-off head that breaks very close to flush with the block. A grinding wheel will take the pins to flush.

Enter another repair technique, Lock-N-Stitch. The Lock-N-Stitch and its related fixtures allow for the repair to be done with the engine in the chassis. For access to the crack you will have to remove the turbocharger and exhaust manifold. Drain the coolant and thoroughly clean the cracked area.
