TURBO DIESEL Buyer's Guide

A Publication of the *Turbo Diesel Register*

A WORD ABOUT THE TURBO DIESEL BUYER'S GUIDE

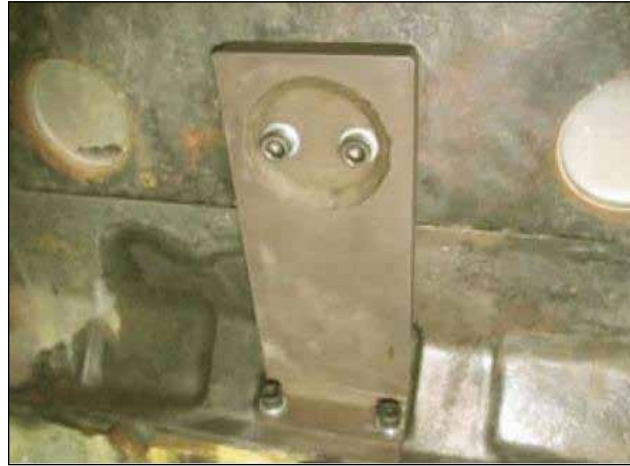
Reinforcement Bracket

Before you call this a complete repair, take some time to prevent future cracking. Lock-N-Stitch sells a support bracket (\$375 each) that adds strength to the block in this weak area. It is recommended that one support bracket be used for cracks that are up to 3", two brackets for cracks that are 3" to 6", and three brackets for cracks that are 6" to 12".

The costs for one stitch kit is \$320 (1"-4" length crack) and one support bracket \$375, totaling approximately \$700. It's prudent to add at least another \$700 for labor. A skilled technician is easily able to perform this repair, albeit a tedious process.

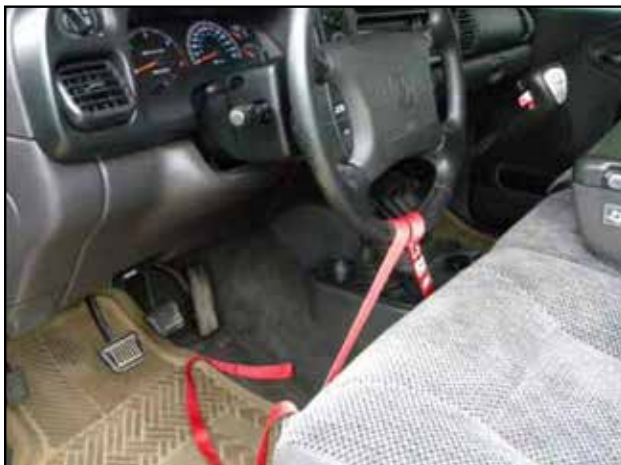
To fix one of these issues I decided to replace the bearing in the bottom of the steering column with the bushing offered by <http://rocksolidramtrucksteering.com>. The instructions supplied with the kit were very straightforward and it appears to be somewhat easier to do on my truck given it is a manual rather than the automatic trucks with the column gear selector. One note worth mentioning here is that any time you uncouple the steering system, the steering wheel is free to turn inside the cab. This must not be allowed to happen as it may bring about the destruction of the “clock spring” inside the column. The clock spring is actually a thin ribbon cable type electrical connection between the portion of the column that rotates and the part that doesn’t rotate. The catch here is that the cable or clock spring is a fixed length so if you connect the steering back up in a different orientation than it currently is, you may run out of cable when turning left or right. The best way to avoid this is to put the truck’s front wheels straight ahead prior to disassembly. Then take a cargo strap and attach it to one of the driver’s seat floor supports, thread it through the steering wheel and connect to the other seat support as shown below:

This technique makes the steering stay put while you work which avoids clock spring damage.

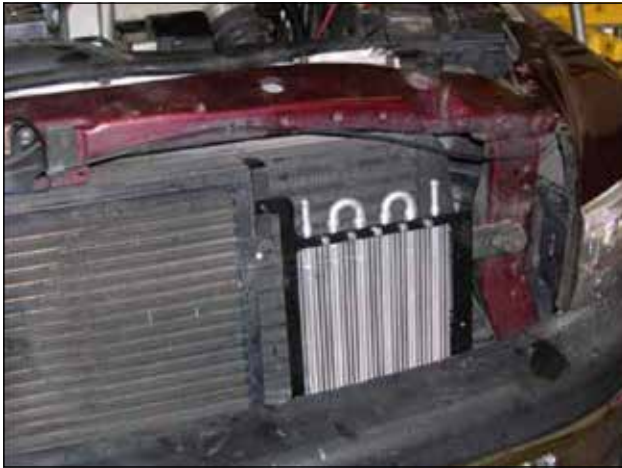
An automatic transmission fluid cooler in its new job as a power steering fluid cooler.

fluid cooler that would fit on the driver's side of the air conditioning condenser in front of the intercooler. I designed a bracket and mounted the cooler in line in the return hose from the steering gear box back to the power steering pump reservoir.

This fluid cooler plumbed into the return line worked like a charm to keep the power steering fluid cool. Even on a 100° day, after driving in traffic, you can put your hand on the return line going from the cooler to the pump reservoir and it is warm/hot to the touch, a major improvement over the “roast your finger” stock system.

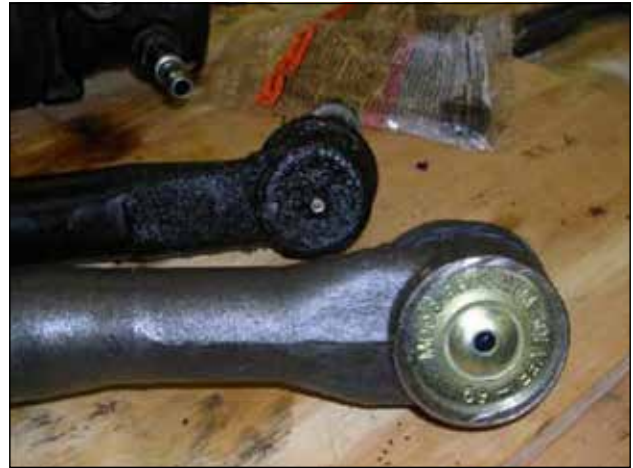
I chose Moog parts for all my front suspension replacements. It is easy to see why the Moog components are better, below is the new Moog track bar lying next to the stock bar.

This track bar replacement settled the truck down quite a bit and gave it some fairly decent road manners. I drove the truck for several months with it at this stage and decided that while it was tolerable, it still lacked the control and stability it had when new.

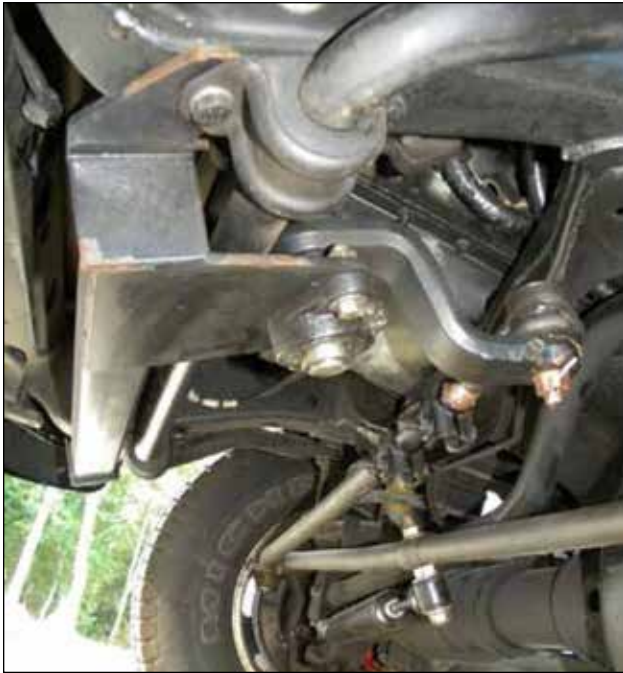
The picture below shows the BD steering box stabilizer installation after two years of use.

The BD steering box stabilizer enhances the truck's steering system by giving the steering shaft support out past the point of load application which reduces stress on the steering box's output shaft bearings. It also stiffens the frame rail near the steering box mounting location, reducing side-to-side flexation.

Since I found the steering box to be good in the Phase One inspection, I decided to look at the steering output shaft and tie rod end. I had an assistant get in the truck while I was sitting in the driveway, engine not running. I had him rock the steering wheel back and forth very slightly while I put my hands on all the joints including the steering box output shaft. It appeared that the steering shaft bearings/bushings inside the steering gearbox were good. I decided that I didn't like the steering box output shaft sticking out without any support on the "free end" and realized this could be a durability problem, so I decided to order and install a BD steering box stabilizer from Geno's Garage. The BD stabilizer is basically a steering box output shaft extension and support bearing. You remove the Pitman arm nut and then add the BD shaft extender. Next you remove the four bolts holding your front sway bar to the truck and install the BD stabilizer under the sway bar brackets, using the sway bar bolt locations and longer bolts supplied with the kit. A self-aligning flange bearing is then added to the BD stabilizer to support the newly extended output shaft. Again, follow BD's installation instructions.

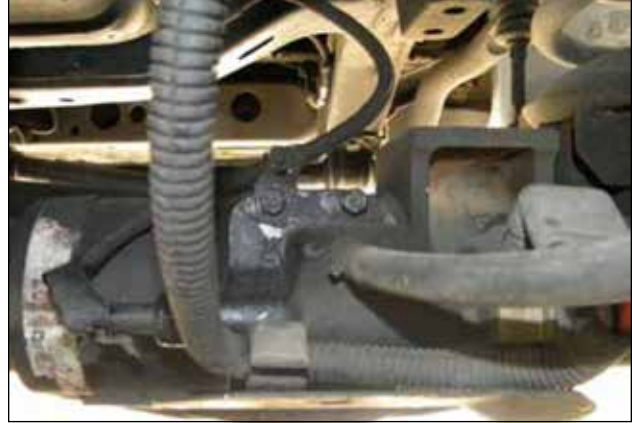
Spline engagement housing on back side of front axle.

The ball joints and tie rod ends are the only tasks left! Many will advise putting the truck in four-wheel drive prior to removing the front axle half shafts. Engaging 4WD puts the spline engagement collar (central axle disconnect – CAD) inside the axle housing half on the intermediate shaft and half on the passenger side half shaft. This allows you to remove the passenger side half shaft without the collar falling down in the housing. If you leave the truck in 2WD as I did and remove the passenger side half shaft, the spline engagement collar will fall down in the engagement housing. This is not a major issue at all since you can disconnect the 4WD sensor and remove the four 1/4-20 bolts holding the spline engagement actuator/housing cover. Once removed simply put the collar on the intermediate shaft while reinstalling the passenger side half shaft. Then position the collar on the spline so that the actuator fork engages the collar and you can bolt up the actuator/housing cover. I recommend removing the spline engagement housing cover anyway to wipe the old differential lube and crud out of the sump.

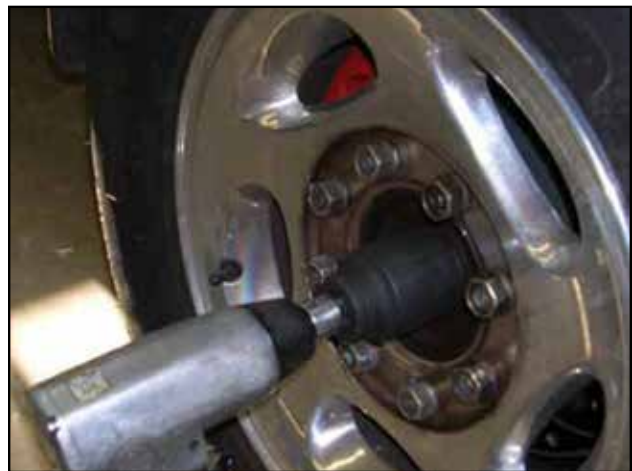
My old Chicago Pneumatic 1/2" impact wrench having a go with a 3/4" socket adapter and 1 11/16" socket. Both nuts are standard clockwise tighten so remember patience and penetrating oil. My impact wrench took about 20 seconds per side and the nuts were off.

Before you put the truck up on the four jack stands, remove the hub caps and take the half shaft hub nuts off. This requires first removing the cotter pins and then a 1 11/16" socket. Penetrating oil and patience are important components for this phase of the project. In my experience the best penetrating oil you can get is mixture of 50% acetone and 50% automatic transmission fluid. One word of caution is that the penetrating oil isn't friendly to the clear coat on your aluminum wheels, so caution with runoff is necessary. However, repeated application of penetrating oil over a week's time prior to disassembly will make the job go much easier, especially with the bearing hubs.

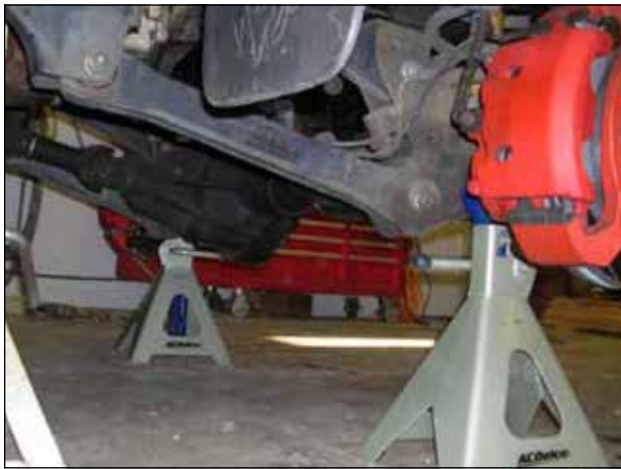
The jack stand configuration I used is shown below.

I had two jack stands with a capacity of six tons each and thought that would be plenty. After using my floor jack and placing my two jack stands under the frame rails just aft of the control arm brackets I decided I had too much weight too high! The truck was fairly steady but it was possible to move it around slightly by pulling on it with my hands. It only took a second for me to decide this wasn't secure enough for me to lie under so I purchased two additional six-ton jack stands and added them under the axle.

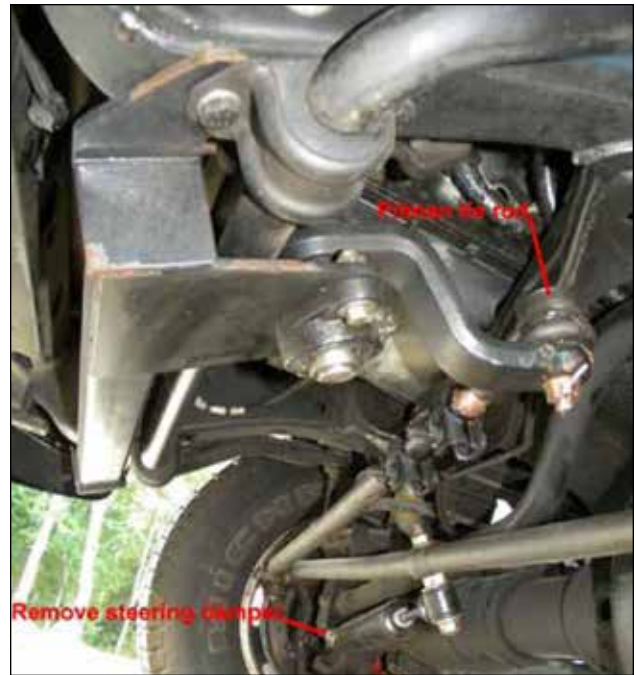
Remove steering damper.

With the brake rotors off both sides, this is a great time to break this project down into two projects: tie rod ends and ball joints. (Well...maybe four projects. You may want to change the front differential oil while the steering components are out of the way.) I recommend removing the steering damper at the axle, the tie rod end out of the end of the Pitman arm, and the tie rods from each steering knuckle.

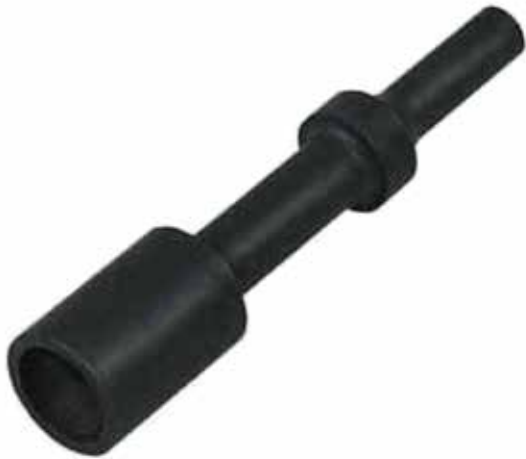
The solution turned out to be a Lisle (LIS39300) Front Hub and Knuckle Separator from ToolTopia.com and my pneumatic impact hammer.

Now for the bearing hubs! With the rotors off, half shaft nuts removed and the tie rod end removed from the steering knuckle, the fun of getting the bearing hubs off begins. Remove the ABS sensor if equipped and tie it back out of the way so the cable and/or sensor can't get damaged. Many pullers exist that connect onto the lug studs and push on the end of the half shaft in an attempt to get the bearing hub off. I don't like these since the reaction force is pushing the half shaft back into the axle. The factory service manual instructs one to back off of the four hub/bearing housing bolts ¼ inch each. Then tap the bolts with a hammer to loosen the hub/bearing from the steering knuckle. Welcome to Fantasy Island! With 141,000 miles on my truck, the bearing hubs didn't respond to "tapping with a hammer."

Andy Redmond adds to Brent's story: I've used all the methods for stuck hub bearings and by far both the easiest and best method is the deep socket extension trick or Snap-On Tool DHP1. Use of the Snap-On tool wedged against a loosened bolt and against the axle tube while an assistant turns the steering wheel will pop them loose every time. Alternate the tool between the bolts to walk it off little bits at the time. In fact, I can even do it by myself, although it's a lot of running back and forth. Most DIY's don't have an air chisel or compressor with adequate power for Brent's pneumatic impact hammer task, plus you don't ruin what bit of hearing you have left, huh?

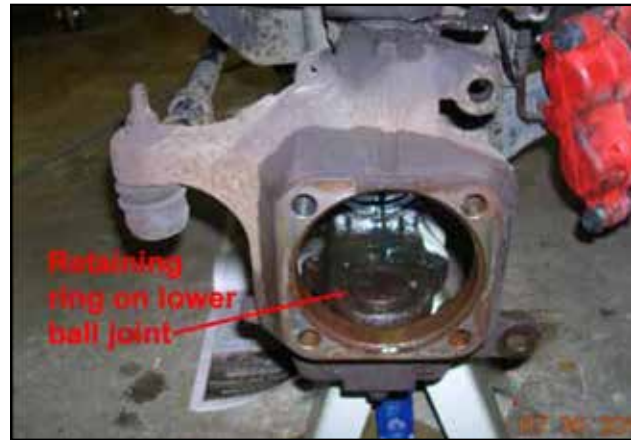
With the bearing hubs and half shafts out, remove the nuts on the ball joints and the large retaining ring off the bottom ball joint as shown below.

Also note extensive use of penetrating oil, it really does help.

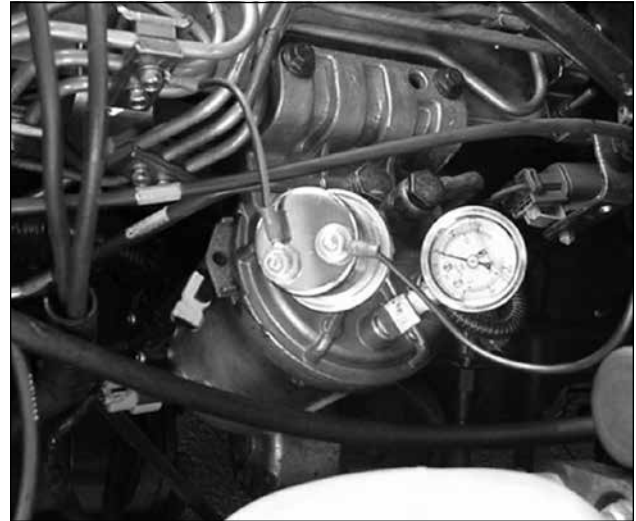
In the photo, note that the Editor's truck (a '99 model) is outfitted with two gauges—one is a mechanical, liquid-filled gauge and the other is a Westach electrical gauge with a pressure sending-unit mounted to the filter head assembly.

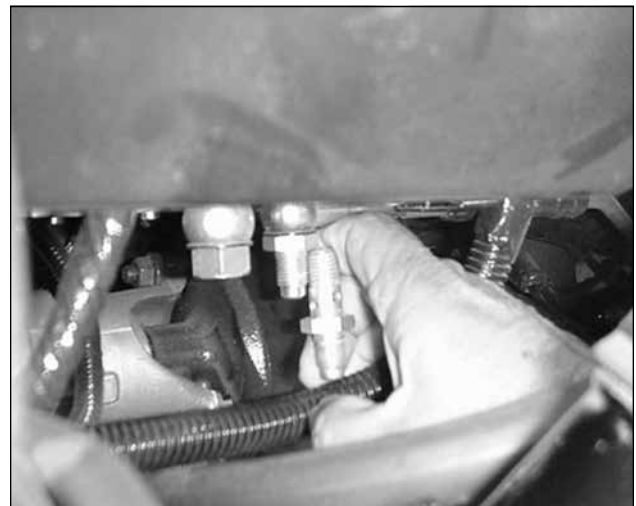
In order to install a gauge, the '98 and '99 24-valve engines have a filter head with easily accessible 1/8 NPT fittings. On the 2000 and up trucks the service design team at Cummins was mindful of the need to test the fuel transfer pump's delivery pressure. Thus, your truck is equipped with a "banjo adapter with a Schrader valve assembly." Say what? For clarification let's look at a photo and a description.

On the inside, the part with the rifled opening attaches the fuel line to the fuel pump. On the outside, the Schrader valve (think A/C valve or, better yet, a tire valve) has a press-for-pressure needle. Here is the catch, you can take the pressure needle out of the Schrader valve.

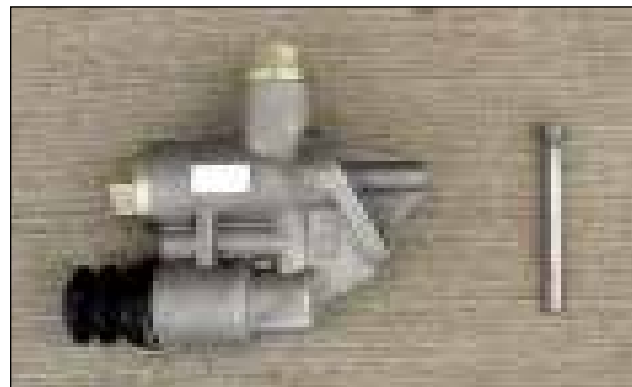
Carter lift pump with plunger removed.

Following the procedure in the Service Manual, the first step is to disconnect the battery terminals. The instructions read to remove the starter motor (Remove the starter...there has to be a better way.), place a drain pan below the pump, remove the fuel line fittings at the top of the fuel pump, and fuel heater housing. Next, remove the fuel hose clamps and rubber fuel hose. (You can leave them connected and remove after you have removed the fuel pump and fuel heater.) Remove the two mounting bolts. Remove the fuel pump and fuel heater as one unit. Be careful not to allow the plunger to catch on the edge of the hole in the cylinder block and drop into the engine. As intimidating as this sounds, you would have to try to do this, as the plunger has to be pulled from its bore. Simple enough?

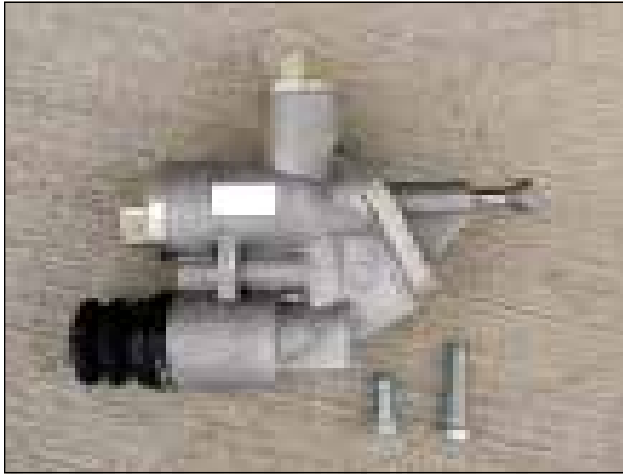
Carter lift pump with regular mounting bolt and longer temporary bolt.

Here is the secret: When you remove the fuel lift pump, take one of the two mounting bolts and find a replacement that is the same metric thread size but about $\frac{3}{4}$ " longer. You probably have one in your parts box or you can borrow one from elsewhere on the engine. When reinstalling your lift pump use the longer bolt as your starter bolt. Once you get the lift pump and fuel heater partially tightened down, install one of the original bolts in the other hole. Once it is partially tightened, remove the longer bolt and replace it with the other original bolt. Tighten the two bolts to 18 ft-lbs torque. (Tighten the two bolts alternately to prevent damage to the fuel pump housing.) I thought this was the easier and less time consuming way than removing the starter and trying to be a contortionist by working my way around the front differential.

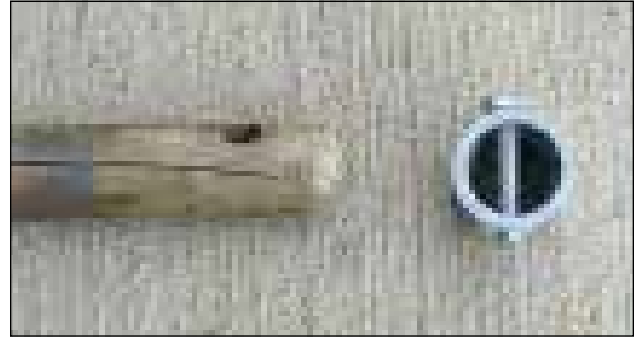
Broom handle, 3/4" coupling with hole drilled and bolt.

Another method that's been used at Geno's Garage is using an old broom handle to push the primer button. I decided to make my broom handle a little easier to use by taking a $\frac{3}{4}$ " PVC coupling and sliding it on the end of the broom handle and drilling a hole about a $\frac{1}{8}$ " below the top ridge and installing a bolt in it. This is to help prevent the rubber boot from tearing. This will always come in handy when you have to prime the fuel system. When you hear the fuel hit the pump, try starting your truck.

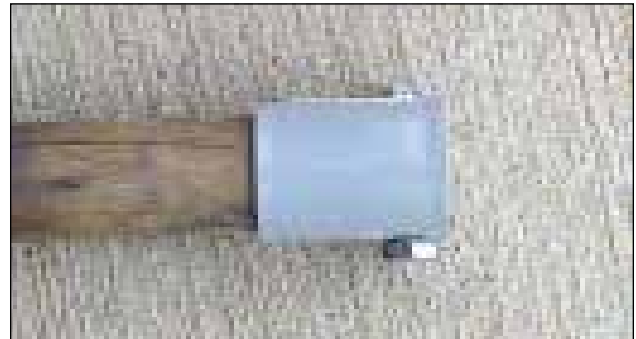
Broom handle, 3/4" coupling with hole drilled and bolt.

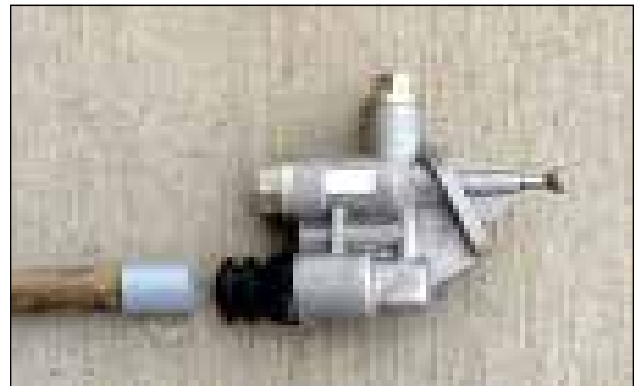
Broom handle assembled.

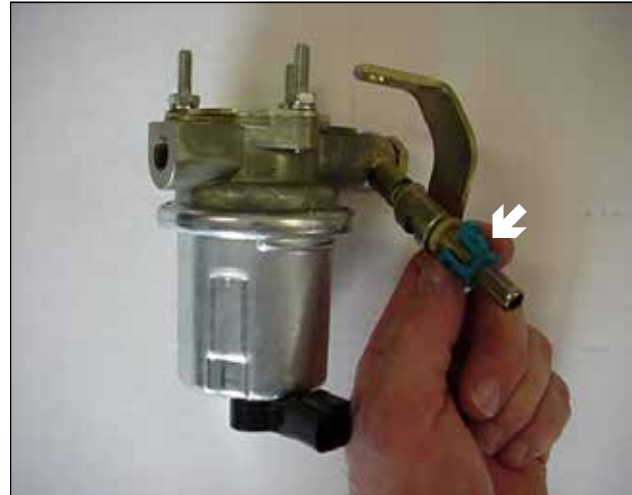
Step (2): Remove the fuel supply line from the transfer pump. From the bench-picture you can see the two, blue quick-connects that you push in to release the fuel supply line.

Pinch the blue disconnect and the fuel line will come loose.

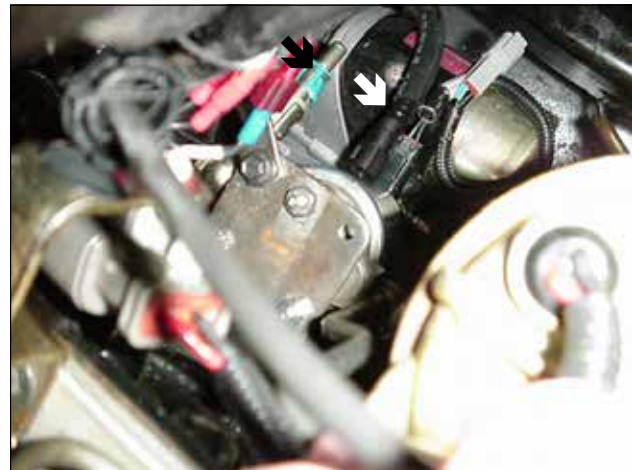
The fuel line to the transfer pump and the fuel line that goes to the fuel tank are pictured here.

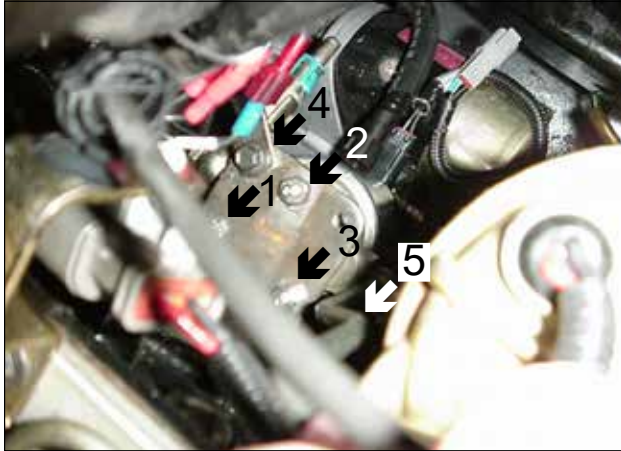
Step (5): Loosen the three 15mm nuts that hold the transfer pump to the bracket. Remove the 10mm bolt that positions the fuel line to the bracket. Remove the 15mm nuts that you previously loosened and remove the transfer pump.

The three 15mm nuts that hold the fuel transfer pump in place (1-3) and 10 mm bolt holding the fuel line (4). Arrow 5 points to a fuel line that you have to remove with a 17 mm stubby wrench.

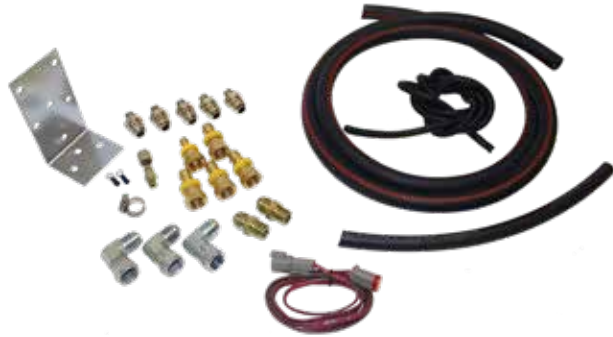
The benefits of relocation: the transfer pump is not subjected to continual engine vibration; the transfer pump is closer to the fuel tank and operates more like a pusher pump. Should the pump fail, the pump is very easy to access.

Moving to \$210: Purchase a spare Cummins fuel transfer pump. Purchase a transfer pump relocation kit for \$59 (Vulcan Performance/Geno's Garage), and move the transfer pump to an easy-to-access location on the truck's frame rail.

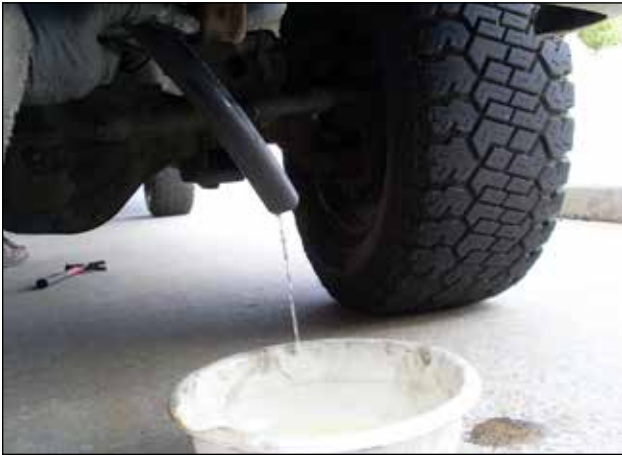
Extend the fuel filter drain hose to save the aggravation of having the fuel drain onto the frame which is caused by the existing short drain hose.

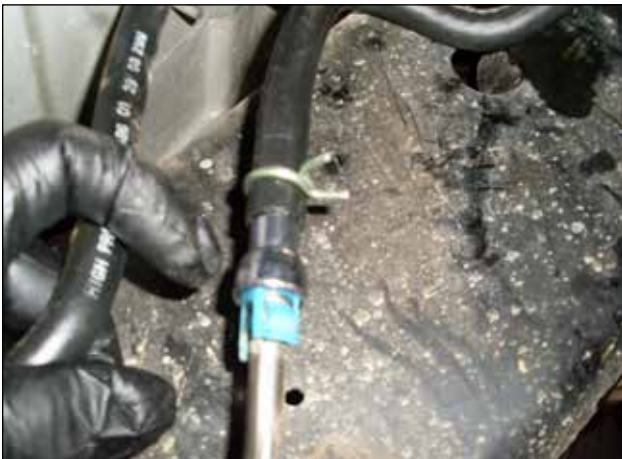
Pinch the outer tangs of the fuel line quick-fitting to separate the rubber hose from the hard fuel line.

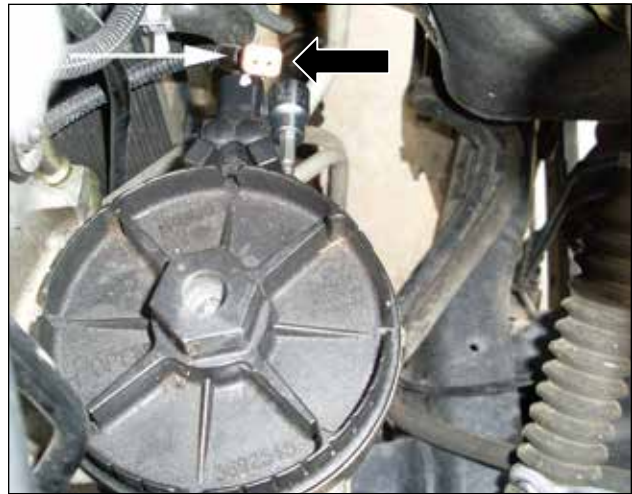
Unplug the water-in-fuel sensor. Note how the wires and cables have been pushed to the side of the fuel filter.

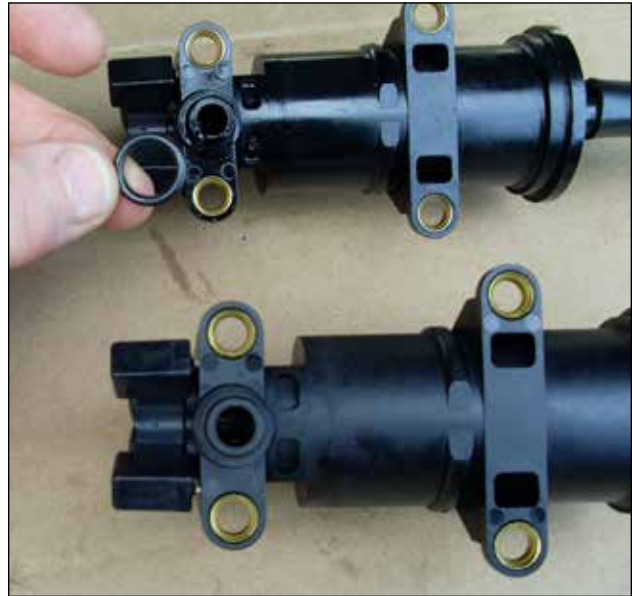
Do not forget to remove the old O-ring. An O-ring on top of an O-ring doesn't work too well. Ask me how I know.

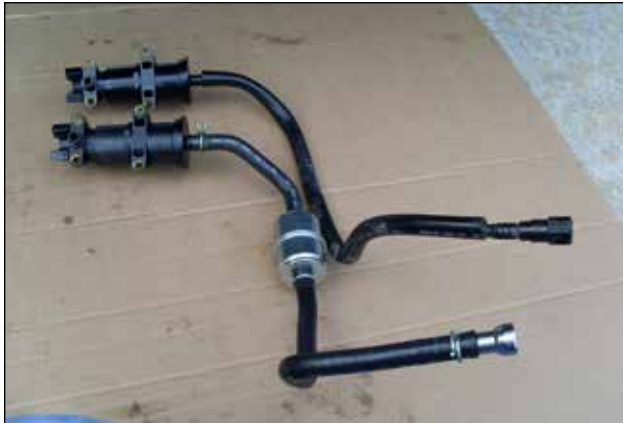
With the old transfer pump and fuel line removed you can see the orientation of the new fuel lines and primary fuel filter.

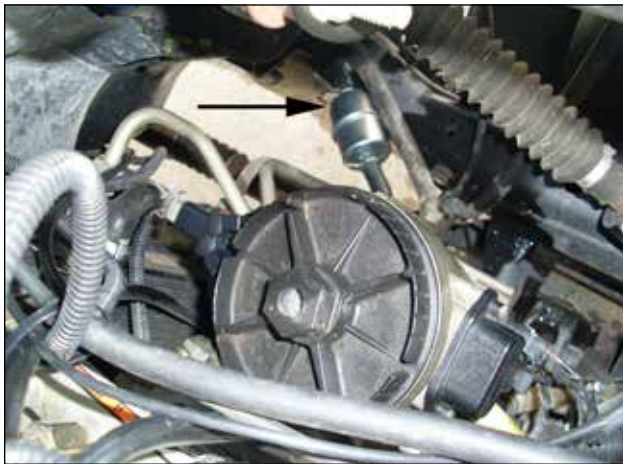
The installed orientation of the new fuel filter.

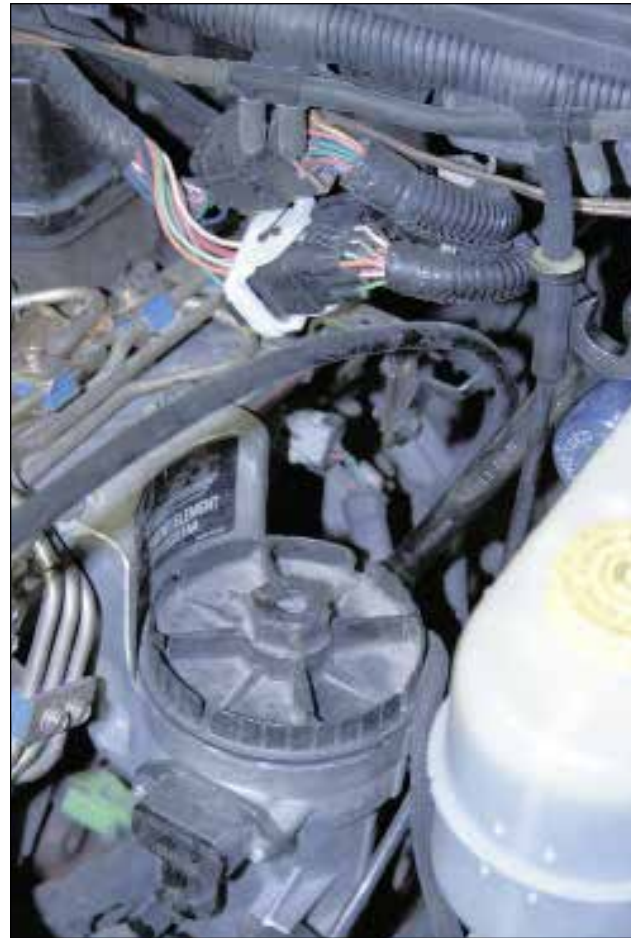
Photo A

It is not necessary to remove the fuel filter housing to replace the lift pump. The arrow points to a 17mm wrench that is used to remove a banjo bolt that holds a fuel line from the fuel transfer pump to the fuel filter canister.

The following is a pictorial installation of the DDRP on a '00-'02 model year truck. The lift pumps are the same for the '98.5-'99 model trucks, but there is a slightly different fuel transfer pump outlet, fuel line plumbing and fuel filter assembly.

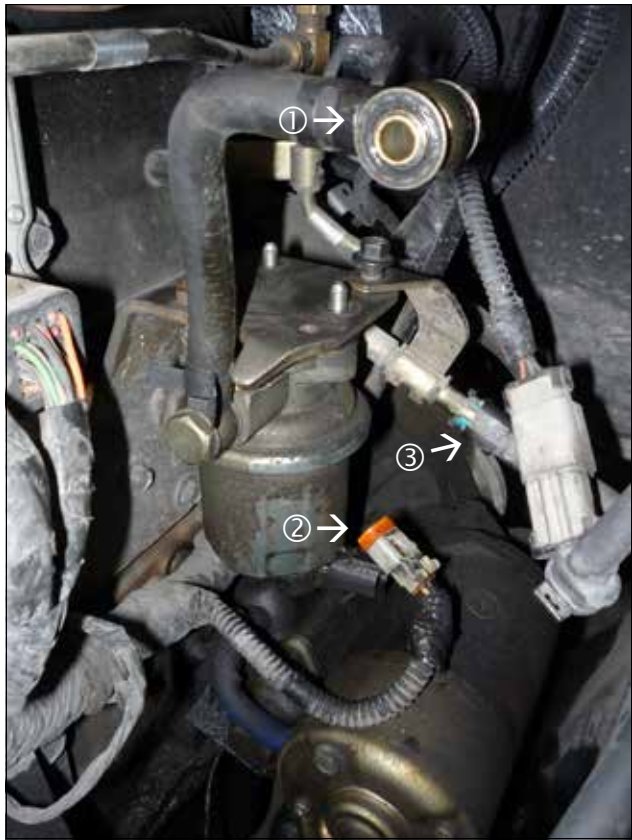
Photo B

For clarity I went ahead and removed the fuel filter housing. You can easily see the following:

① the pump outlet pipe; ② the Deutsch electrical connector disconnected; ③ the fuel transfer pump inlet piping, with blue quick-disconnect fitting. The fuel transfer pump is attached to the support bracket with three nuts (13mm) and one inlet pipe bracket support fastener (10mm head). Those that have changed a few of these fuel transfer pumps know how frustrating it is for the 13mm nuts to loosen the studs. If the stud spins with the 13mm nut you have to go underneath the support bracket with a thin 7/16 open wrench to hold the stud to keep it from rotating. Look at photo C, item ① and you'll see what I mean.

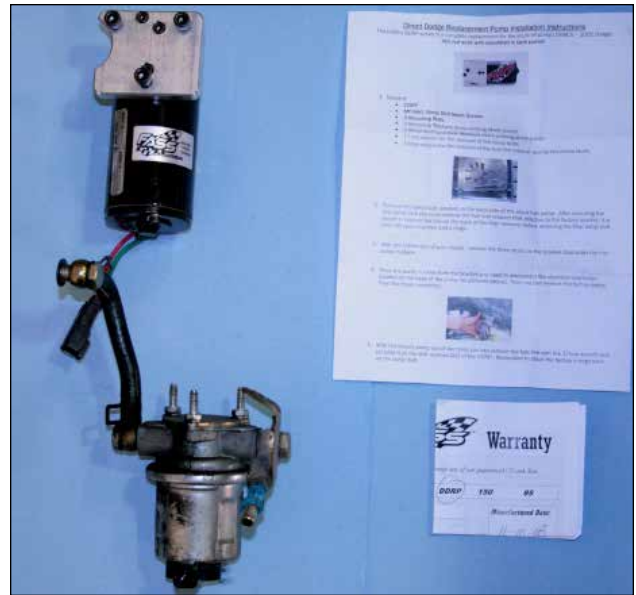
Photo C

The old and the new. The inlet and outlet pipes are moved over to the DDRP unit when it is installed. The DDRP comes with a female Deutsch connector to plug-n-play into the factory wiring.

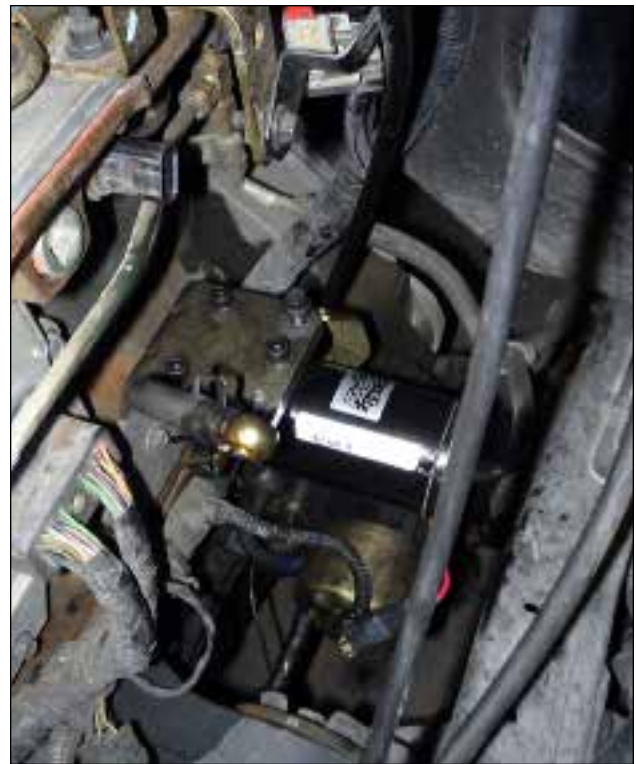
Photo D

The installed DDRP unit. The kit contents provide an inlet screen (144 micron) for the inlet banjo bolt. The pump is primed easily with WD-40. The unit is quieter than the OEM unit.

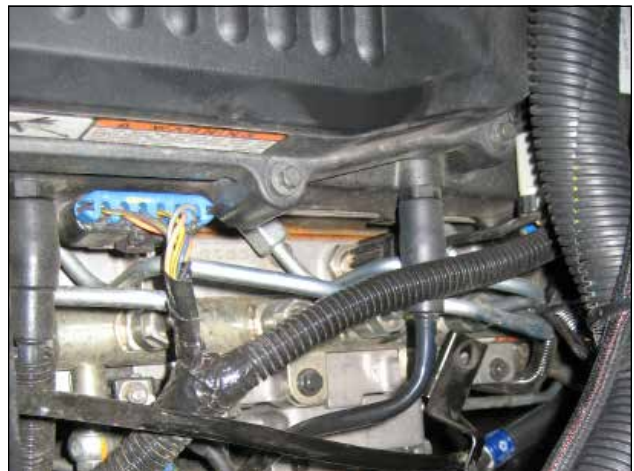
As I mentioned in Issue 59, page 42, the fuel filter is buried under a myriad of electrical wires, electrical relays and cables. The fuel filter is next to impossible to access.

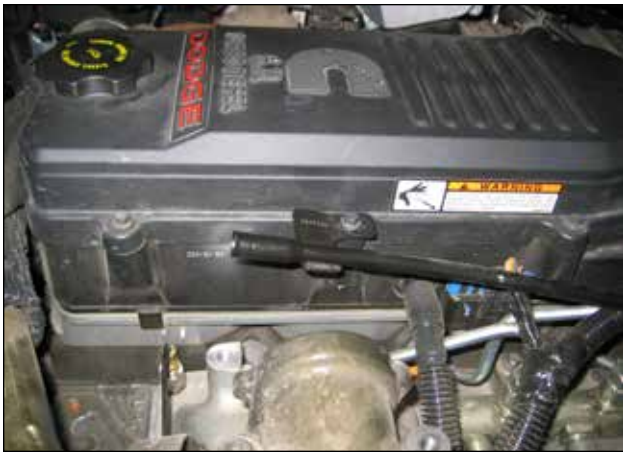
Relocate the oil dipstick tube to the valve cover.

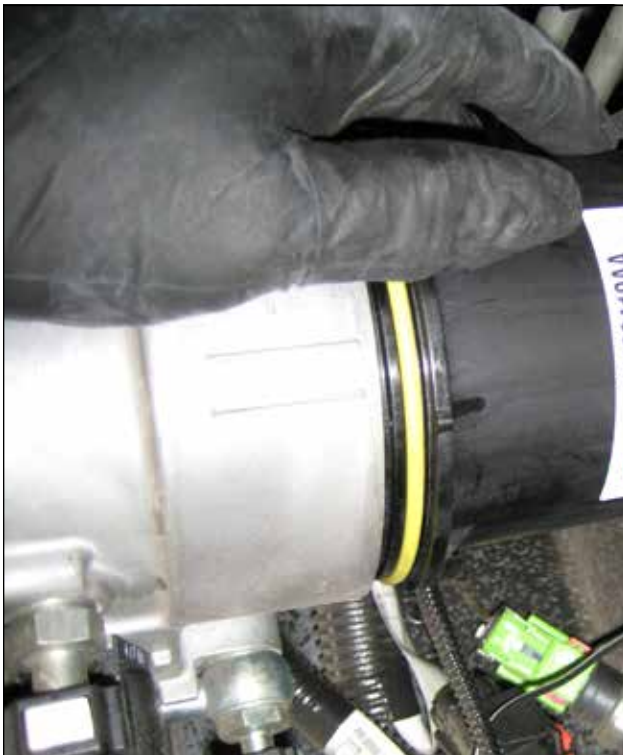
With one hand above and one hand below you can get to the fuel filter from above.

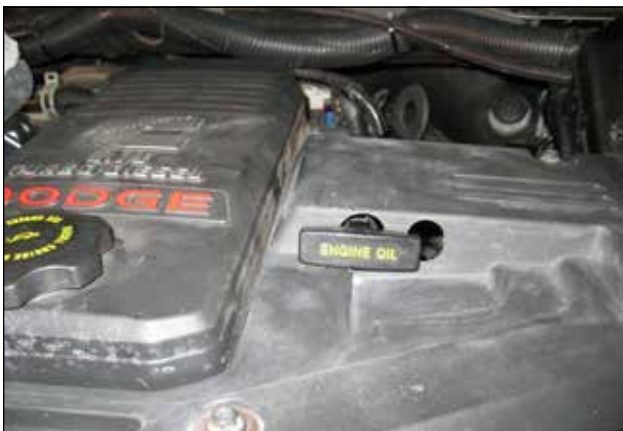
Modified "bat wing" with new dipstick location.

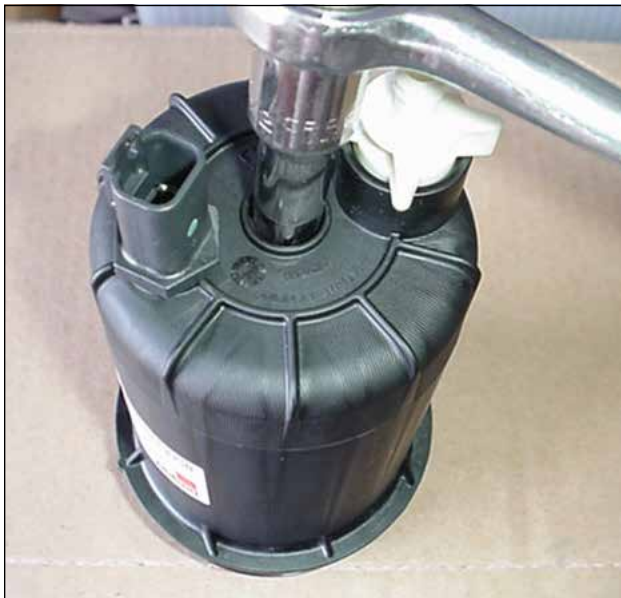
I'll bet you didn't know that there was a 1/2" drive indentation on the bottom of the filter canister.

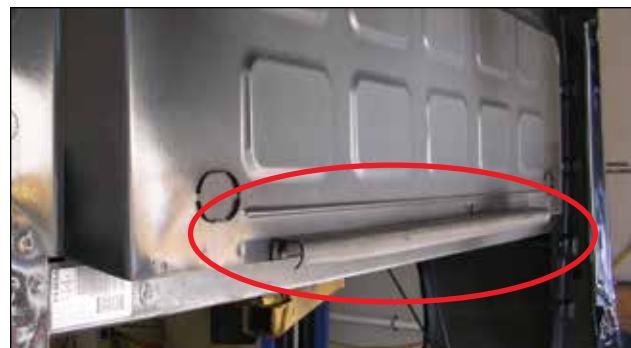
The plastic truck bed snubber.

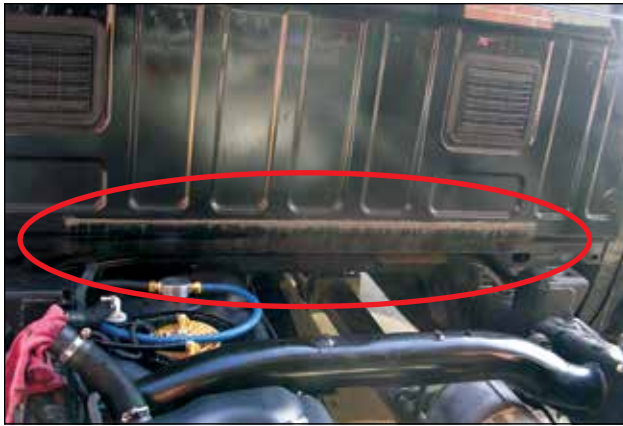
The abrasion at the cab.

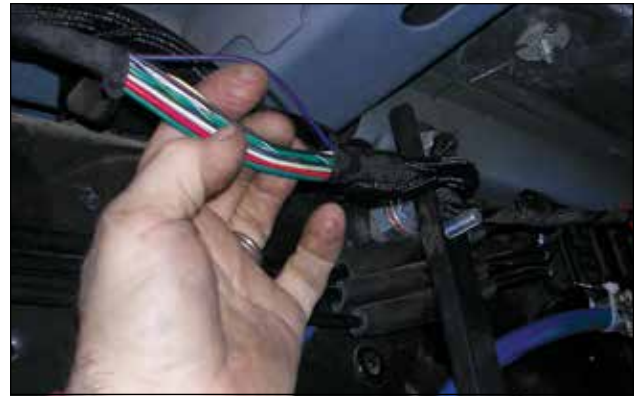
Intercept the wiring harness at the area of the driver's door and you can manually operate the fuel transfer pump.

Here's how: With my 2010 truck I learned that the 12-volt positive wire to the fuel transfer pump is blue with a red stripe. From underneath the truck intercept the wiring harness at the driver's door area, slice into the cover and locate the blue/red power wire. With a long wire fastened to battery positive you can crimp wires and turn the fuel pump on to drain the tank.

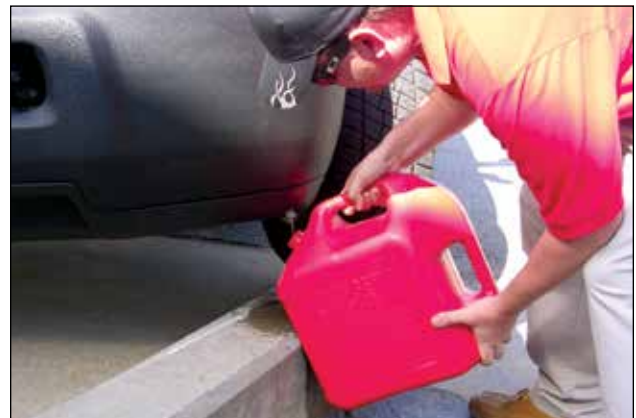
Utilizing the fuel drain line extension tip from Issue 75 it is easy to drain the fuel tank.

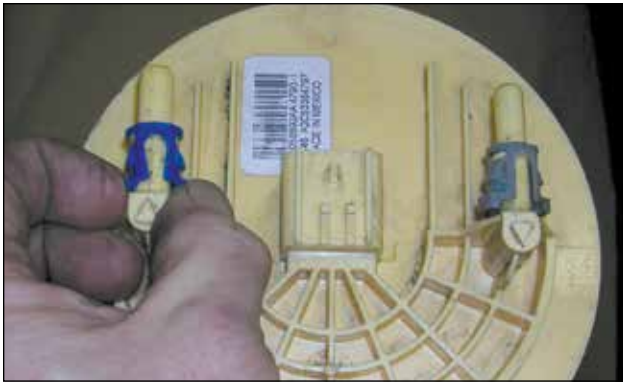
The pesky “pinch-in” clips that hold the fuel lines to the fuel pump assembly.

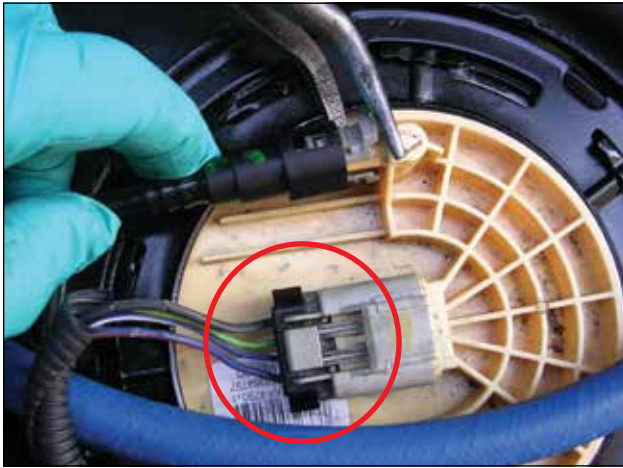
To remove the wiring harness you have to pinch down the grey tab to release the connector.

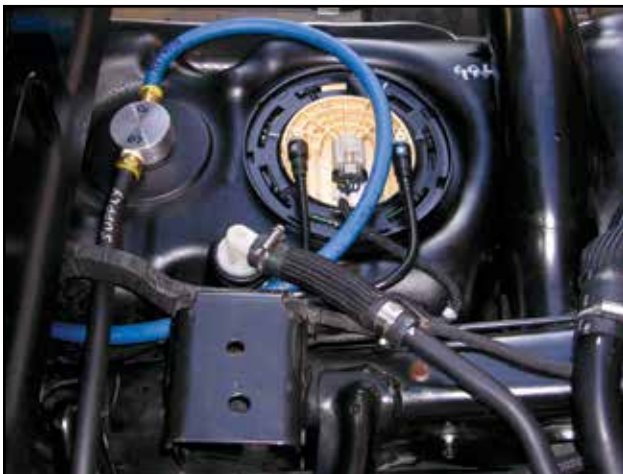
From this photo (yes, the bed was really removed) you can see how it all goes together.

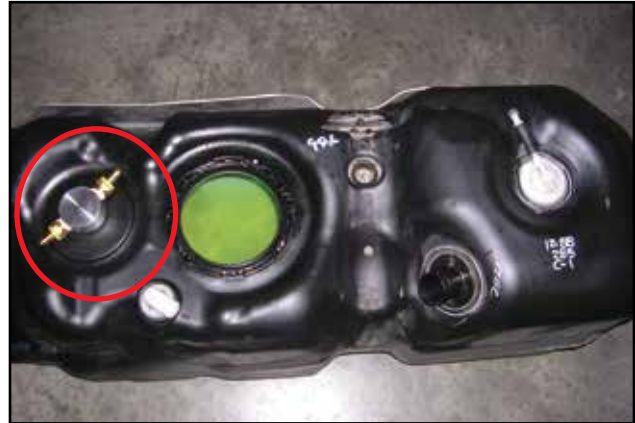
Here is a picture of the tank that has been removed from the truck. Look to the front and you can see the location of the new FASS drawstraw.

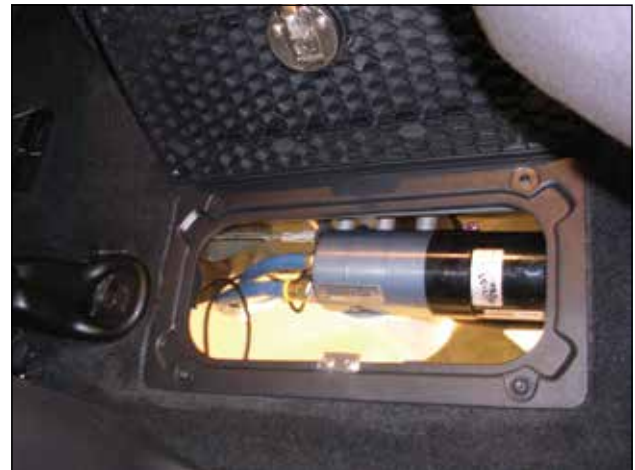
From above, a picture of the FASS unit that I installed on the outside of the driver's side frame rail.

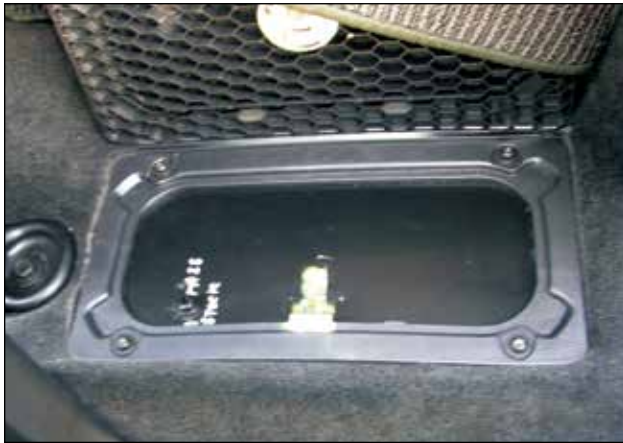
Open the driver's side rear floor compartment and you can see my FASS switch panel.

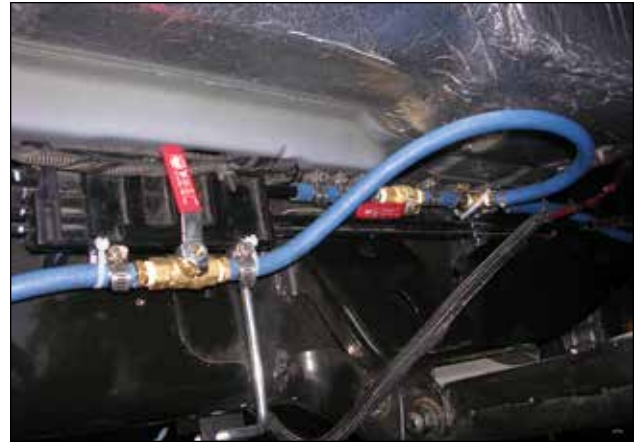
Stock valve is open, FASS valve is closed.

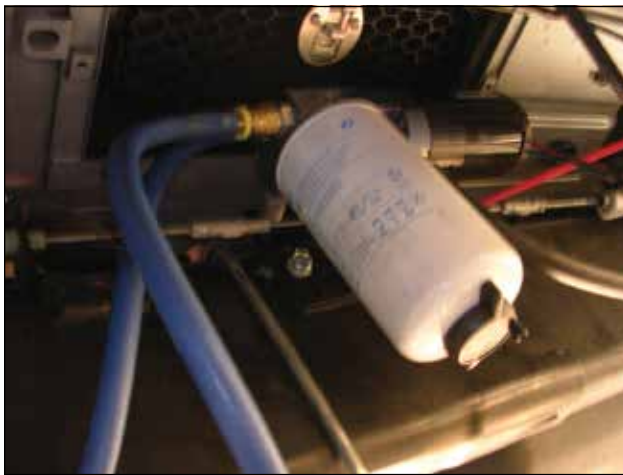
The FASS unit from the underside.

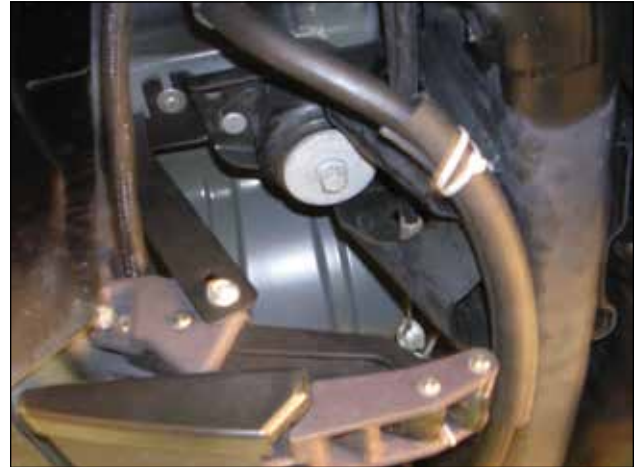
Heater hose for fuel line protection.

- I spliced some 3/4" heater hose and wrapped it around the new fuel lines to protect them.

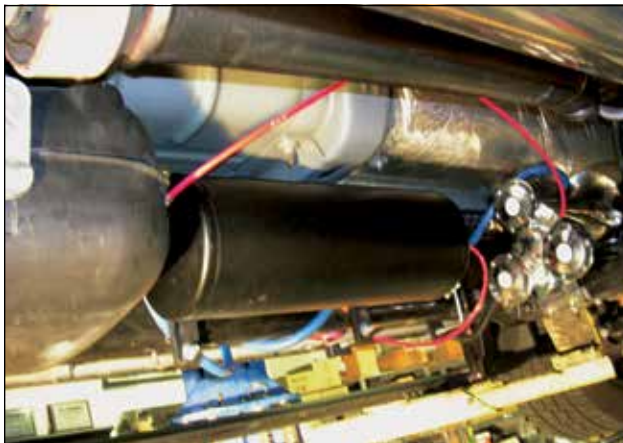
The inside of the driver's side frame rail holds an air tank and air horns.

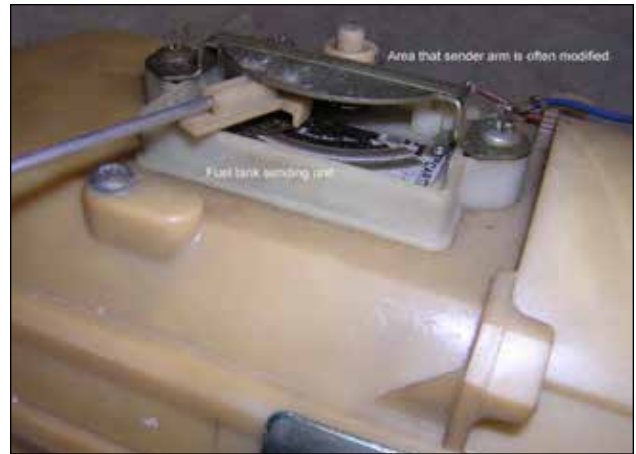
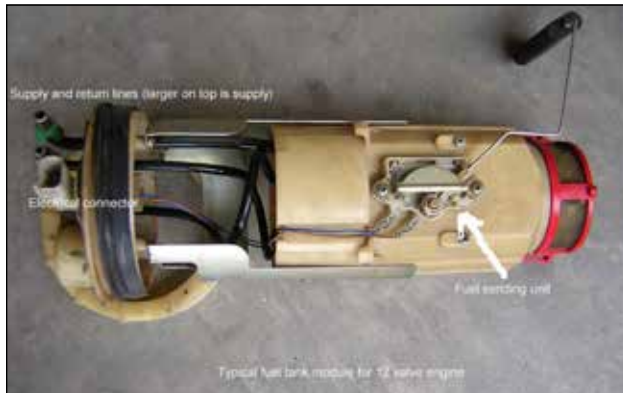
The module has metal pipes exiting the top of the module (supply and return) and has hard plastic tubing coils that extend to the bottom of the module where a removable screen covers the pickup and return. Most of them that I've dissected have a one-way check valve in the fuel pickup to assist in holding fuel prime. Many members have noted that these lines sometimes chafe and develop a pinhole, which allows for fuel aeration, not a good thing! The perforated tubing seems to have rubbed on a sharp edge, or on the mounting hardware for the lower float we previously discussed. The return also returns fuel to the bottom of the module (above tank bottom about 1/4"). This is preferable, as it allows returned fuel to be released into the remaining fuel rather than spraying on the tank's upper surface introducing foam and air.

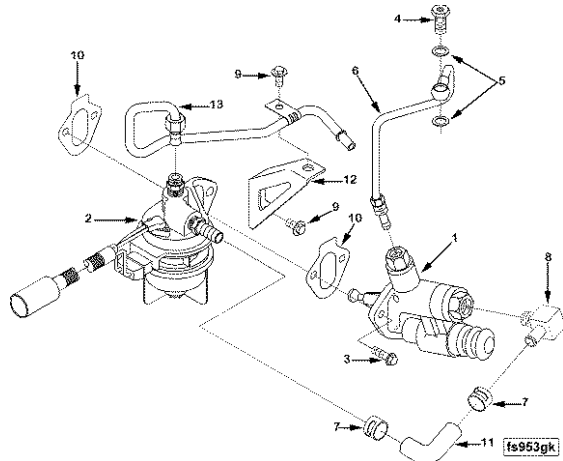
1998 12-valve illustration, part number 13 differs on 1994-1997 designs.

pre-filter screen, then the fuel heater then back out through a port and over to the transfer lift pump. This connection is made by a rubber supply line elbow that makes a sharp ninety-degree bend. I change this rubber elbow (item 11) when a transfer lift pump is serviced. Often this line is a major source of air leakage and subsequent fuel aeration.

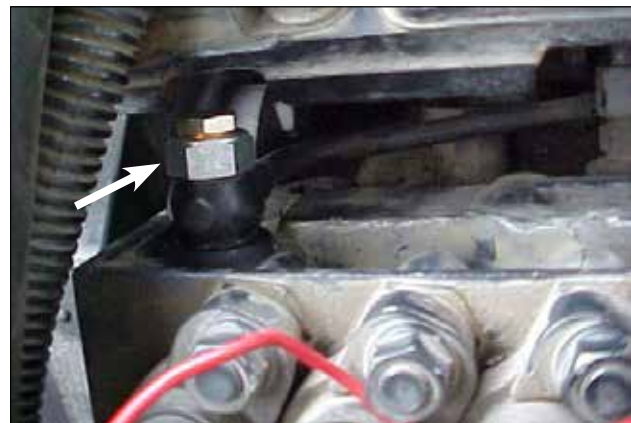
The Bosch P7100 over-flow valve.

The fuel then travels from the filter outlet to the Bosch P-7100 fuel injection pump. This concludes the delivery portion of the tour of the low-pressure fuel system. However, several other items are worth mentioning on the return circuit of the fuel system. On the backside of the injection pump near the front corner of the pump is the location of the Bosch P7100 fuel pump overflow valve. This valve opens and allows fuel return to the fuel tank at approximately 22psi. When diagnosing fuel pressure problems, one can often determine if a lift pump or overflow valve problem exists by doing the following test. Let's assume we see a 12psi reading on our fuel pressure gauge. With the engine idling and a pressure gauge attached, slowly squeeze the rubber return line (this infamous rubber fuel return line is often

problematic, but more on that subject in a minute) that runs behind the fuel filter. If the pressure gauge starts to rise, it means that the lift pump is making good pressure and that the overflow valve may be opening too soon. An overflow valve that opens at too low of a pressure will result in poor performance. Too much fuel will return to the fuel tank which robs the injection pump of fuel pressure that is necessary for proper operation. If the line pinch test makes little or no difference on the fuel pressure gauge, it would suggest that the lift pump is weak.
