TURBO DIESEL Buyer's Guide

A Publication of the *Turbo Diesel Register*

A WORD ABOUT THE TURBO DIESEL BUYER'S GUIDE

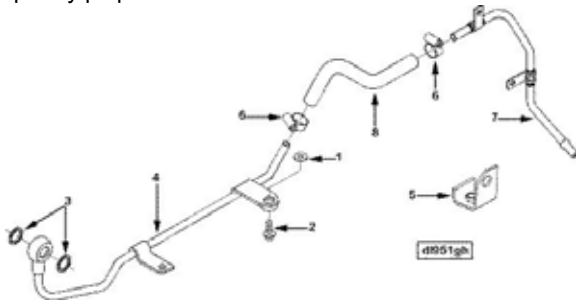
Notice the return line parts diagram: (illustration for 1998 12-valve). Part number 8, rubber fuel return line, is about three times as long on the earlier 12 valve applications. Also, part no. 7 is different as well.

Last, but not least (as evidenced by the numbers of problems that this hose has caused) is the rubber fuel return line. The illustration shows the rubber line used on a '98 12-valve. The '94-'97 trucks use a rubber line (5/16") that is about three times as long. The illustration is misleading. This hose is very difficult to see and access as it is tucked behind the fuel filter assembly.

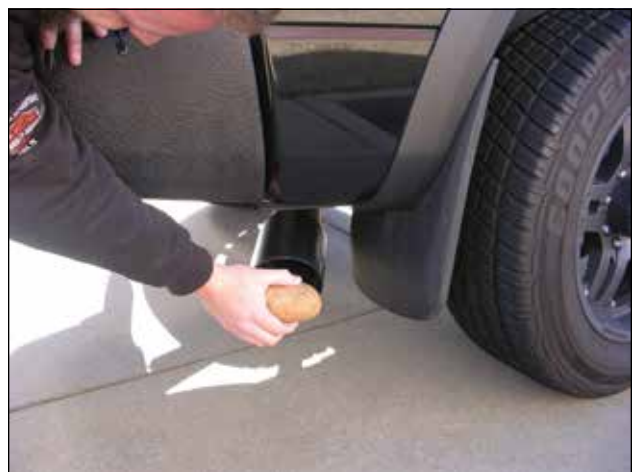
An exhaust brake is, in its simplest form, nothing but a valve that closes off the exhaust when the throttle pedal is released, a mechanical potato-up-the-tailpipe as it were. It is often referred to as a butterfly valve but, in truth, it is a one-piece, round disc on a central pivot-arm that rotates within a close-fitting housing. With the potato-up-the-tailpipe turned on, the exhaust cannot escape and back pressure builds in the exhaust system. The engine is working against itself and, since it is directly coupled to the drivetrain (a manual clutch or an automatic with a lock-up torque converter), the vehicle slows down. The faster the engine turns, the more backpressure is created, and therefore the more braking effect is felt. But that compressed exhausted air cannot be completely blocked off, it has to go somewhere in a controlled manner so that the engine is not damaged, while still allowing the brake to do its job, and this can be accomplished in a number of ways.

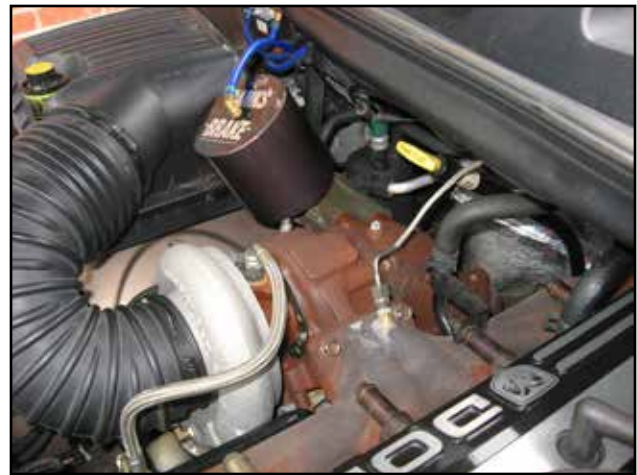
The Banks Brake on my truck is typical of turbo-mount brakes, replacing the stock transition elbow that connects the turbocharger to the downpipe. Being under the hood makes them less exposed to the elements than the inline models and also makes installation a simpler, bolt-on procedure. Mounting close to the engine also keeps the run of hoses to a minimum with less chance of damage. If you have twins or a non-stock single turbo though, this type is not an option.

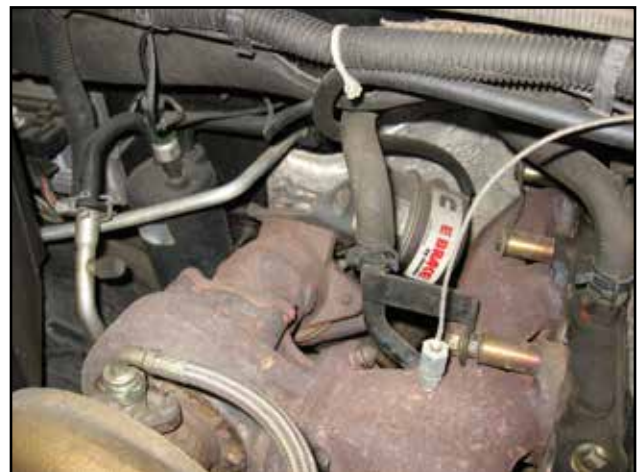
This picture is of the Cummins/Jacobs version of a turbo-mount brake installed on a 2002 truck. The vacuum cylinder is smaller and is positioned down lower next to the firewall than the Banks version.

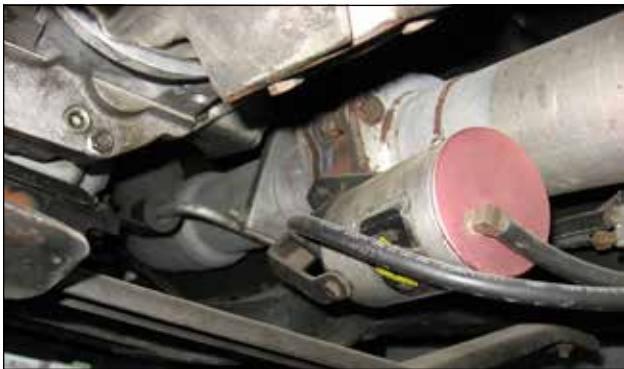
You can see that the inline, under-truck mounted exhaust brakes install in the exhaust pipe instead of directly on the turbo. They are a little more work to install because the existing exhaust pipe must be cut to allow the brake housing to be inserted. They are more exposed to the weather in this location. This one has the flanges nicely welded to the 4" pipe for a leak-free installation.

This second type of installation is an inline brake and it can be mounted anywhere on the exhaust, usually after the downpipe, but the closer to the turbo the better so as to reduce the volume of air that has to be compressed in use. Mounting further down the exhaust system would result in a delay in activation while the larger volume of air in the pipe is compressed to operating pressure. The installation of this type of brake requires some exhaust work, cutting and removing a section of the existing exhaust pipe and inserting the brake in that area with the supplied flanges, clamps and connectors. Because it is installed under the truck, this type is more routinely exposed to the elements and, as such, will require more attention than the under-the-hood turbo mounted brake. Maintenance on any brake is minimal, with some manufacturers supplying a lubricant for the main pivot bearing while others are completely maintenance-free other than to check the hoses and fittings for wear or leaks.

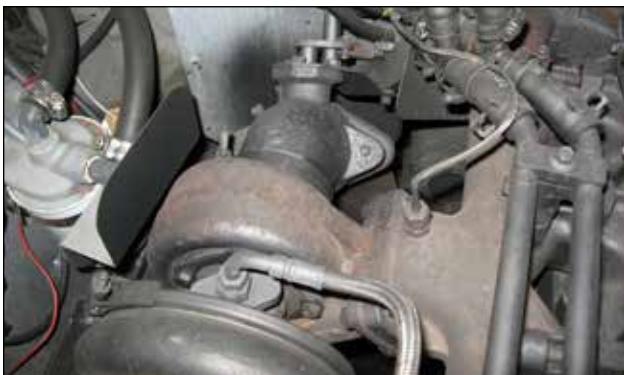
This picture shows a PacBrake installed on a First Generation, manual transmission equipped truck and is very similar to the Jacobs in the positioning of the air cylinder.

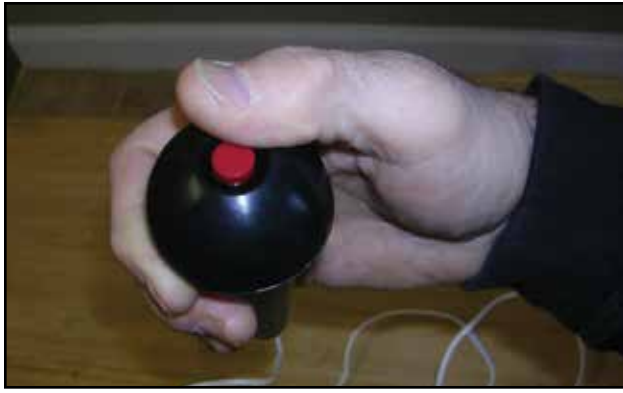
Those with a manual transmission can use this gear shift with a switch at the top to turn on/off the exhaust brake. Trick, eh?

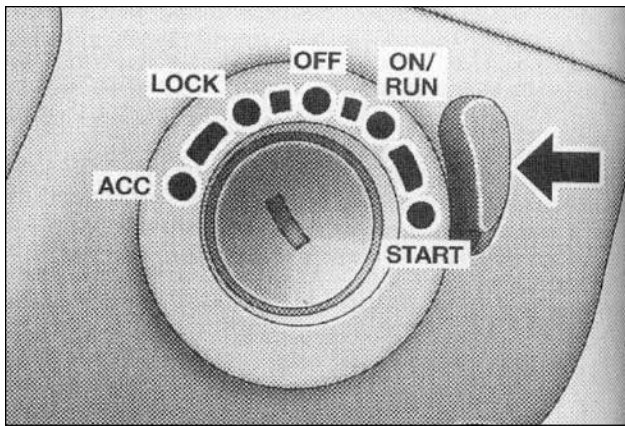
I'll save you the time finding the photobucket video. The technique is the same as it has been since 1994. (I think it is that long ago.) Here is a diagram from your owner's Manual so that we're using the same words.

- Insert key
- Move it from Lock to Off, pause
- Move to On/Run
- Back to Off
- Move to On/Run
- Back to Off
- Move to On/Run and stop

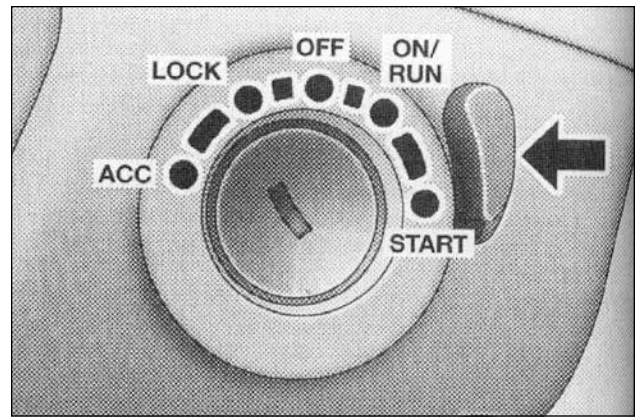
I'll save you the time finding the photobucket video. The technique is the same as it has been since 1994. (I think it is that long ago.) Here is a diagram from your owner's Manual so that we're using the same words.

- Insert key
- Move it from Lock to Off, pause
- Move to On/Run
- Back to Off
- Move to On/Run
- Back to Off
- Move to On/Run and stop

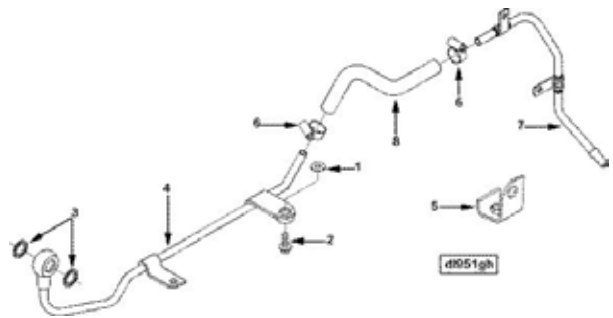
Look closely for the problematic fuel return line.
