HAVE RAM, WILL TRAVEL

**IS THIS THE “KDP” OF THE 6.7 ENGINE?
PART ONE OF MY TURBO ACTUATOR STORY**

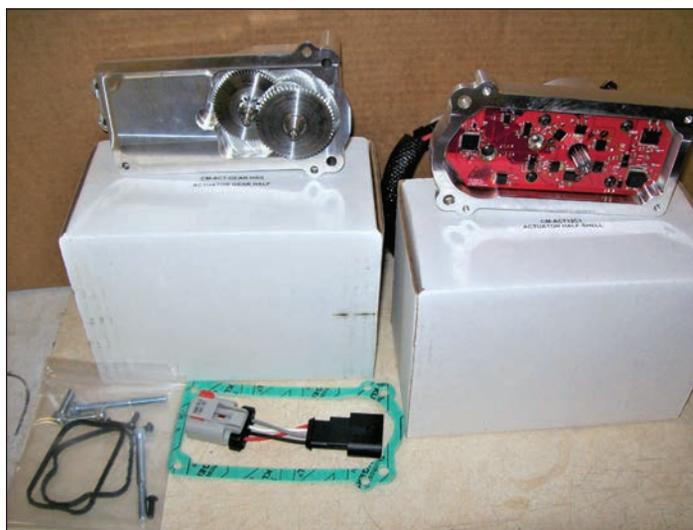
The City Diesel gearbox on the left, and the electronics and drive gear module on the right. This photo shows the halves that mate together, with the gasket and controller cable adapter below.

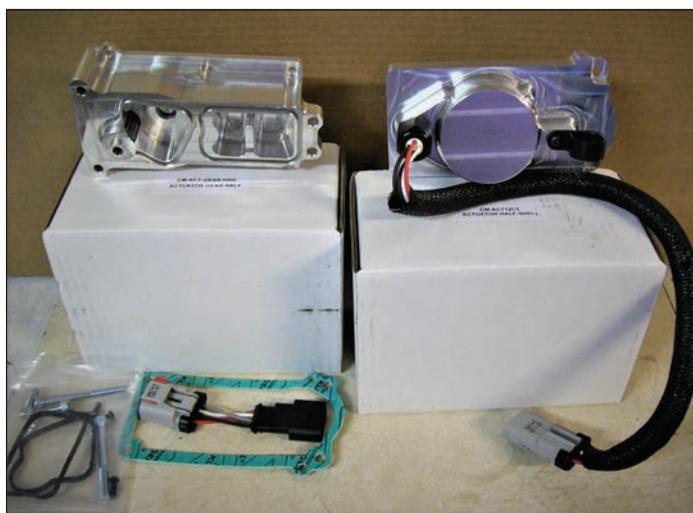
This photo shows the opposite sides of the City Diesel actuator. Both halves are machined from billet aluminum, not made of castings like the Cummins OEM parts.

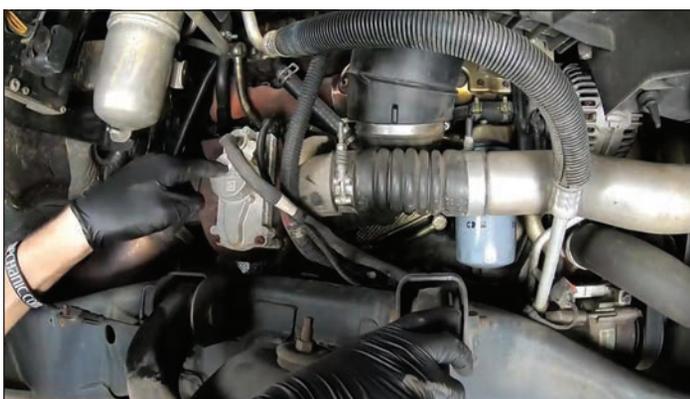
Stock actuator on a 2007.5 Turbo Diesel, as shown in David Pike’s video.

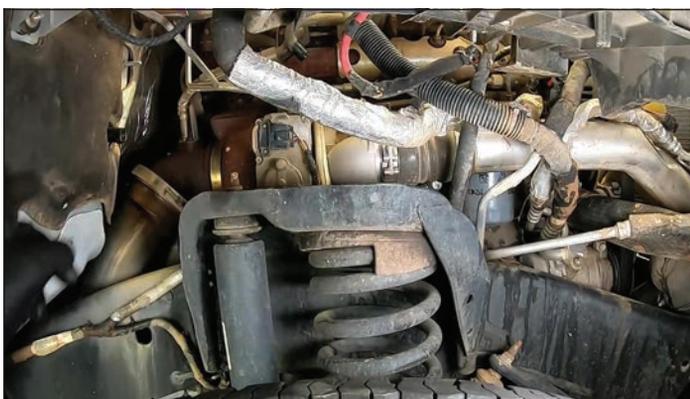
Stock actuator on a 2013-up Turbo Diesel, as shown in David Pike’s video.
