ISSUE 40

2003

BRAKE ROTORS AND U-JOINTS

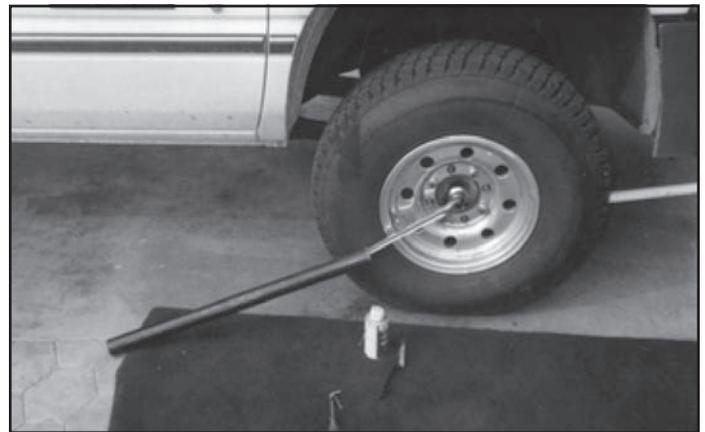
Removing the axle nut.

I did not experience any problem in removing the brake rotor/hub assembly, possibly because rust is not much of an issue here in the Southwest. However, I did find some helpful tricks that might benefit people in other parts of the country when performing this work. First, before removing the axle nut in the center of the wheel, soak it in rust removal solvent such as Mopar 4318039. Some folks had the threads on the end of the axle damaged when removing the nut, so be sure it is well lubricated with penetrating oil/derusting agent. This 1 11/16" nut is very tight (torque value 175 ft. lbs.) so don't jack up the truck first! I used 3/4" drive socket, breaker bar, and cheater pipe after pulling the cotter pin (a 5/32" by 1.75" or 2" long cotter pin works well for replacement).
